AIRCRAFT INCIDENT REPORT AND EXECUTIVE SUMMARY

Reference:	CA18/3/2/1067	
Aircraft Registration	ZS-NMF / ZS-SZZ	Date of Incident	10 July 2014		Time of Incident	1108Z
Type of aircraft	Bombardier CL600 / Airbus A320		Type of operation		Part 121 - Commercial	
Pilot-in-command licence type		Airline Transport	Age	38	Licence valid	Yes
Pilot-in-command flying experience		Total flying hours	8 724.1		Hours on type	1 657.5
Last point of departure		King Shaka International aerodrome (FALE), Kwa-Zulu Natal province				
Next point of intended landing		Port Elizabeth aerodrome (FAPE), Eastern Cape province				
Location of the incident site with reference to easily defined geographical points (GPS readings if possible)						
Overhead Port Elizabeth (GPS position: 33°59'38.02" South 025°35'35.30" East)						
Meteorological information		Surface wind; 040°5 knots, Temperature; 18°C, Visibility; +10 km				
Number of people on board	3 + 27	No. of people injured	0	No. of people killed	0

AIRCRAFT INCIDENT REPORT

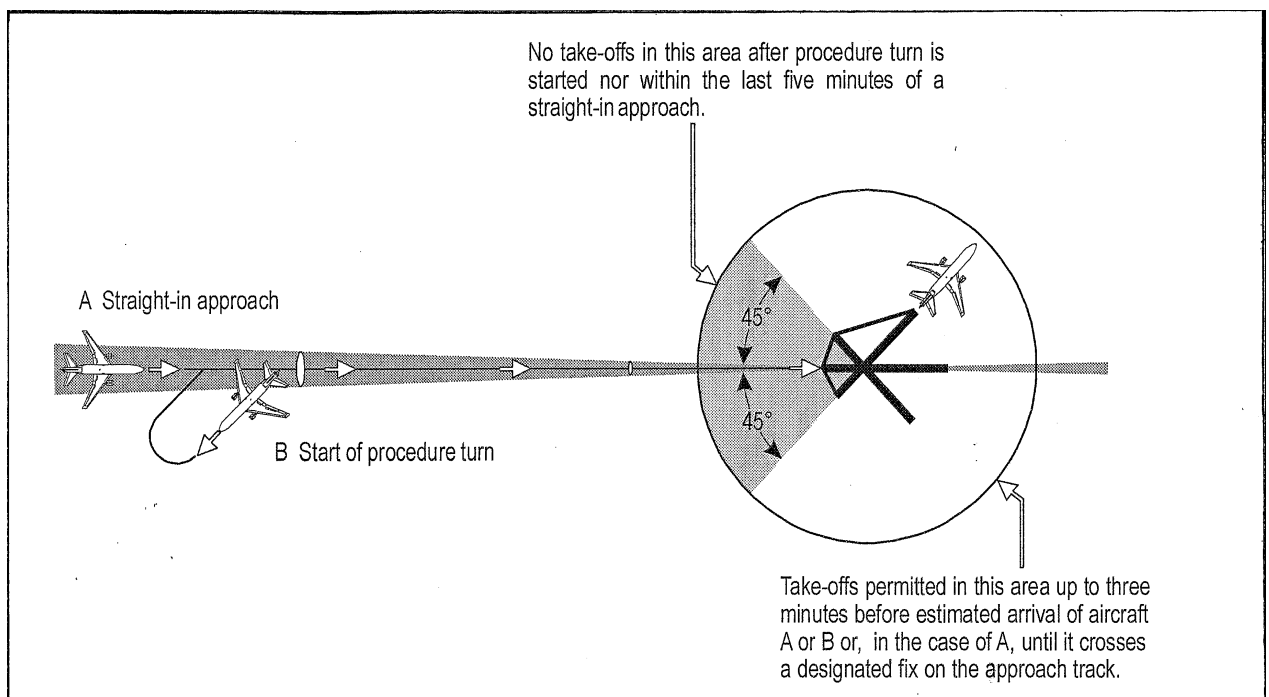
Figure 5. Separation of departing aircraft from arriving aircraft

- a) in any direction until an arriving aircraft has started its procedure turn or base turn leading to final approach;*
- b) in a direction which is different by at least 45 degrees from the reciprocal of the direction of approach after the arriving aircraft has started procedure turn or base turn leading to final approach, provided that the take-off will be made at least 3 minutes before the arriving aircraft is estimated to be over the beginning of the instrument runway (see figure 5).*

1) until 3 minutes before the arriving aircraft is estimated to be over the beginning of the instrument runway (see figure 5); or
