# **Air Accident Investigation Sector**

**Serious Incident**

**- Final Report -**

## **Hydraulic Fluid Mist and Protective Breathing Equipment Fire in the Passenger Cabin**

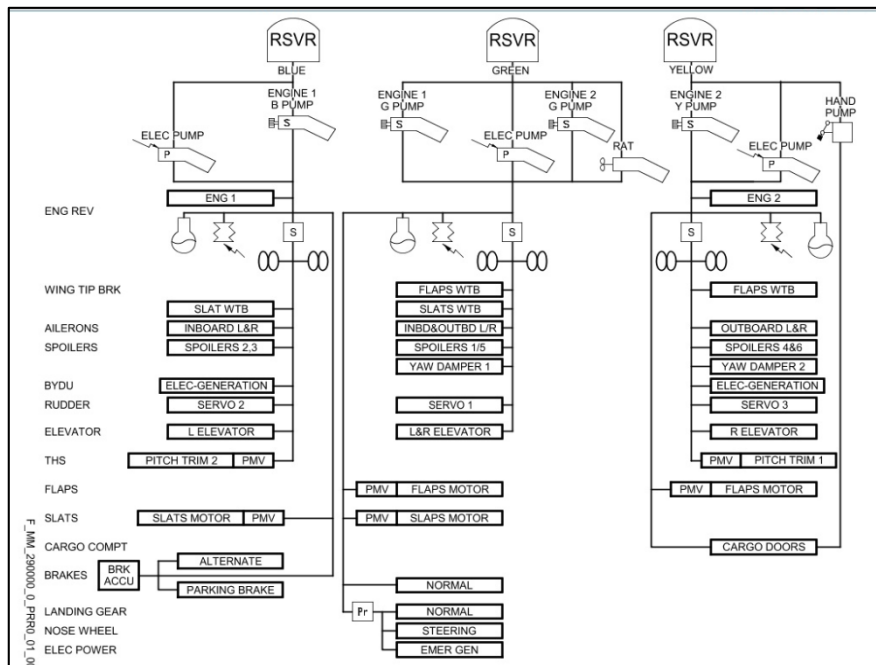
Figure 2. Hydraulic system architecture

A schematic of the hydraulic power supply to the various flight controls is illustrated in figure 2.

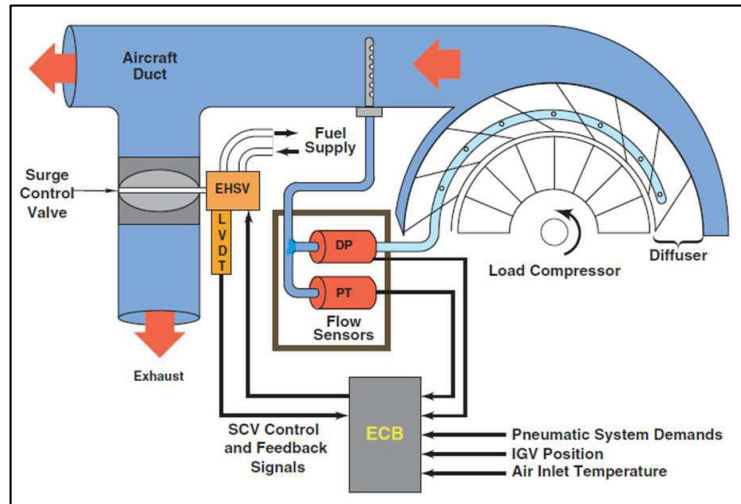
Figure 5. Bleed system schematic

The leaking hydraulic fluid that entered the APU inlet had been heated and atomized as it passed through the load compressor and diffuser.

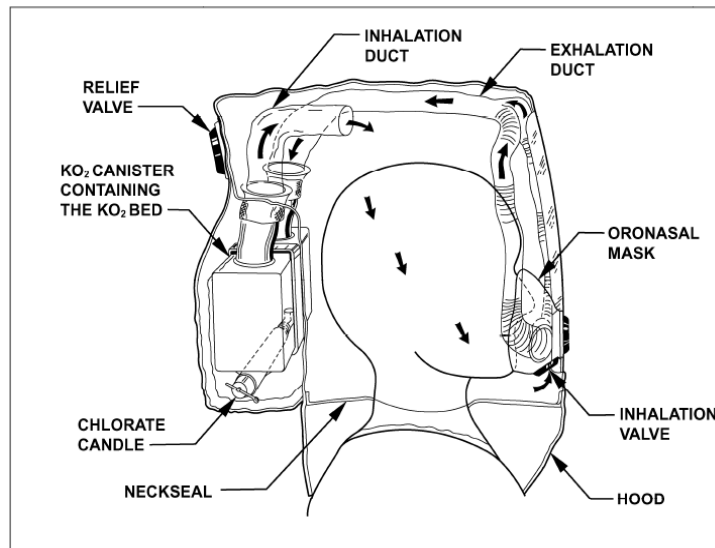
**Figure 7.** PBE schematic

The PBE is equipped with a hood which fits over the user's head, sealing against the user's neck to protect against the ingress of smoke and fumes, and has polycarbonate visors on its front and sides that allow the user to identify and combat the fire. (Figure 7).

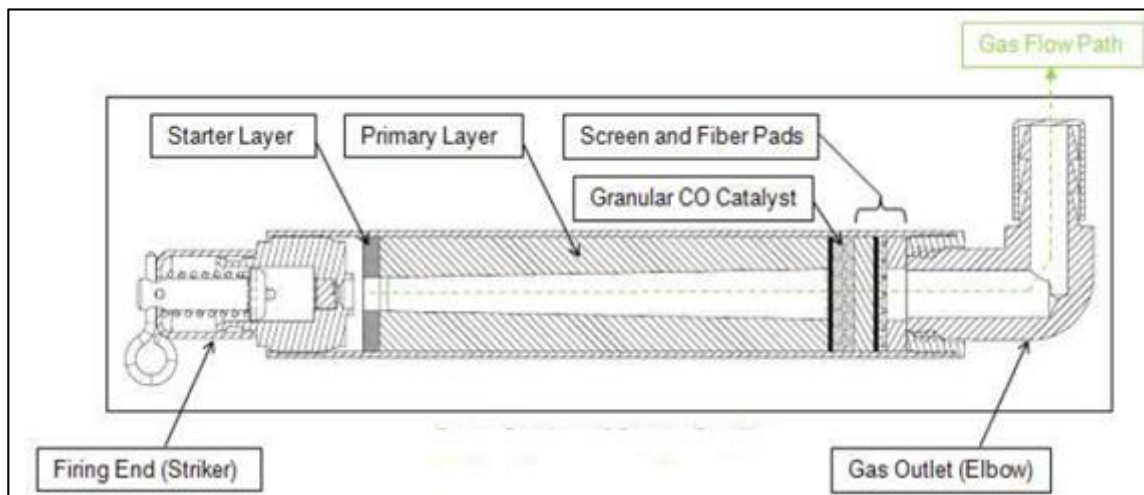
**Figure 8.** Cross section of the starter candle [Source: B/E Aerospace CT scan report]

The chlorate starter candle is designed to deliver a fixed volume of approximately eight liters of oxygen over duration of less than 20 seconds by the chemical decomposition of sodium chlorate. The starter candle is contained in a small stainless steel cylinder affixed to the base of the  $KO_2$  canister (figure 8).

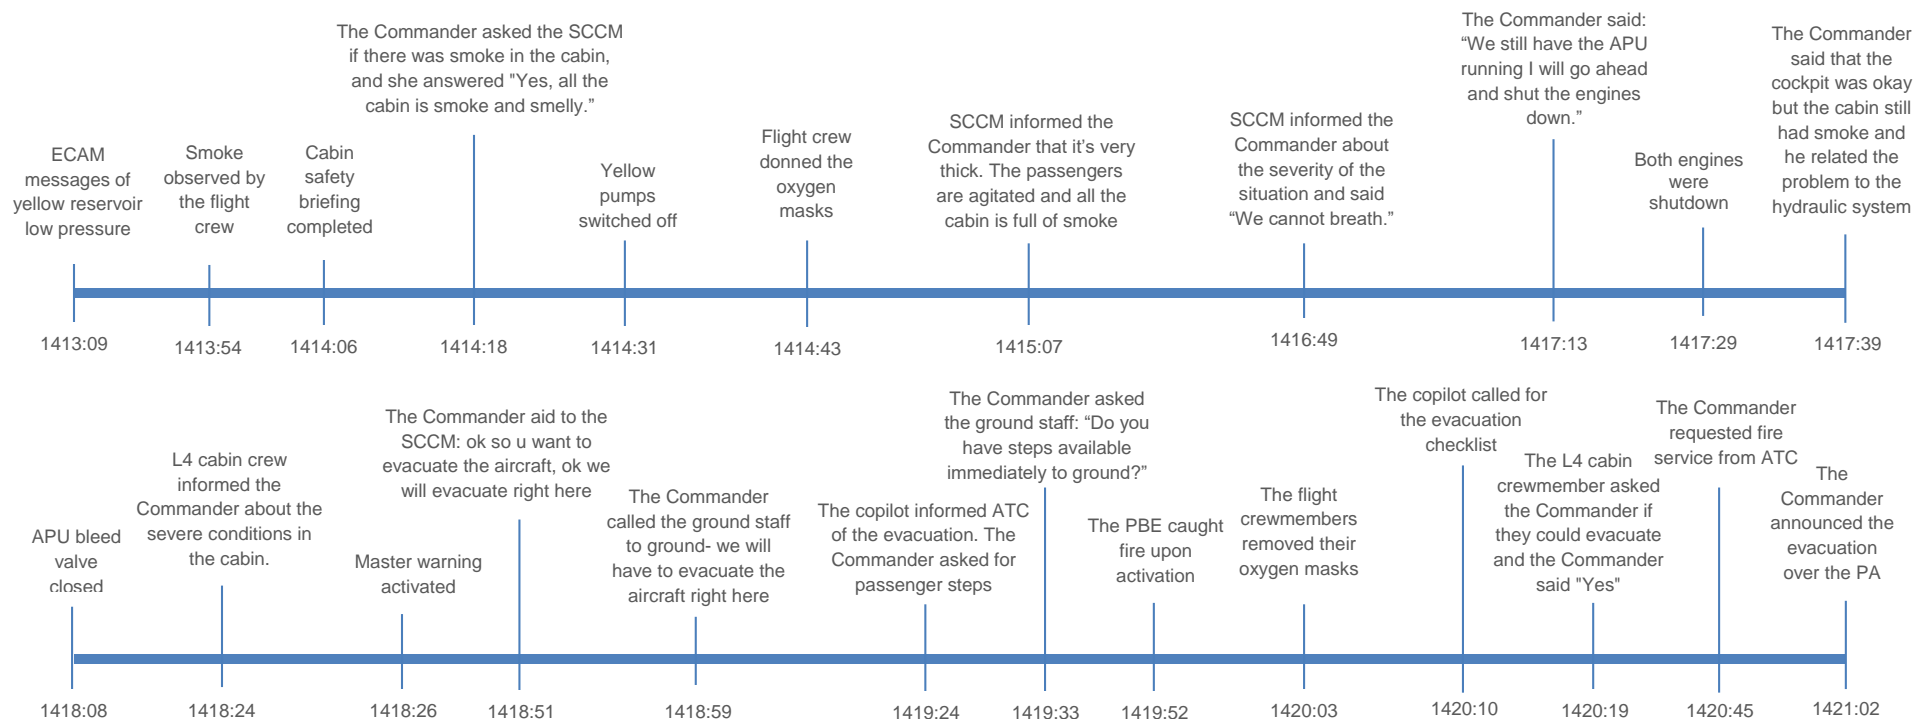
Figure 9. Timeline of emergency related events

The cabin crew managed the emergency by using the Aircraft's PA system. The megaphones were not used to provide evacuation instructions. The PBE unit that caught fire had been installed next to the L3 door, but the cabin crewmember who was positioned at L3 door handed the PBE to the cabin crewmember who was positioned at door L1A and had gone to the aft cabin to assist the other crewmembers. As the L1A crewmember was having difficulties with breathing and seeing, she was handed the PBE that had now been removed from its sealed package, and immediately donned it and pulled the straps as per the procedure. Figure 9 illustrates the time line of events relevant to the emergency management.

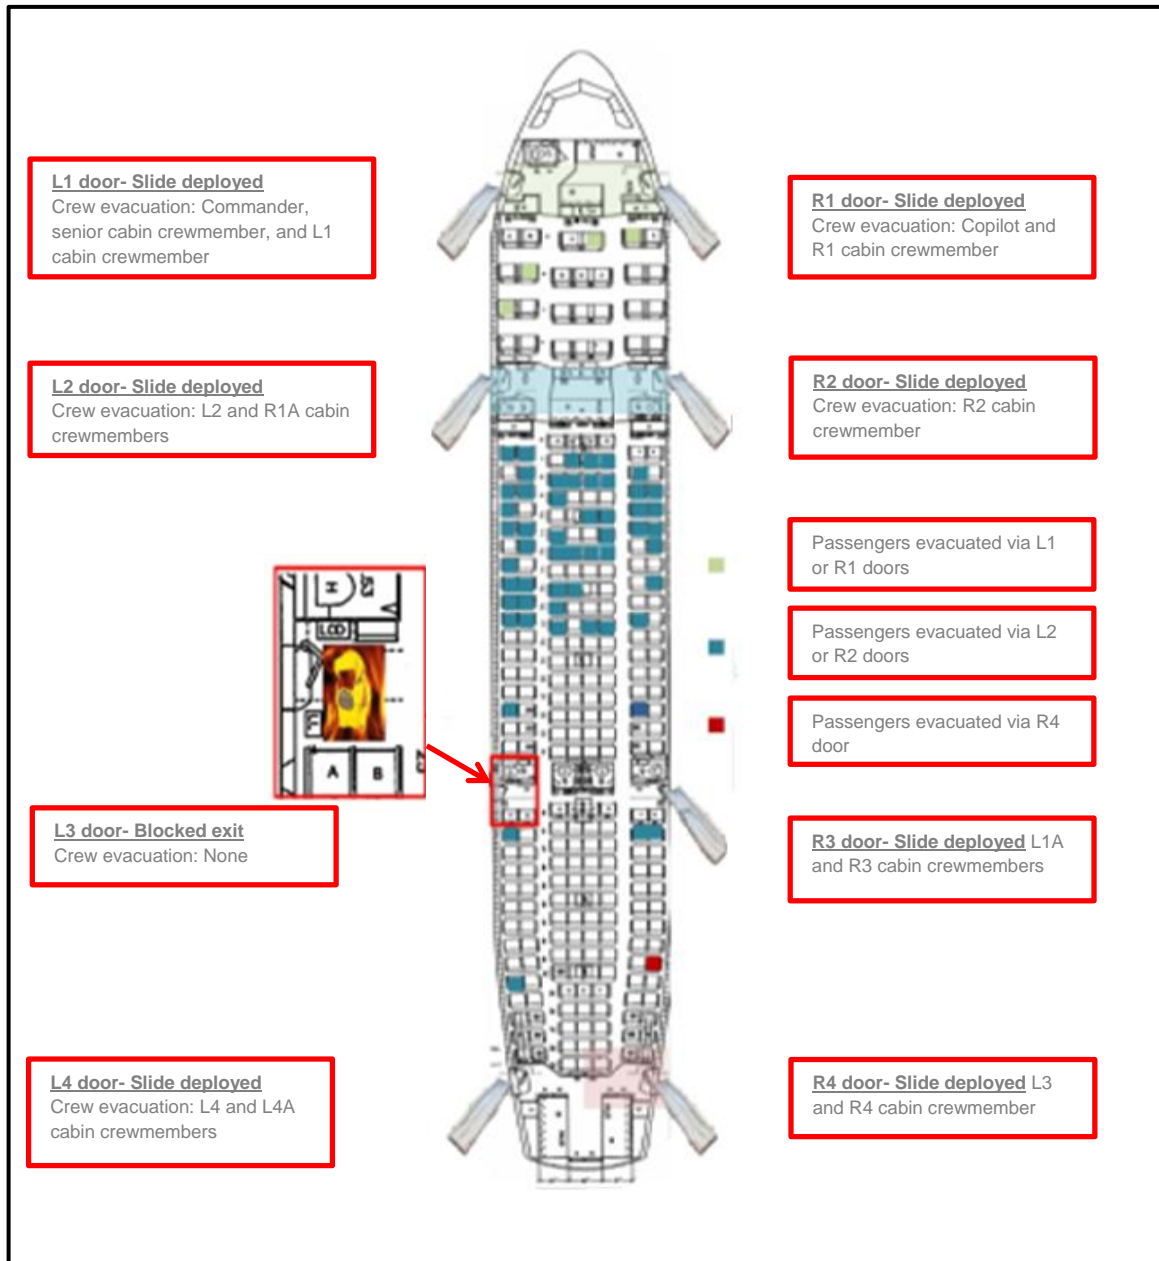
Figure 10. Evacuation doors [Source: the Operator]

The evacuation of the Aircraft was well-managed with only minor injuries to some of the passengers. Following the evacuation, the passengers wandered close to the Aircraft as they were not given directions as to what to do or where to go. Figure 10 illustrates the doors used during the evacuation and the slides deployed, and from which doors the crew and passengers evacuated.
