**KOMITE NASIONAL KESELAMATAN TRANSPORTASI
REPUBLIC OF INDONESIA**

Aircraft Accident Investigation Report

PT. Kalstar Aviation

Embraer 190-200LR; PK-KDC

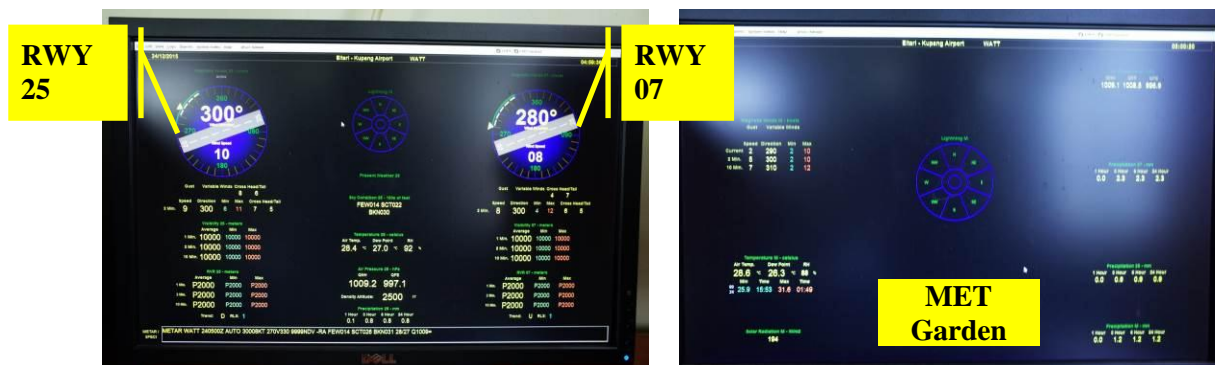
Figure 4: The display of AWOS

Kupang Meteorological Station utilized Automated Weather Observation System (AWOS) with three different displays from three different sensor locations. The first sensor was located at the touchdown area of runway 07 – approximately 130 meters on the left of runway 07 centerline and approximately 400 meters from the beginning of runway 07. The second sensor was located at the touchdown area of runway 25 – approximately 98 meters on the right of runway 25 centerline and approximately 350 meters from the beginning of runway 25. The third sensor was located near the tower building named MET Garden.

The AWOS information displayed in Meteorology Station office and also in El Tari Tower station. The display showed information according to its sensor location, which were labeled 07, 25 and M (Figure 4).

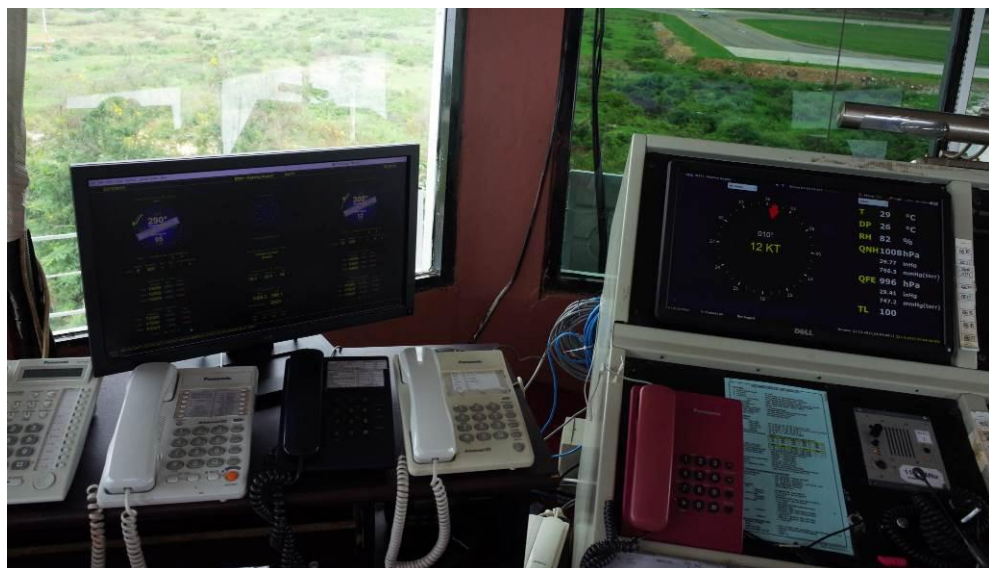
Figure 5: AWOS display (left) and Tower Set display (right).

On 1 December 2015, the AirNav Indonesia District Office Kupang as a unit providing Air Traffic Services at Kupang installed a new tower set display to provide meteorological information. The display provides information of wind, temperature, dew point, QNH and QFE (Figure 5).

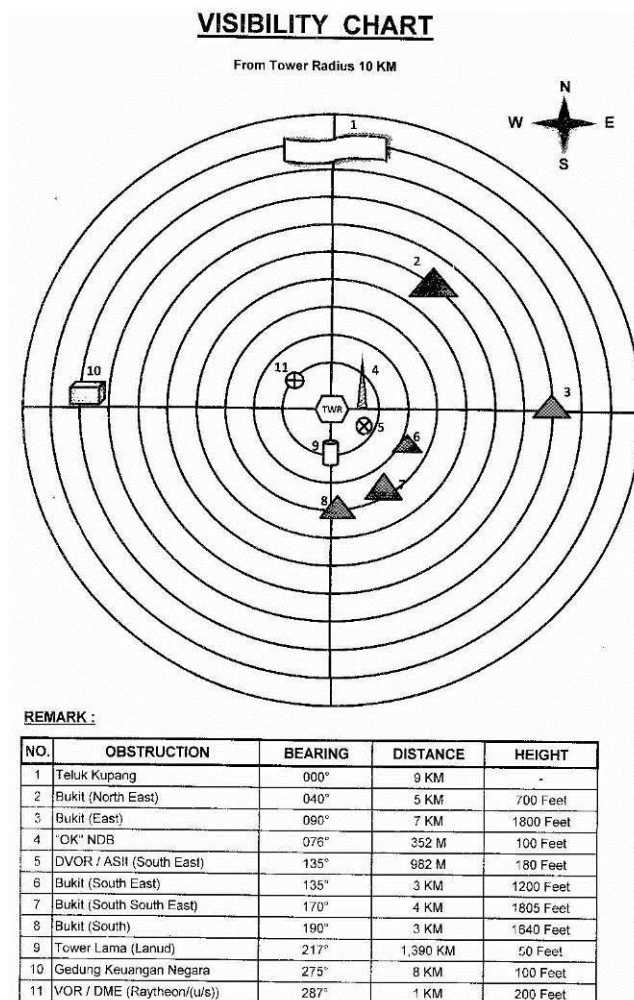
Figure 6: El Tari visibility chart

The air traffic controller was provided with visibility information by the AWOS display and visibility chart that was provided in tower (Figure 6).

Based on the interview of the air traffic controller on duty, the visibility chart is used to compare the information on the AWOS display with the actual conditions based on the air traffic controller observation from tower.

There were several landmarks that were used as reference points to determine the visibility. The landmarks were selected to provide visibility information. The investigation could not find the standard operating procedure that describes the usage of the visibility chart.

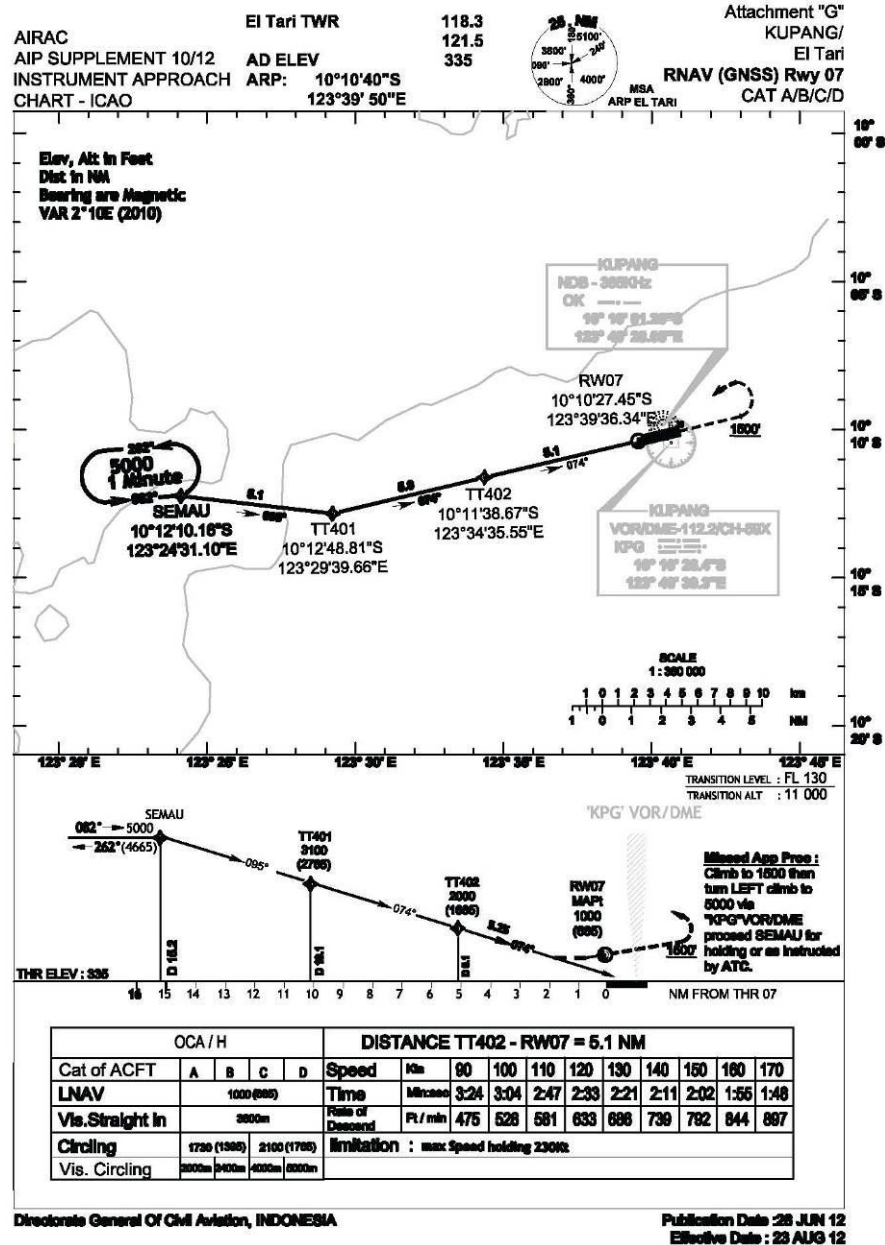
Figure 8: RNAV approach Runway 07 chart published on AIP supplement

Runway 07 Kupang was equipped with a Global Navigation Satellite System (GNSS) that can be used for RNAV Approach since 23 August 2012. The detail of RNAV Approach can be seen figure 7.

Approach guidance facilities such as Precision Approach Path Indicator (PAPI) lights and runway lights were all serviceable.

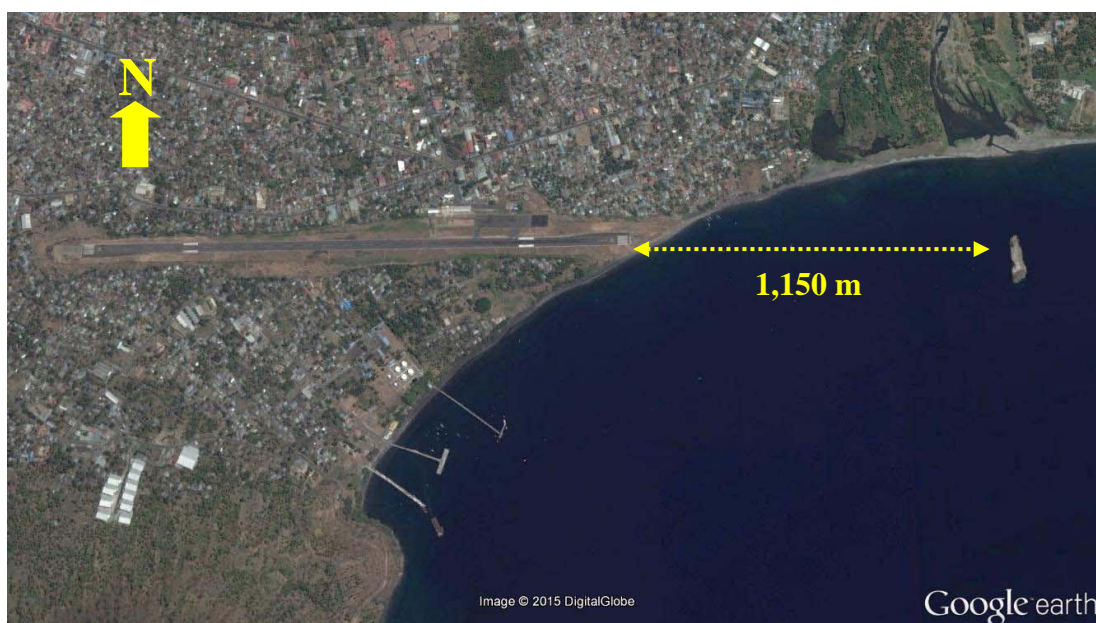
Figure 10: Atoll in final path runway 27

There was an atoll on final path runway 27 located at about 1,150 meters (0.62 Nm) from beginning of runway 27 and the height of atoll was approximately 180 feet.

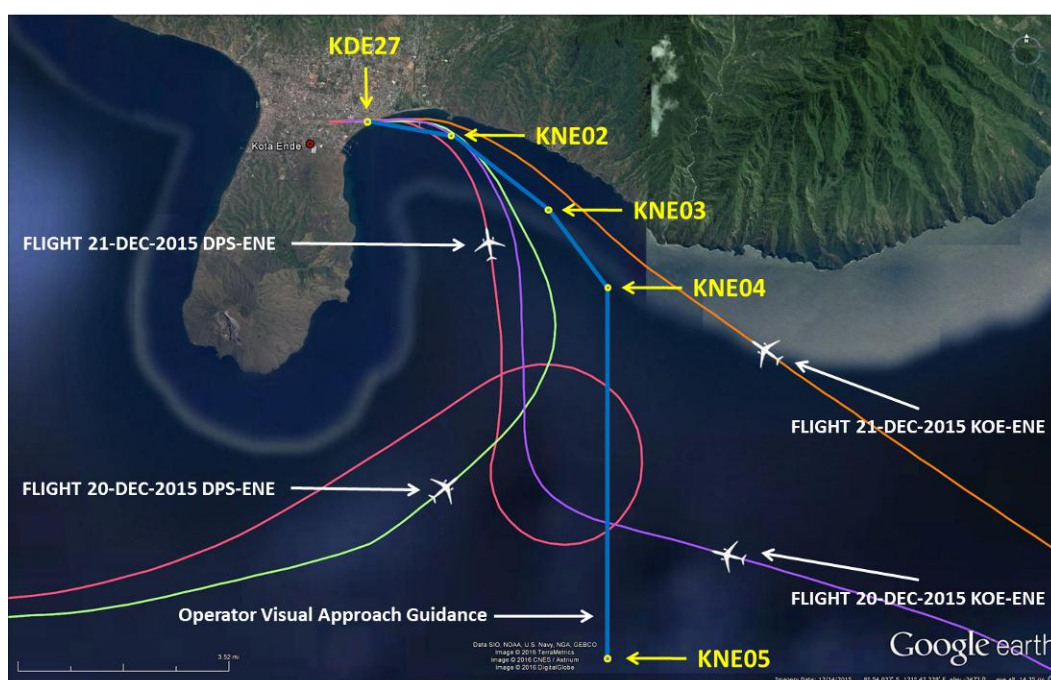
Figure 13: Flight paths of approach to Ende on 20 and 21 December 2015

The DVDR recorded four approach flights to Ende including the flight on 20 and 21 December 2015 prior to the accident flight. The recorded approach flight paths were as follows:

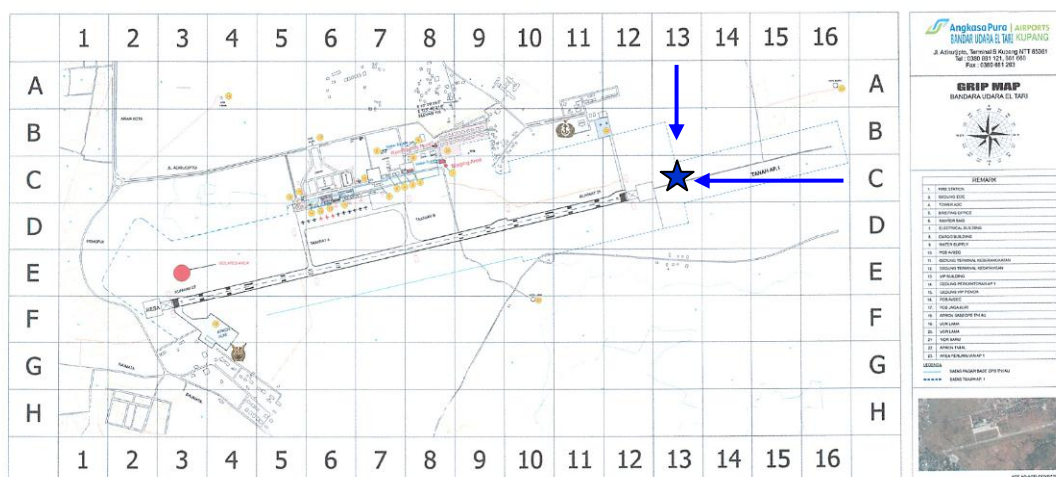
Figure 19: The aircraft location on grid map

At 0946 UTC, the El Tari Tower controller noticed that the aircraft overran the runway and pushed the crash bell to inform the Aircraft Rescue and Fire Fighting (ARFF) personnel. The controller then called the ARFF personnel and informed that there was aircraft overrun from runway 07 on sector C13 of the grid map (Figure 19). The ARFF team then deployed three vehicles.

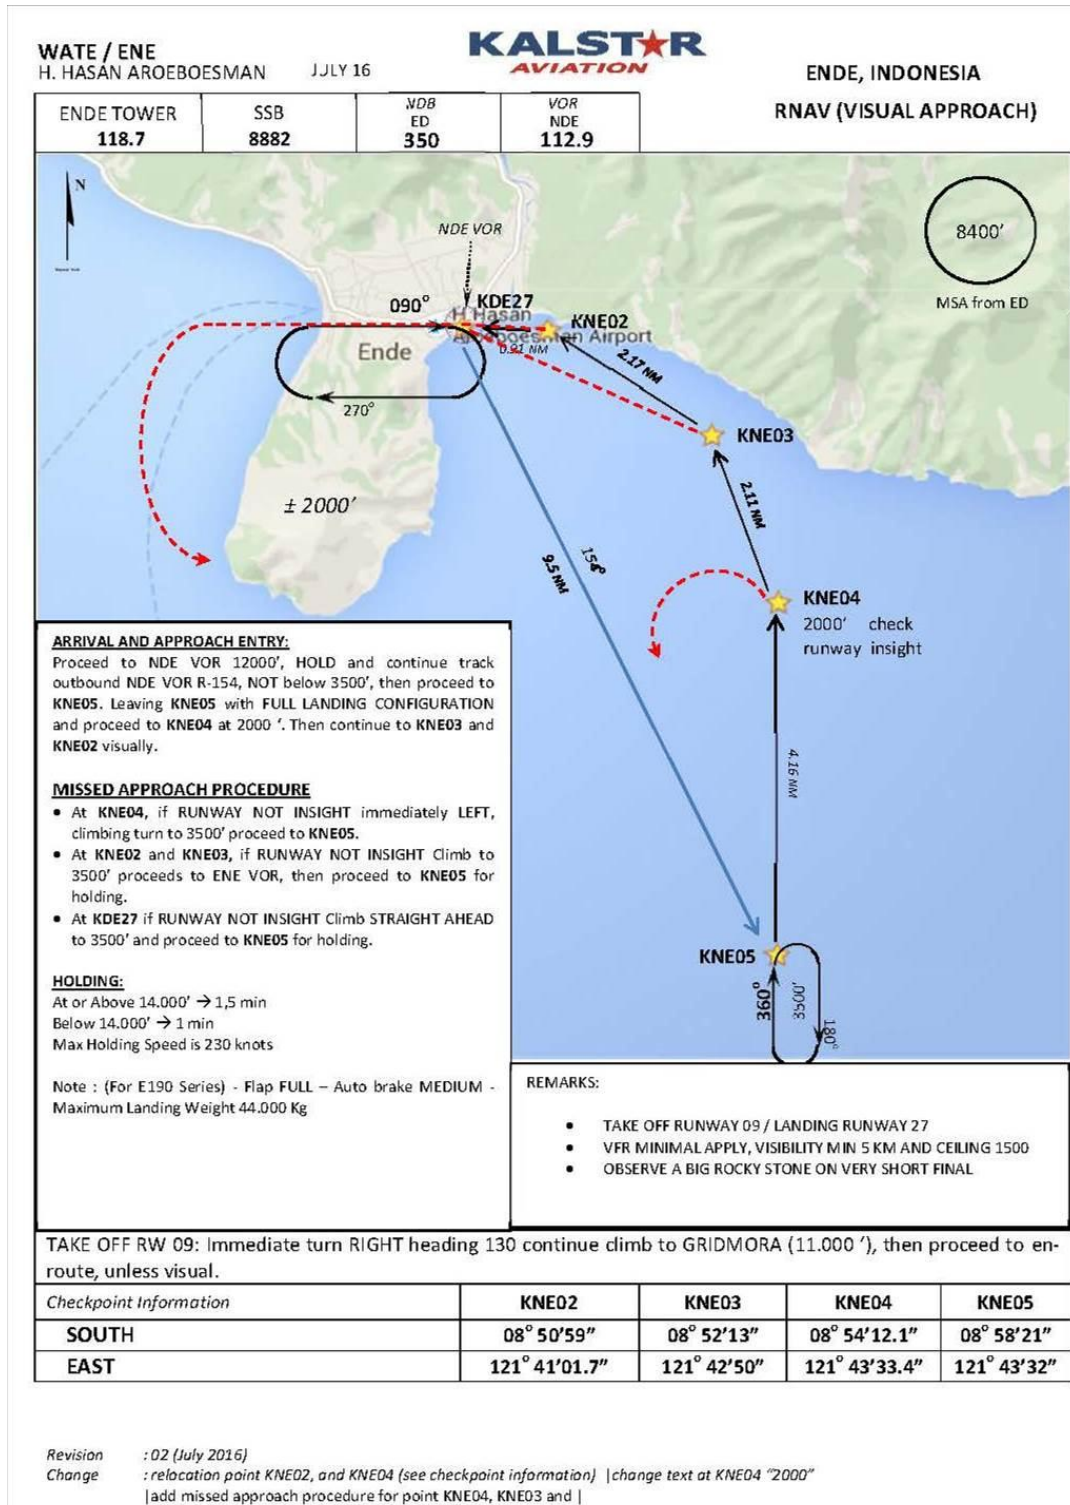
WATE/ENE - ENDE, INDONESIA

1. Windshock : Available
2. Obstacle : High Trees & Hills on Extension RW 27
3. Fuel : Available
4. Special Info :
 - Observe obstacle (100') on Final RW 27
 - Caution strong sea breeze occurred during dry season on short final RW 27
