This document is an English translation of the Final Report on the fatal accident involving the Boeing 747-412F aircraft registered TC-MCL that occurred on January 16th, 2017 at Manas International Airport, Bishkek, Kyrgyz Republic.

**INTERSTATE AVIATION COMMITTEE
AIR ACCIDENT INVESTIGATION COMMISSION**

**FINAL REPORT
ON RESULTS OF THE AIR ACCIDENT INVESTIGATION**

Type of occurrence	Fatal accident
Type of aircraft	Boeing 747-412F
Registration mark	TC-MCL
Owner	LCI Freighters One Limited (Ireland)
Operator	ACT Airlines
Aviation Authority	Directorate General of Civil Aviation of Turkey (Turkish DGCA)
Place of occurrence	Near Manas International Airport, Bishkek, Kyrgyz Republic, coordinates: N 43°03.248' E 074°2.271'
Date and time	16.01.2017, 07:17 local time (01:17 UTC), night time

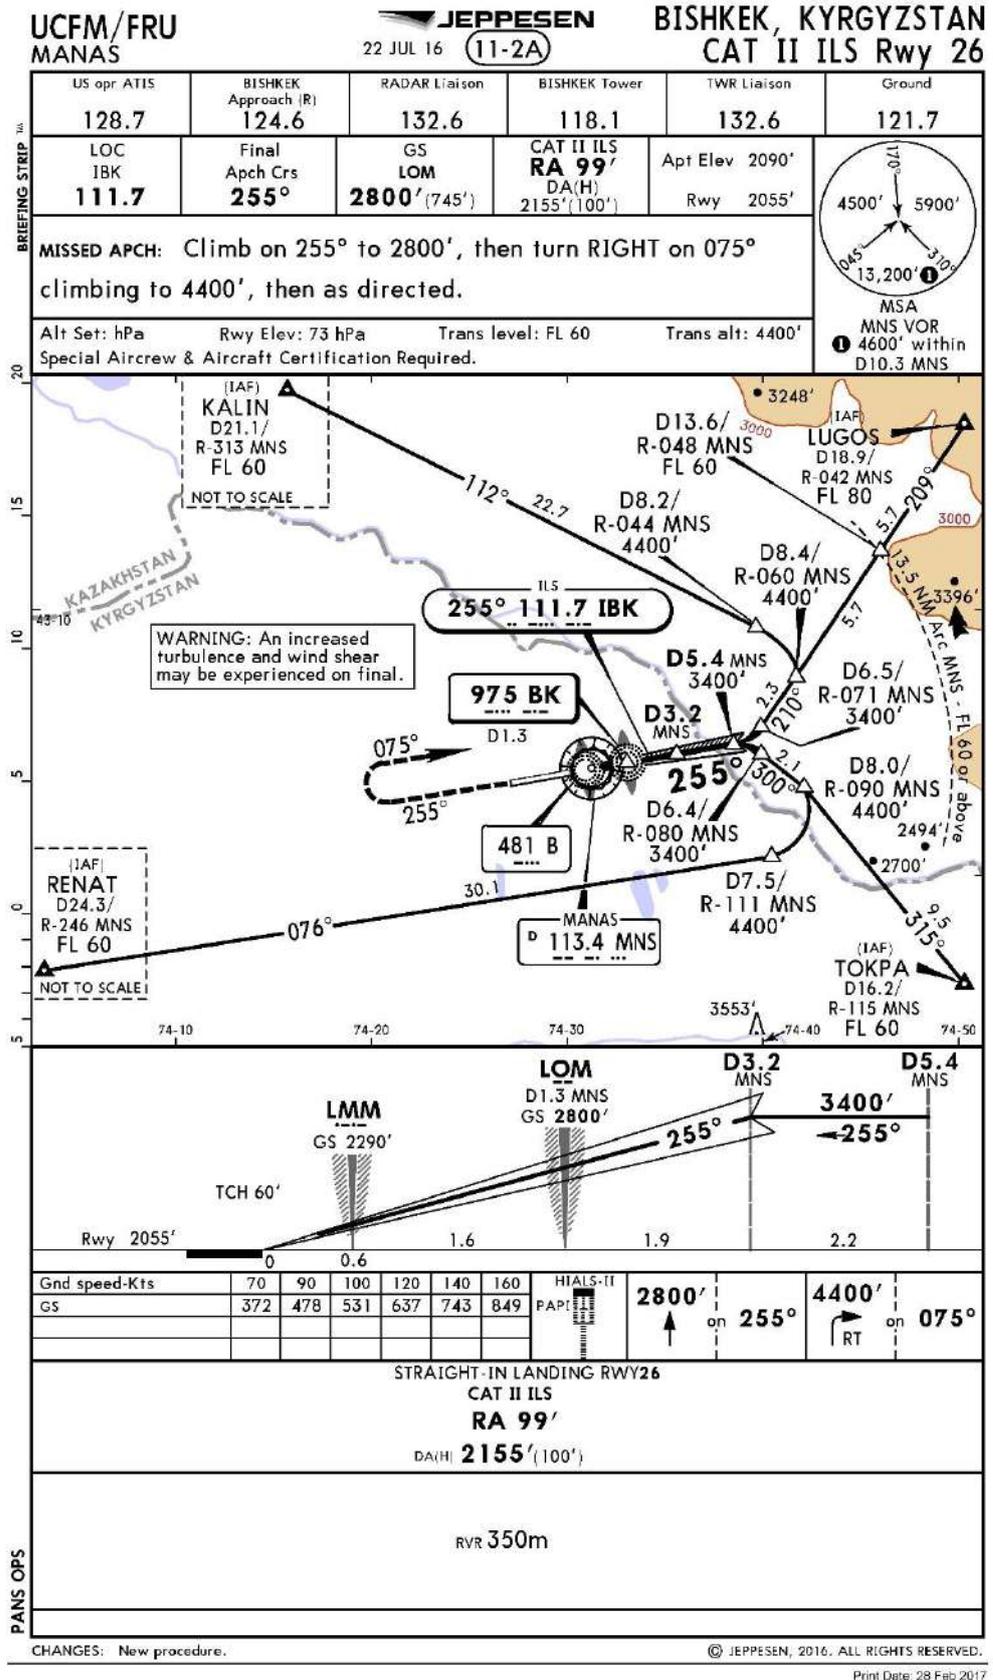
Figure 23. RWY 26 approach chart (Jeppesen)

The flight past TOKPA was performed at 01:11:18, the aircraft reached 9200 ft in descent with the IAS of approximately 270 kt. According to the chart, the flight past TOKPA must be conducted at 6000 ft (FL 060) or above. Thus, the chart requirements were not formally violated, but the aircraft was too high for continuing the approach in accordance with the chart without additional maneuvering for decreasing the altitude (Figure 23 and Figure 24).

The flight past the D 8.0/R-090 MNS 4400 guidepoint was performed at 01:13:28 at 6500 ft with the IAS of 220 kt (Figure 37). Thus, the aircraft was 2100 ft higher than the approach chart requires. (Figure 23 and Figure 24).

According to the Boeing 747 FCOM and ACT Airlines SOP, at the point of Final Approach Fix (FAF), the crew must check the flight altitude. The onboard recorder contains no data confirming that the crew performed this procedure. For Manas aerodrome (Bishkek), this point corresponds to the Final Approach Point (FAP D 6.0 ¹⁴3400' and is provided in the RWY 26 approach chart of AIP of the Kyrgyz Republic (Figure 24)). In Jeppesen Route Manual, which was used by the crew (Figure 23), the FAP/FAF is not shown.

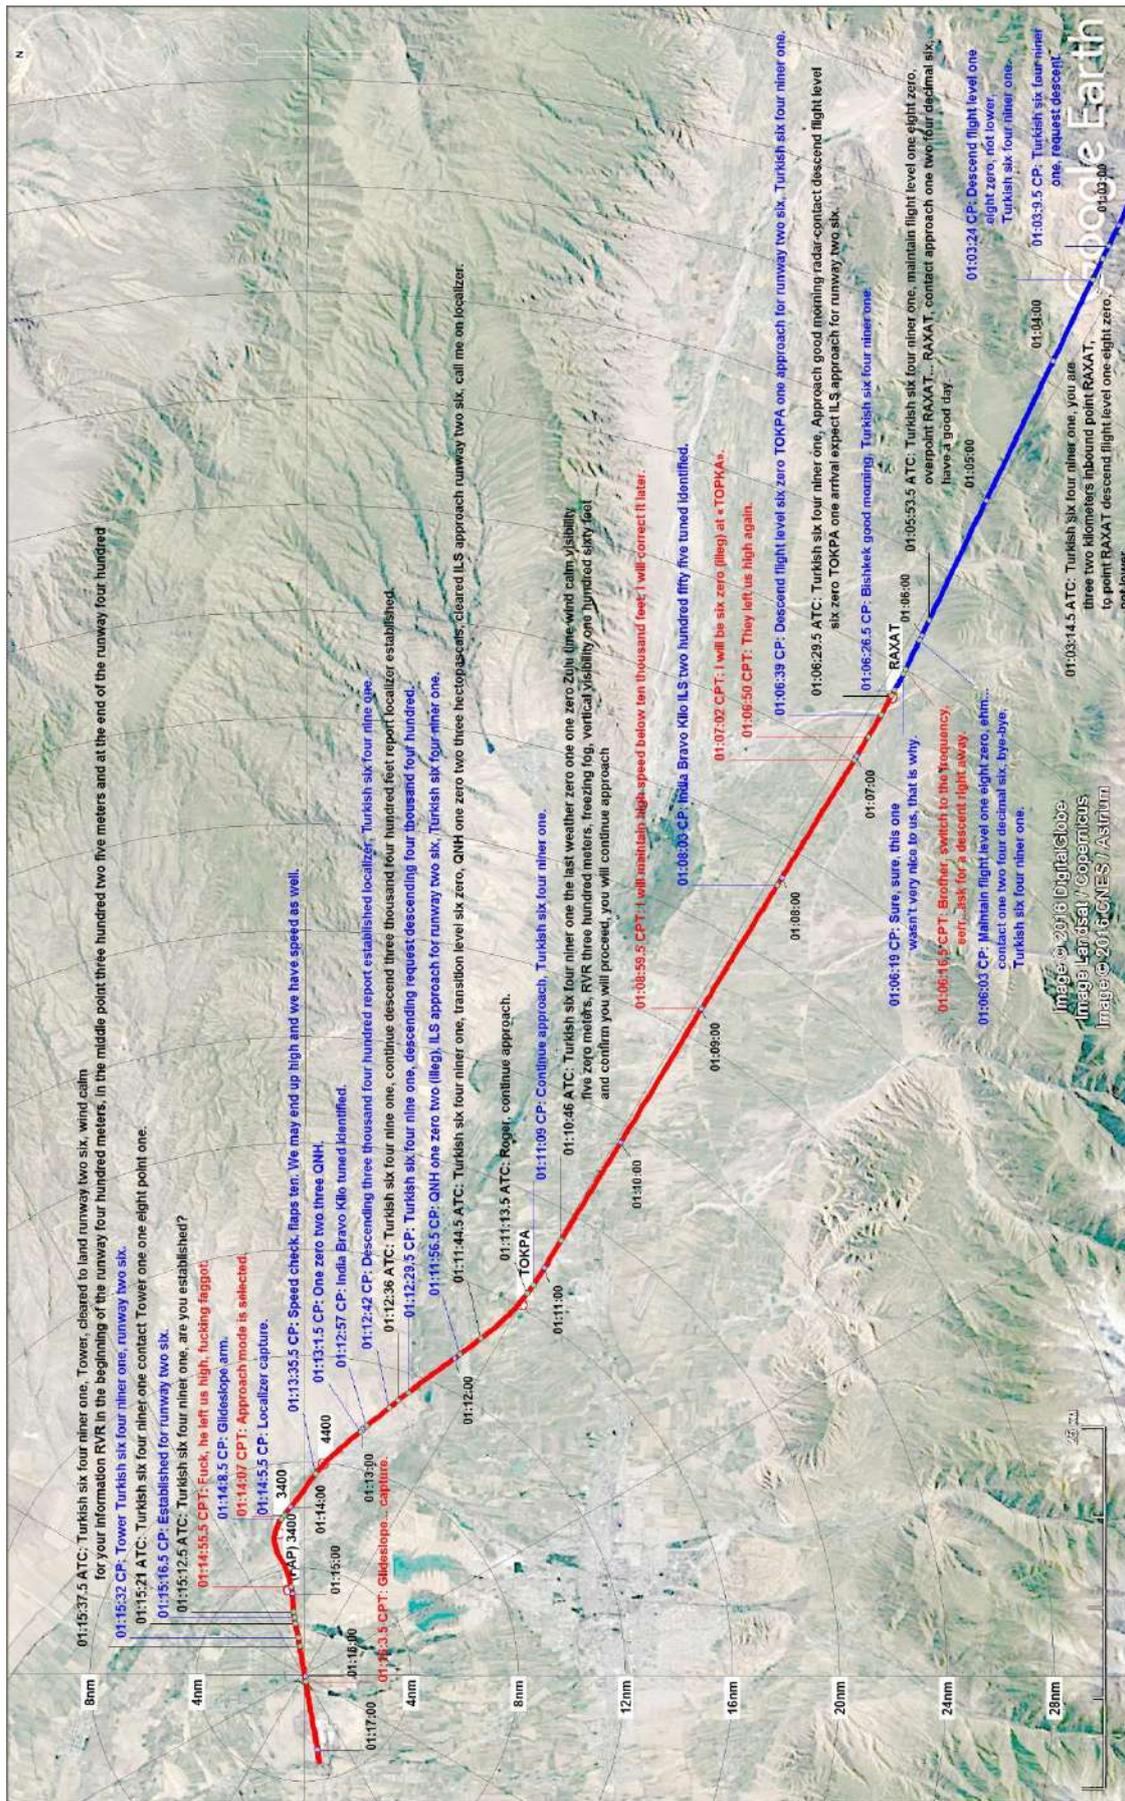
Figure 36. Aircraft flight trajectory during the approach and landing at Manas aerodrome (Bishkek)

At 01:06:30, when flying over RAXAT, the aircraft was positioned at FL 180. The descent from FL 180 was started at 01:06:40. At the beginning of the descent, the crew engaged the autopilot in the "FLIGHT LEVEL CHANGE OPER" mode in the longitudinal channel and the "LATERAL NAVIGATION OPER" mode in the lateral channel. The selected altitude was set to 6000 ft, the selected IAS on the MCP was set to 262 kt, the aircraft engines were operating in the mode close to the flight idle. At the beginning of the descent, the vertical speed was 2900...2700 ft/min. Judging by the phrase "*I will be six zero (illeg) at "TOPKA"*¹¹", the PIC was expecting to reach FL 60 by the time the aircraft reached the reporting point (Figure 36).
