FINAL INVESTIGATION REPORT ON
ACCIDENT TO SPICEJET BOEING B737-800
AIRCRAFT VT-SGK AT SURAT ON
06.11.2014

AIRCRAFT ACCIDENT INVESTIGATION BUREAU
MINISTRY OF CIVIL AVIATION
NEW DELHI

FINAL INVESTIGATION REPORT ON ACCIDENT TO SPICEJET BOEING B737-800
AIRCRAFT VT-SGK AT SURAT ON 06.11.2014

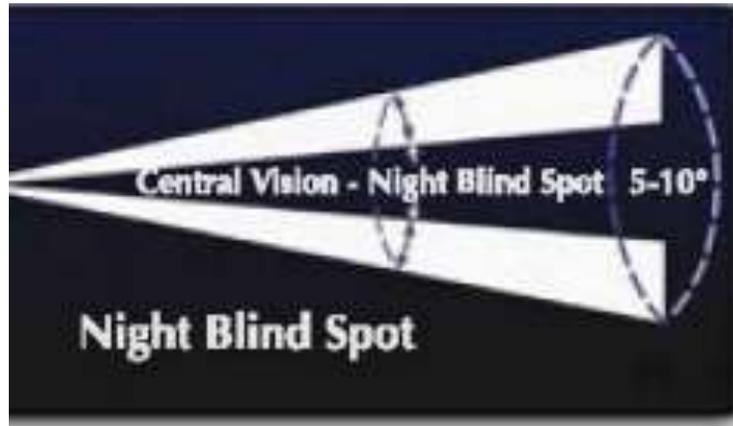
1.18.5 Night Blind Spot

Due to the distribution of rods and cones on the retina, if the ambient light is below cone threshold light intensity, a blind spot 5 to 10 degrees wide develops in the center of the visual field. As a result, an object viewed directly at night may not be detected because of the night blind spot and, if it is detected, may fade away.
