Incident Final Report

State File Number: I139201299MXAC
Type of Occurrence: Incident (RWY Excursion)
Date of Occurrence: April 18th 2013
Place of Occurrence: I.R.IRAN
Aircraft Type: A340-300
Registration: 9M-XAC
Operator: Air Asia

State File Number: I139201299MXAC
Type of occurrence: Incident (Runway Excursion)
Date of occurrence: April 18th 2013
Place of occurrence: on RWY 30L, Tabriz INTL Airport (OITT) Islamic republic of Iran
Aircraft Model: A340-300
Registration: 9M-XAC
Operator: Air Asia
Lessor: Saudi Arabian Airlines

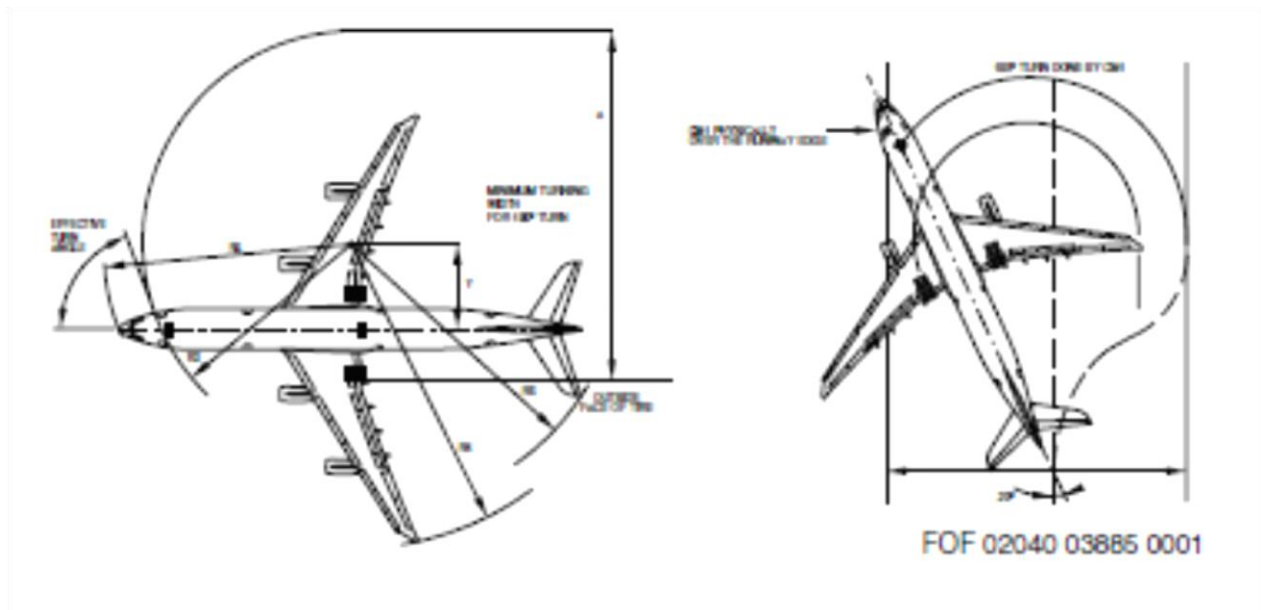
AIRCRAFT DIMENSIONS

Y	R3	R4	R5	R6	NWS Limit Angle	Minimum Runway Width with Asymmetric Thrust
13 m 43 ft	29 m 100 ft	44m 144 ft	35 m 114 ft	39 m 128 ft	72 degrees	45 m 148 ft

With the maximum nose wheel steering angle (72 °), the actual turn width (**without margin**) is [...] 45 m for an A340-300.” This distance is based on the attached procedure provided in the FCOM and considering favorable circumstances, in particular dry and good condition runway.

❖ *Therefore, to verify the required runway width, some margins must be added to the turn width considering in particular the runway condition.*
