Accident Investigation Final Report

State File Number: A13940723EPMNE
Type of Occurrence: Accident
Date of Occurrence: Oct. 15th 2015
Place of Occurrence: Near Mehrabad Airport
Aircraft Type: B747-300
Registration: EP-MNE
Operator: Mahan Air

Final Report

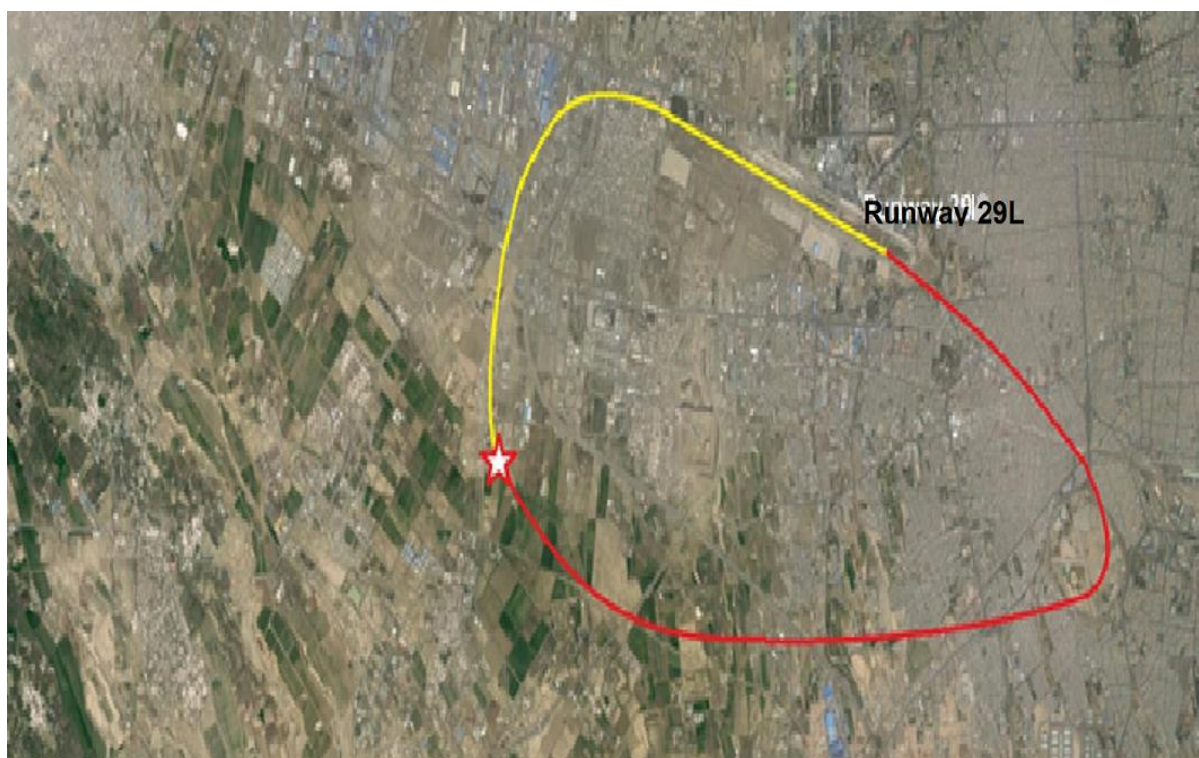
Estimated Flight Path

On 15 Oct 2015, a Boeing 747-300, registered EP-MNE operated by MAHAN Airlines was scheduled for a flight from Mehrabad International Airport to Bandar Abbas airport within IR of IRAN territory. The aircraft with flight number 1095 was carrying 19 flight crew accompanied with 422 passengers. The aircraft upon departure from Tehran at (03:46UTC) and climbing on 7500ft experience engine failure. The evidences denotes that some seconds after aircraft departure the engine no. 3 was failed .The aircraft Engine #3 was damaged (due to uncontained engine failure), and some parts of the engine rear components detached and stroke to the engine #4 , as well as aircraft structure . the aircraft hydraulic systems no; 1, 3 and 4 were failed due to impact of thrown detached engine #3 parts. The pilot tried to take control of aircraft in spite of engine vibration and made emergency landing at Tehran at (04:23UTC).

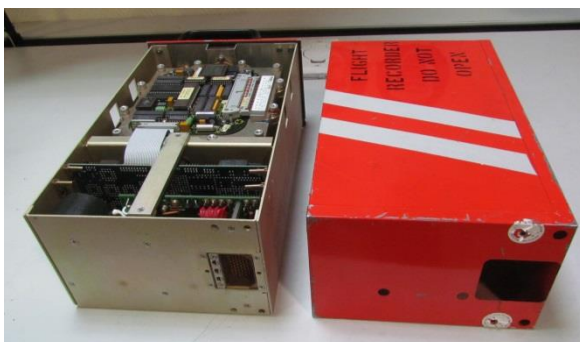
Fig 1 – CVR opened

A visual inspection was performed. No physical damage was found. The technical seals were still in place and intact. It was decided to perform a direct readout.

The download for this kind of recorder is performed by analog acquisition. The readout requires opening the recorder to connect an adapter on one of the electronic boards to digitize simultaneously the recorded tracks.

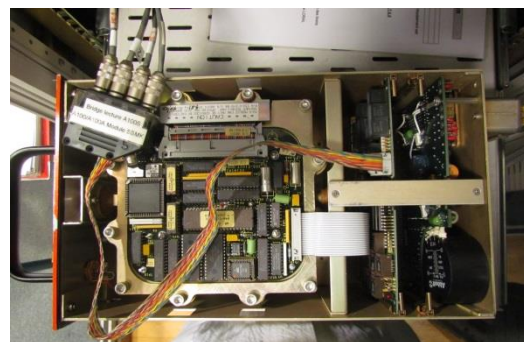
Fig 2 – CVR download

The download was successful. Four audio files with duration of 31 min 54 s were retrieved:
