SERIOUS INCIDENT

Aircraft Type and Registration:	Airbus A330-323, N276AY	
No & Type of Engines:	2 Pratt & Whitney PW400 turbofan engines	
Year of Manufacture:	2001 (Serial no: 0375)	
Date & Time (UTC):	26 June 2016 at 1115 hrs	
Location:	London Heathrow Airport	
Type of Flight:	Commercial Air Transport (Passenger)	
Persons on Board:	Crew - 12	Passengers - 277 Ground staff - 2
Injuries:	Crew - None	Passengers - 1 (Minor)
Nature of Damage:	APU failure	
Commander's Licence:	Airline Transport Pilot's Licence	
Commander's Age:	61 years	
Commander's Flying Experience:	31,635 hours (of which 1,912 were on type) Last 90 days - 200 hours Last 28 days - 28 hours	
Information Source:	AAIB Field Investigation

Synopsis

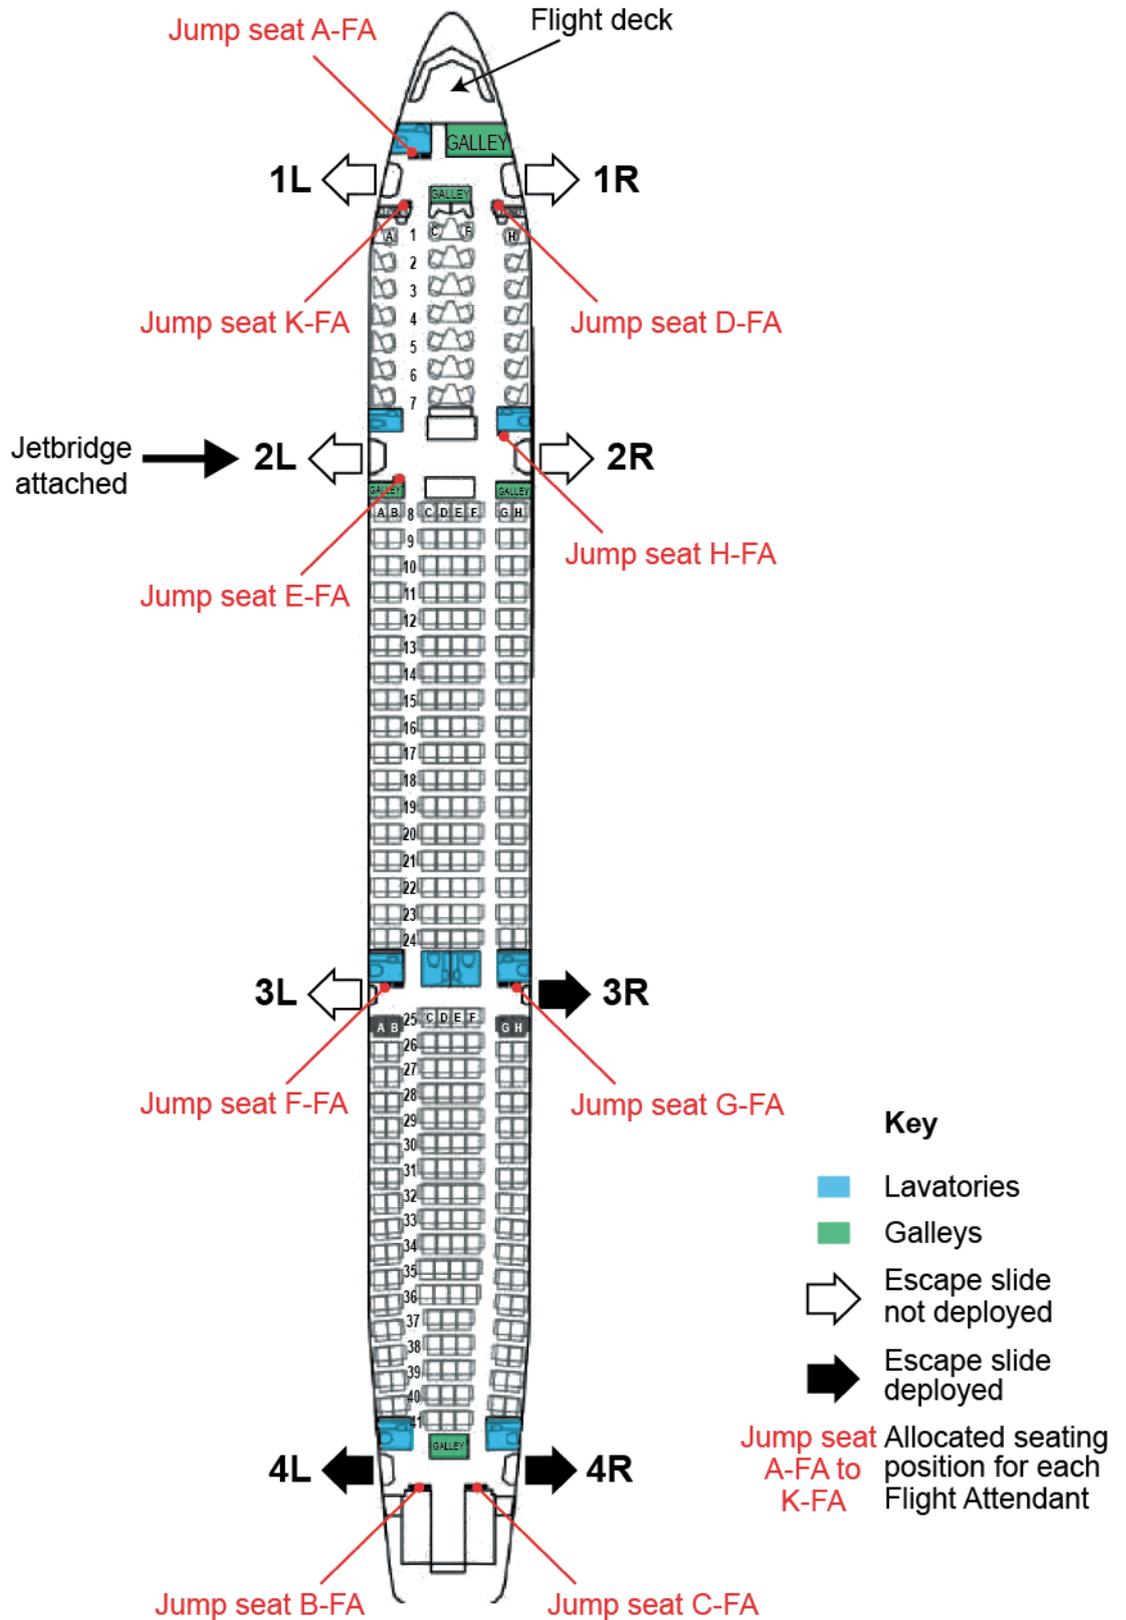
Figure 1

The jetbridge was removed at 1057 hrs but two minutes later the commander requested further engineering assistance because there was an indication of a navigation system defect. All the doors were disarmed, the jetbridge was re-attached at exit 2L (Figure 1), and an engineer went to the flight deck, accompanied by the Gate Operational Co-ordinator (GOC).

Cabin layout of N276AY showing numbered exits and FA jump seat locations

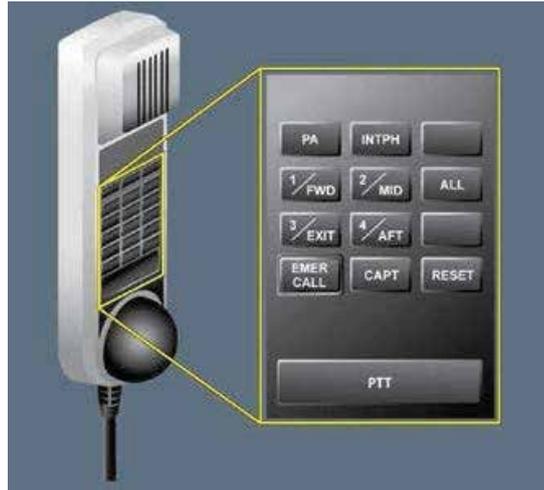
Figure 7

There is no common standard concerning the keypad layout on interphone handsets for passenger aircraft, therefore neither the equipment manufacturer nor the aircraft operator have any obligation to consider keypad standardisation between aircraft types. On the Airbus A330-300 each FA station has an interphone handset with a number of buttons (Figure 7). When a handset is lifted from its base station and the button marked CAPT is pressed, a single long buzzer¹¹ sounds through the flight deck loudspeakers and small push buttons, marked ATT, flash amber on the pilots' Audio Control Panels (ACPs). When a pilot responds by depressing his ATT push button, the interphone system connects to the calling station and the light in the push button changes to green. If no pilot responds to the call within 60 seconds, the lights in the ATT push buttons extinguish. Replacing the handset in its cradle or pressing the reset button returns the handset to its original status.

Interphone communication handset showing keypad
