# AVIATION INVESTIGATION REPORT

## A17F0052

### **Risk of collision with terrain**

Boeing 737-800, C-GWSV

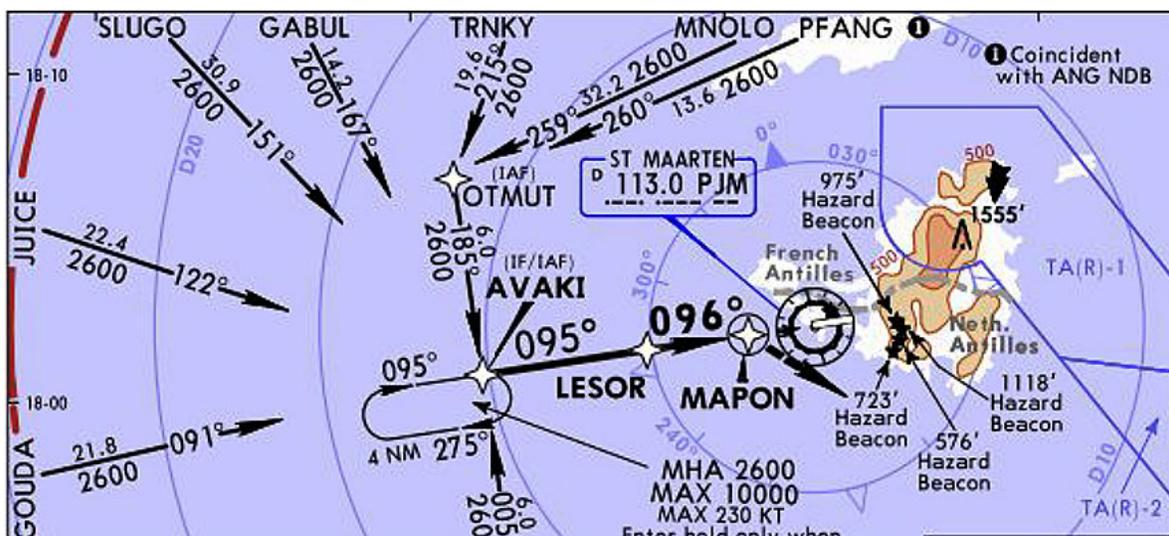
At 1518:14, the TNCM air traffic controller (controller) instructed the flight crew to report when they were over the SLUGO waypoint<sup>8</sup> (Figure 1) and to expect descent instructions at that time, and advised them that the current ATIS information was Mike and the altimeter was 30.09 inches of mercury.

Figure 1. Plan view of the RNAV (GNSS) Rwy 10 approach to Princess Juliana International Airport (TNCM), showing the SLUGO, AVAKI, and MAPON waypoints (Source: Jeppesen Sanderson Inc., approach chart)

At 1524:48, the flight crew of WJA2652 were instructed to fly direct to the AVAKI initial approach waypoint<sup>9</sup> (Figure 1) once they had descended through 8000 feet above sea

At 1530:32, the flight crew of an aircraft that had just landed at the airport reported that there had been steady winds and reduced visibility during the approach, but that they had visually acquired the runway while over the MAPON missed approach point (MAP)<sup>11</sup> (Figure 1). The WJA2652 flight crew acknowledged the information when they were 10 nm from the airport, on final approach and descending through 2100 feet.

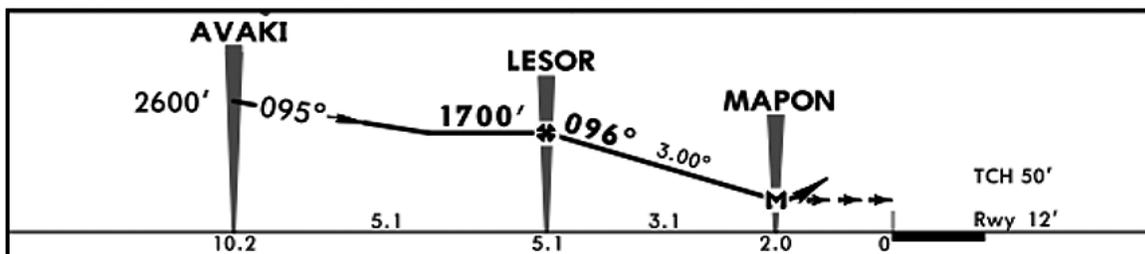
In this occurrence, the FMS provided the crew with vertical guidance to the MAP during the inbound final approach course. Because there is a mountain close to the runway, the MAP is situated 2 nm (3704 m) before the runway threshold, and the MDA is at 700 feet ASL (688 feet AGL), to meet the PANS-OPS<sup>39</sup> criteria for obstacle clearance in the event of a go-around. Therefore, there is a long visual flight segment following the MAP where the crew is required to manage the descent to the runway threshold in order to complete the landing (Figure 4). It is not common for WestJet pilots to fly long visual segments of an IFR approach such as that of the RNAV (GNSS) Rwy 10 at TNCM. Even less common are long visual segments over water and with the type of weather encountered during the occurrence approach.

Figure 4. Descent profile for the RNAV (GNSS) Rwy 10 approach to Princess Juliana International Airport (Source: Jeppesen Sanderson Inc., approach chart)

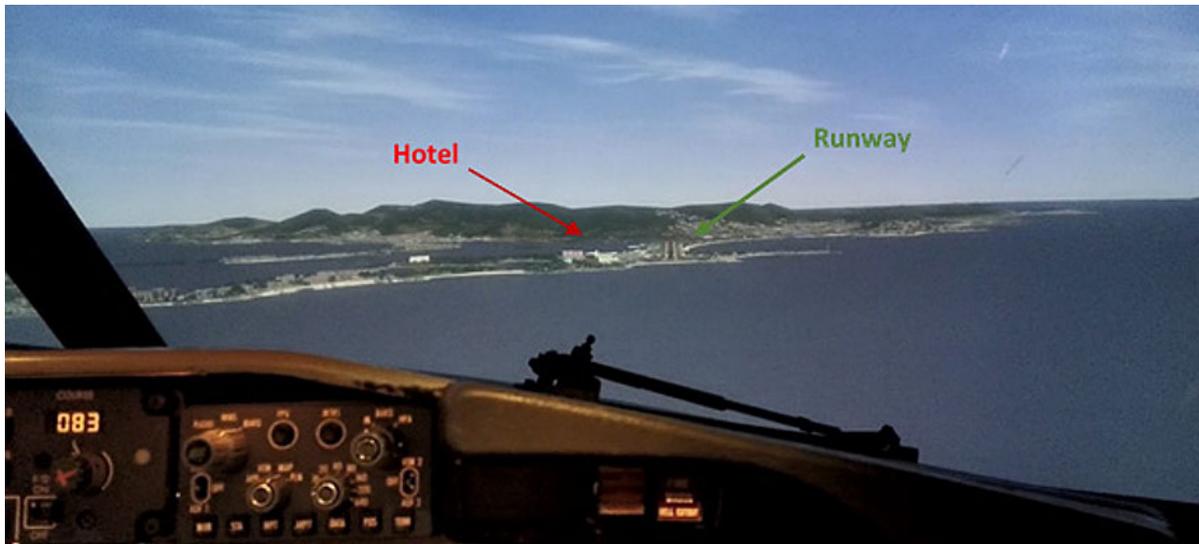
At TNCM, the RNAV (GNSS) Rwy 10 inbound final approach course is situated over ocean and includes a visual segment of 2 nm from the MAP to the threshold, which is adjacent to the shore (Figure 5). The visual references available for the RNAV (GNSS) Rwy 10 approach include

Figure 5. Approach to Runway 10 at TNCM on a clear day, viewed in a flight simulator
