AA2019-8

**AIRCRAFT ACCIDENT
INVESTIGATION REPORT**

CABIN ATTENDANT INJURY
BY SHAKING OF AIRCRAFT
JAPAN AIRLINES CO., LTD.
BOEING 777-300, JA8944
AT FL300 OVER KURIHARA CITY,
MIYAGI PREFECTURE, JAPAN
AROUND 15:56 JST, JUNE 24, 2018

August 30, 2019

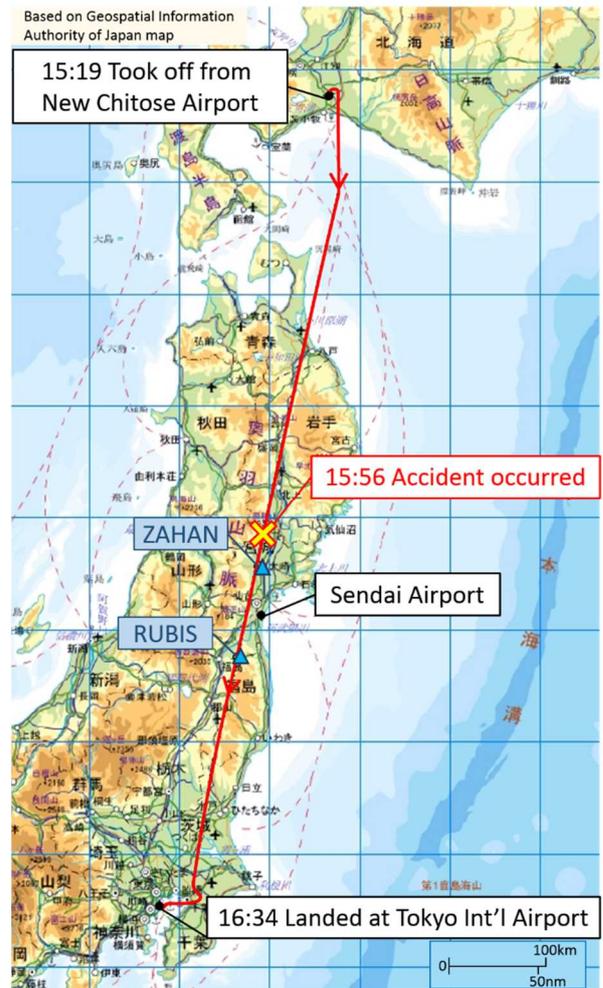
Figure 2: Estimated flight route

The place of the occurrence of the accident was at FL300 over Kurihara

City, Miyagi Prefecture (38° 50'34" N, 140° 55'03" E) and time of the occurrence was June 24, 2018 around 15:56.

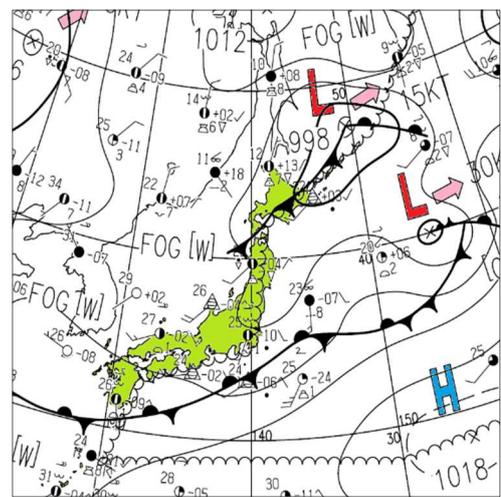
Figure 5: Asia Pacific Surface Analysis Chart (excerpt)

| 2.6 Meteorological Information | <p>(1) General Weather Conditions</p> <p>According to Asia Pacific Surface Analysis Chart (excerpt) (see Figure 5) as of 15:00, June 24, 2018, a cold front line extending from a low pressure centered in the Sea of Okhotsk was passing over northern part of Japan and a seasonal rain front was stationary on the sea of southern part of Japan.</p> <p>(2) Hourly Atmosphere Analysis</p> <p>Hourly atmosphere analysis chart (see Figure 6) as of 16:00, June 24, 2018 in the vertical cross-sectional chart of air route indicated that there were jet stream with the maximum wind velocity of about 150 kt centering at FL370 and VWS region of 9 – 12 kt/1,000 ft near the accident site.</p> |
