Air Accident Investigation Sector

- Final Report -

AAIS Case N°: AIFN/0010/2017

Descent below Cleared Altitude during Approach and FMS not reconfigured following a reset during the Second Approach

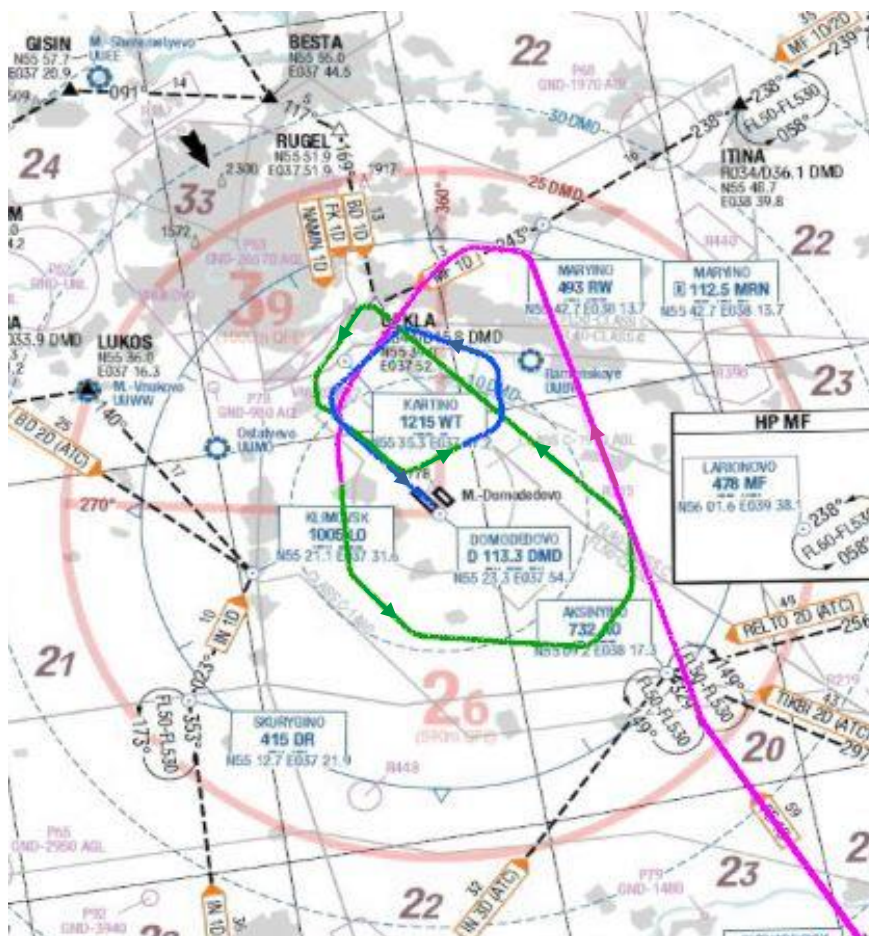
Figure 2 – Approaches and Landing attempts - UDD Runway 14R STAR Transitions Chart

The flight crew flew one go-around and one discontinued approach and landed on runway 14R from the third approach. The go-around, discontinued and landing are shown in figure 2. The trajectory in magenta depicts the first approach and go-around, the green line illustrates the second approach and discontinued approach, and the third approach and landing is shown by the blue line.

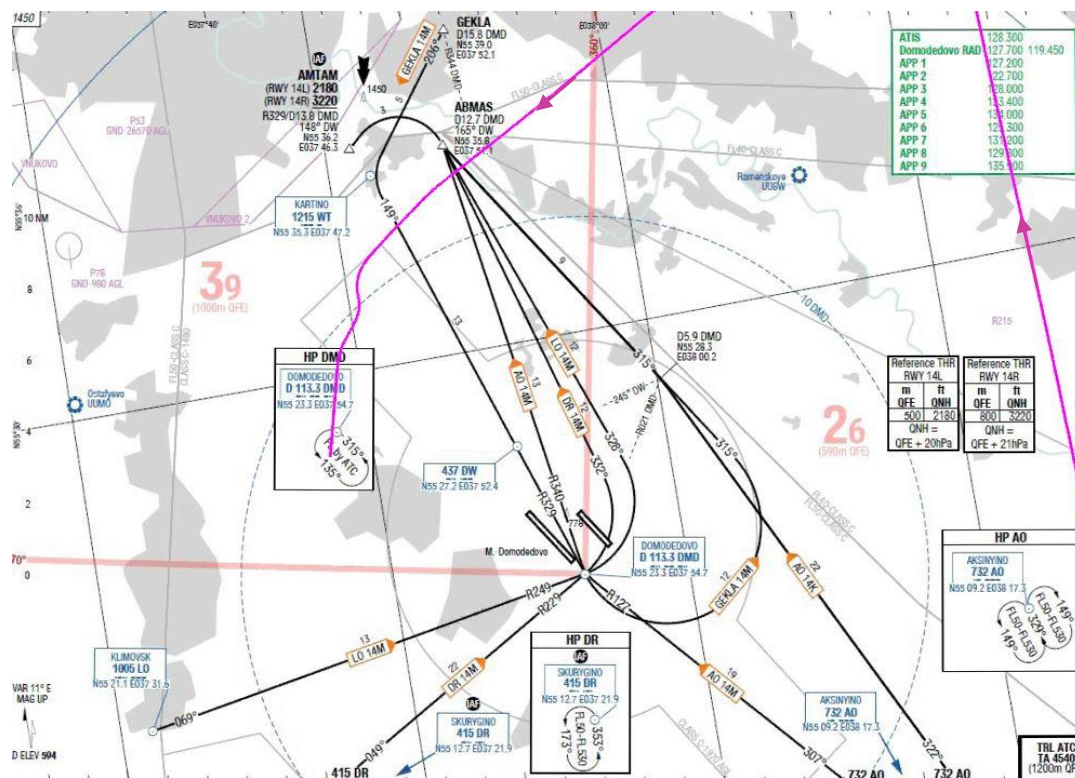
Figure 3 – First Approach and Go-around (magenta line) - UDD STAR Runways 14L/R Chart

Before the Aircraft reached the Aksinyino (AO) NDB³ point, air traffic control (ATC) vectored the Aircraft for an approach different to that in the operational flight plan. The route, according to the flight plan, began with FE1D as the standard arrival transition, then had AO14K as the standard arrival for the instrument landing system (ILS) and landing on runway 14R (figures 3 and A2.2).

During the descent, the Radar Controller provided vectoring, which resulted in a wider compared to the standard arrival through the AO14K route due to traffic in the vicinity of UDD (see figure 3). The Aircraft started to slow before the AO NDB waypoint. The selected airspeed was reduced gradually from 315 to 180 knots, as instructed by ATC.

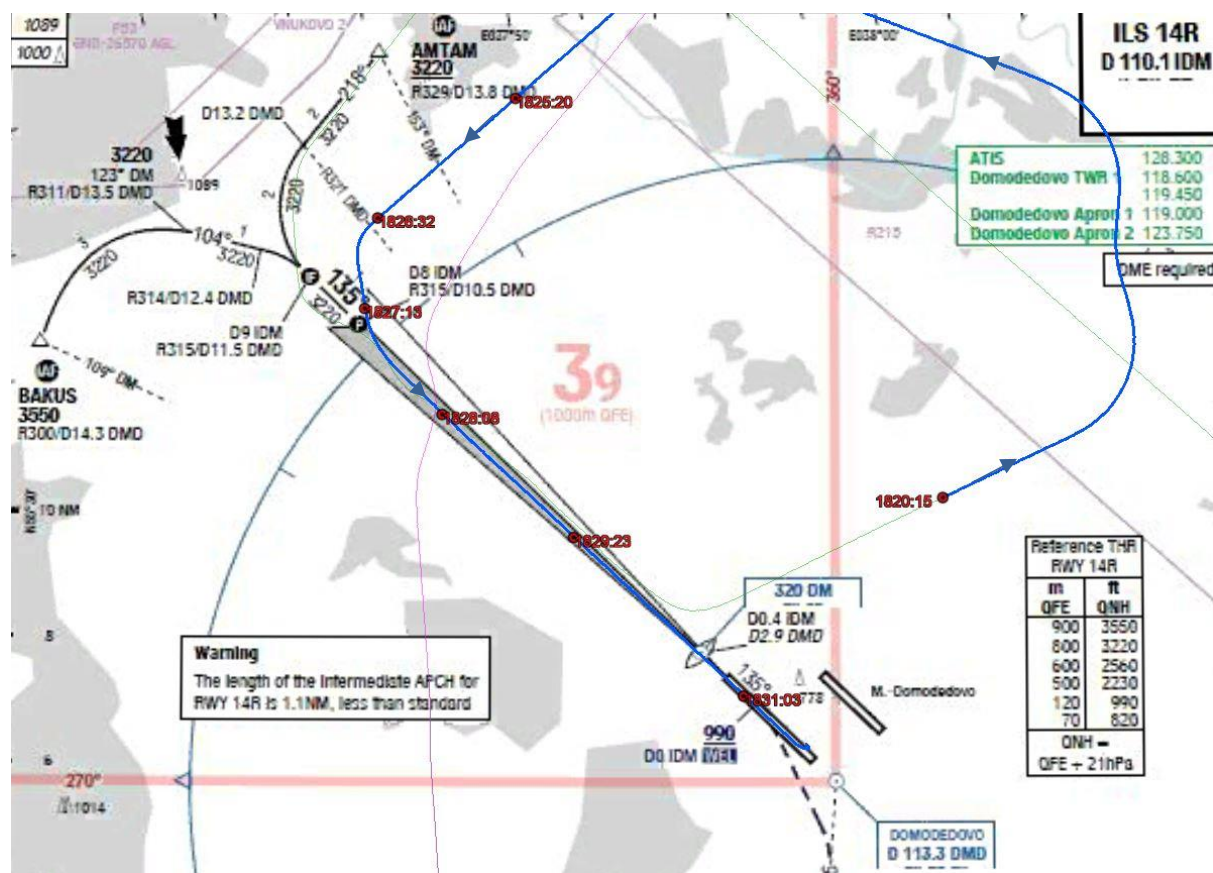
Figure 6 – Third Approach and Landing Path on IAC Chart of ILS 14R

The radar vectors provided for the third approach were such that the Aircraft flight path was as shown in figures 2 and 6. The Aircraft did not fly through the IAF point on the path given in the instrument approach chart (IAC) for the runway 14R ILS. Instead, the Aircraft flew closer to the runway on the base leg, on almost the same flight path as on the first attempted approach, but slightly further from the runway.

After switching the communication to Radar Control, the Radar Controller queried the flight crew as to the reason for the go-around. The Commander replied that the go-around was necessary, as the Aircraft was not stable on the approach. The Commander also requested radar vectors for the third approach, which were subsequently provided by the Radar Controller, as shown in figure 6.

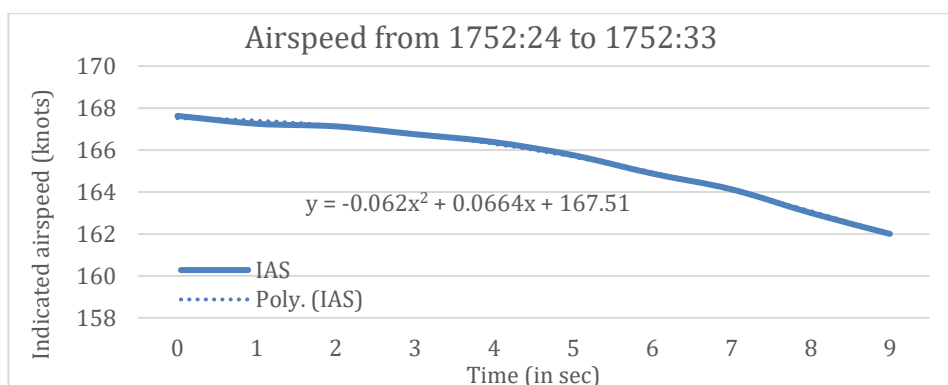
Figure 30. Second order polynomial of IAS

Figure 30 shows the equation for the indicated airspeed for the stated period as:

$$y = -0.062x^2 + 0.0664x + 167.51 \dots\dots\dots \text{(Equation 1)}$$

The target speed of the 'speed managed' mode was 143 knots, and by using Equation 1, it takes about 21 seconds for the IAS to reach 143 knots as target speed.

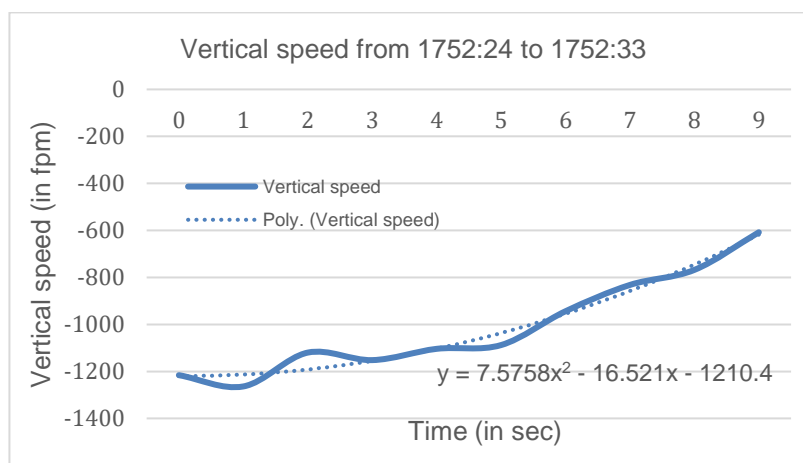
Figure 31. Second order polynomial of V/S

Figure 31 shows the equation for the vertical speed for the stated period as:

$$y = 7.5758x^2 - 16.521x - 1210.4 \dots\dots\dots \text{(Equation 2)}$$

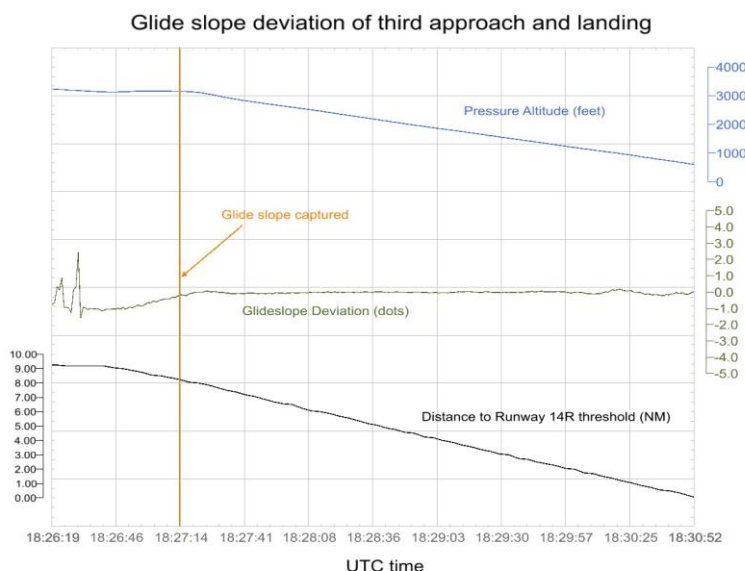
Figure 39. Glideslope deviation for the third approach and the landing

flight plan as per SOP requiring the adjust of the sequencing of the flight plan. Sixteen seconds later, the II14R (IF) waypoint was inserted using the DIR TO function. No multi-waypoint sequencing occurred this time, as the Aircraft crosstrack position from the runway centerline axis was more than seven nautical miles (10.4 nautical miles).

Figure 39 shows the proper glideslope deviation indication for the third approach.

The Aircraft flew as per the approach vectors provided by Radar Control and the Aircraft landed uneventfully.

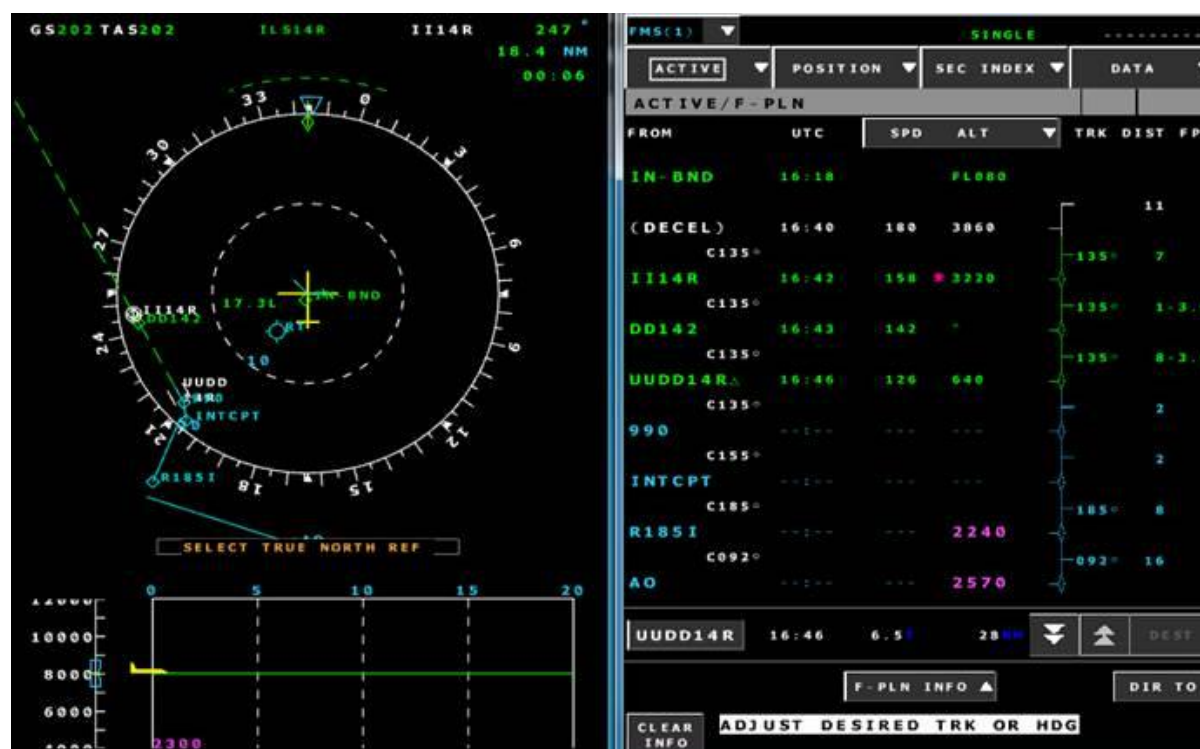
At 1746:20, a lateral revision of the flight plan was performed by inserting I14R (IF) waypoint using the DIR TO CRS IN function from Commander side. The pressure altitude was 8,080 feet, and the airspeed just reached 180 knots. The FMS flight plan displays on the MFD and ND were as given in figure A1.1 below. The DIR TO CRS IN is a FM function used to help capturing the LOC (localizer).

Figure A1.1 – Illustration of FMS flight plan displays on MFD and ND after selection of II14R waypoint using DIR TO CRS IN

The DIR TO CRS IN function was used to create a direct leg from the Aircraft present position to intercept an inbound course of II14R (IF) waypoint.

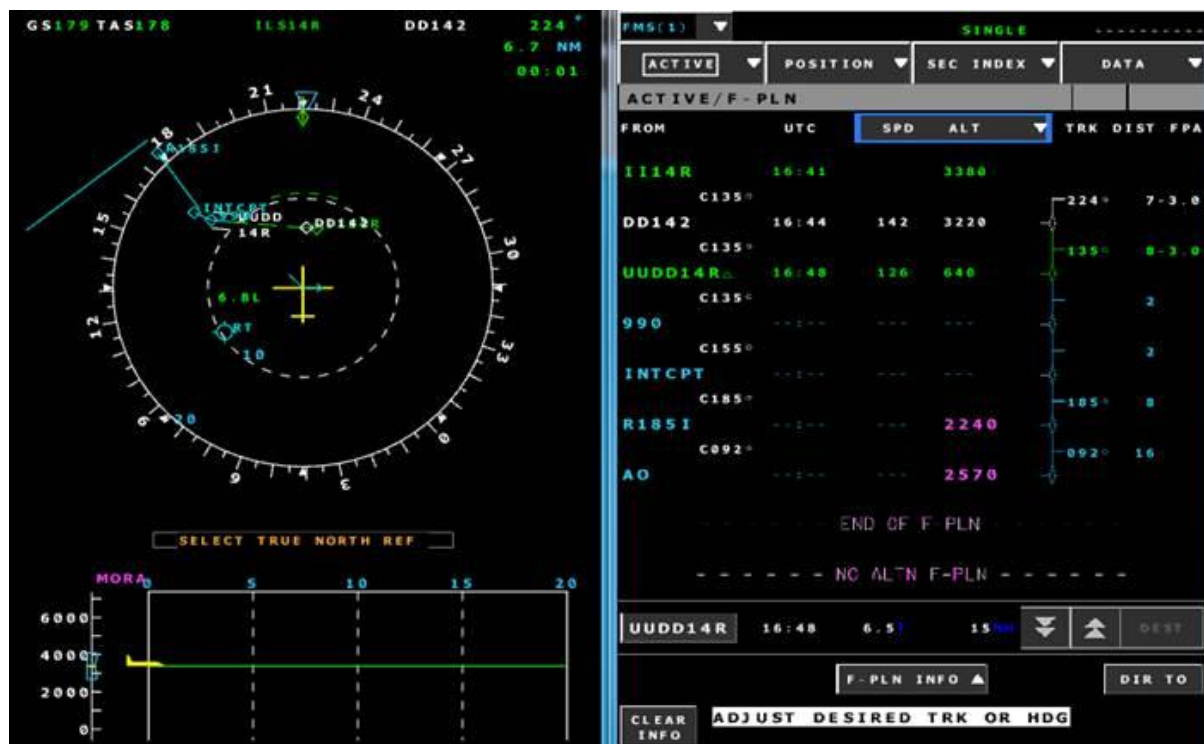
At 1751:15, the indicated active waypoints were DD142 on the FMS flight plan as displayed on the MFD and ND (figure A1.2 below).

Figure A1.2 – Illustration of FMS flight plan displays on MFD and ND after II14R waypoint was sequenced

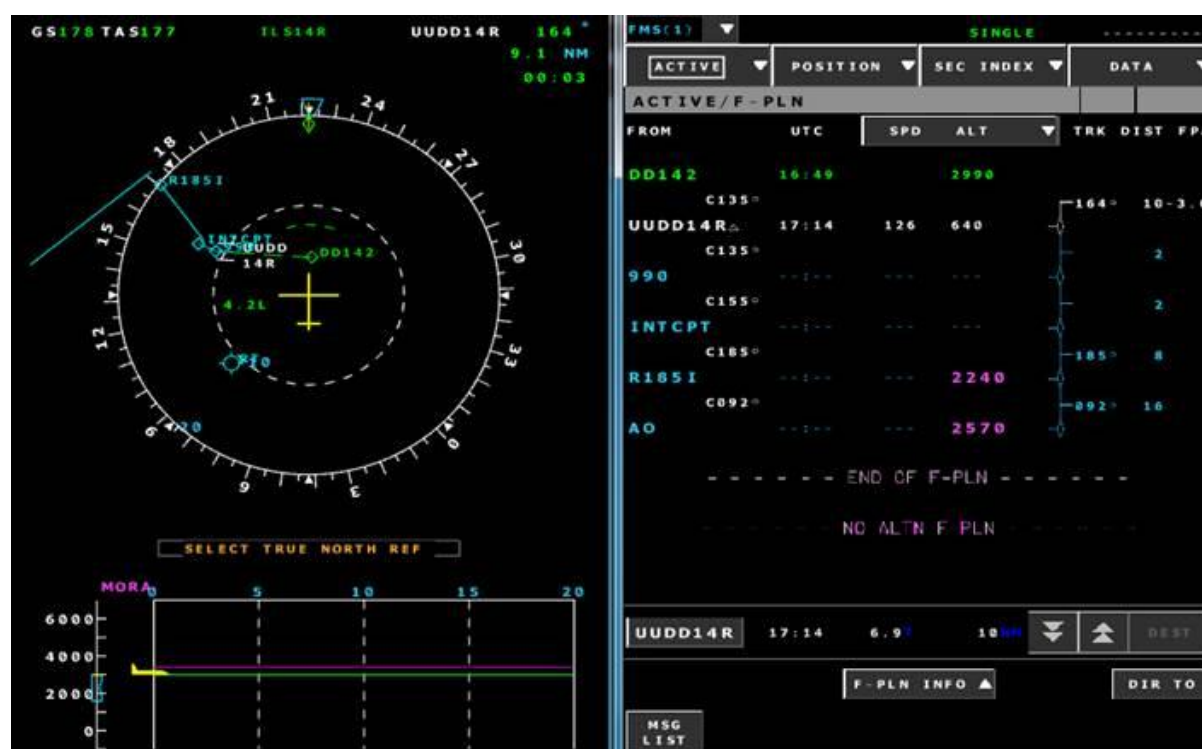
At 1752:15, the indicated active waypoints were UDD14R as displayed on the FMS (figure A1.3).

Figure A1.3 – Illustration of FMS flight plan displays on MFD and ND after DD142 waypoint was sequenced

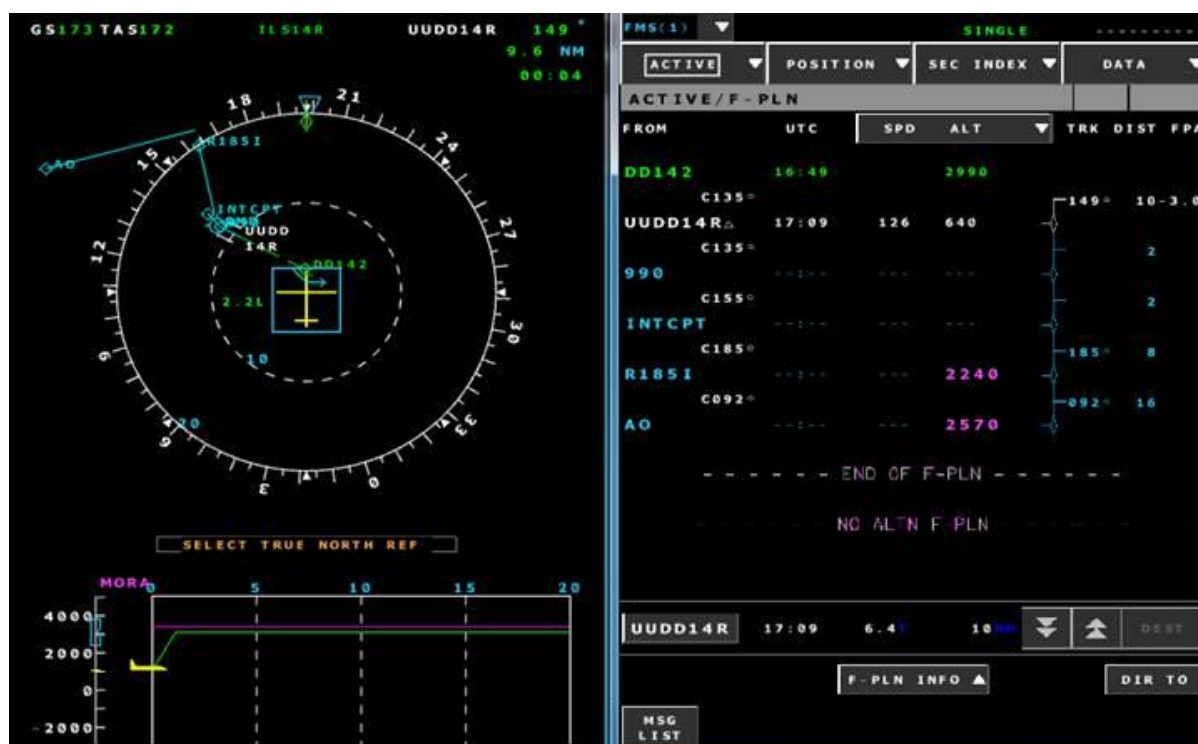
The figure A1.4 below illustrates the Aircraft position versus approach path at the time of go-around activation.

Figure A1.4 – Illustration of FMS flight plan displays on MFD and ND at the time of go-around activation

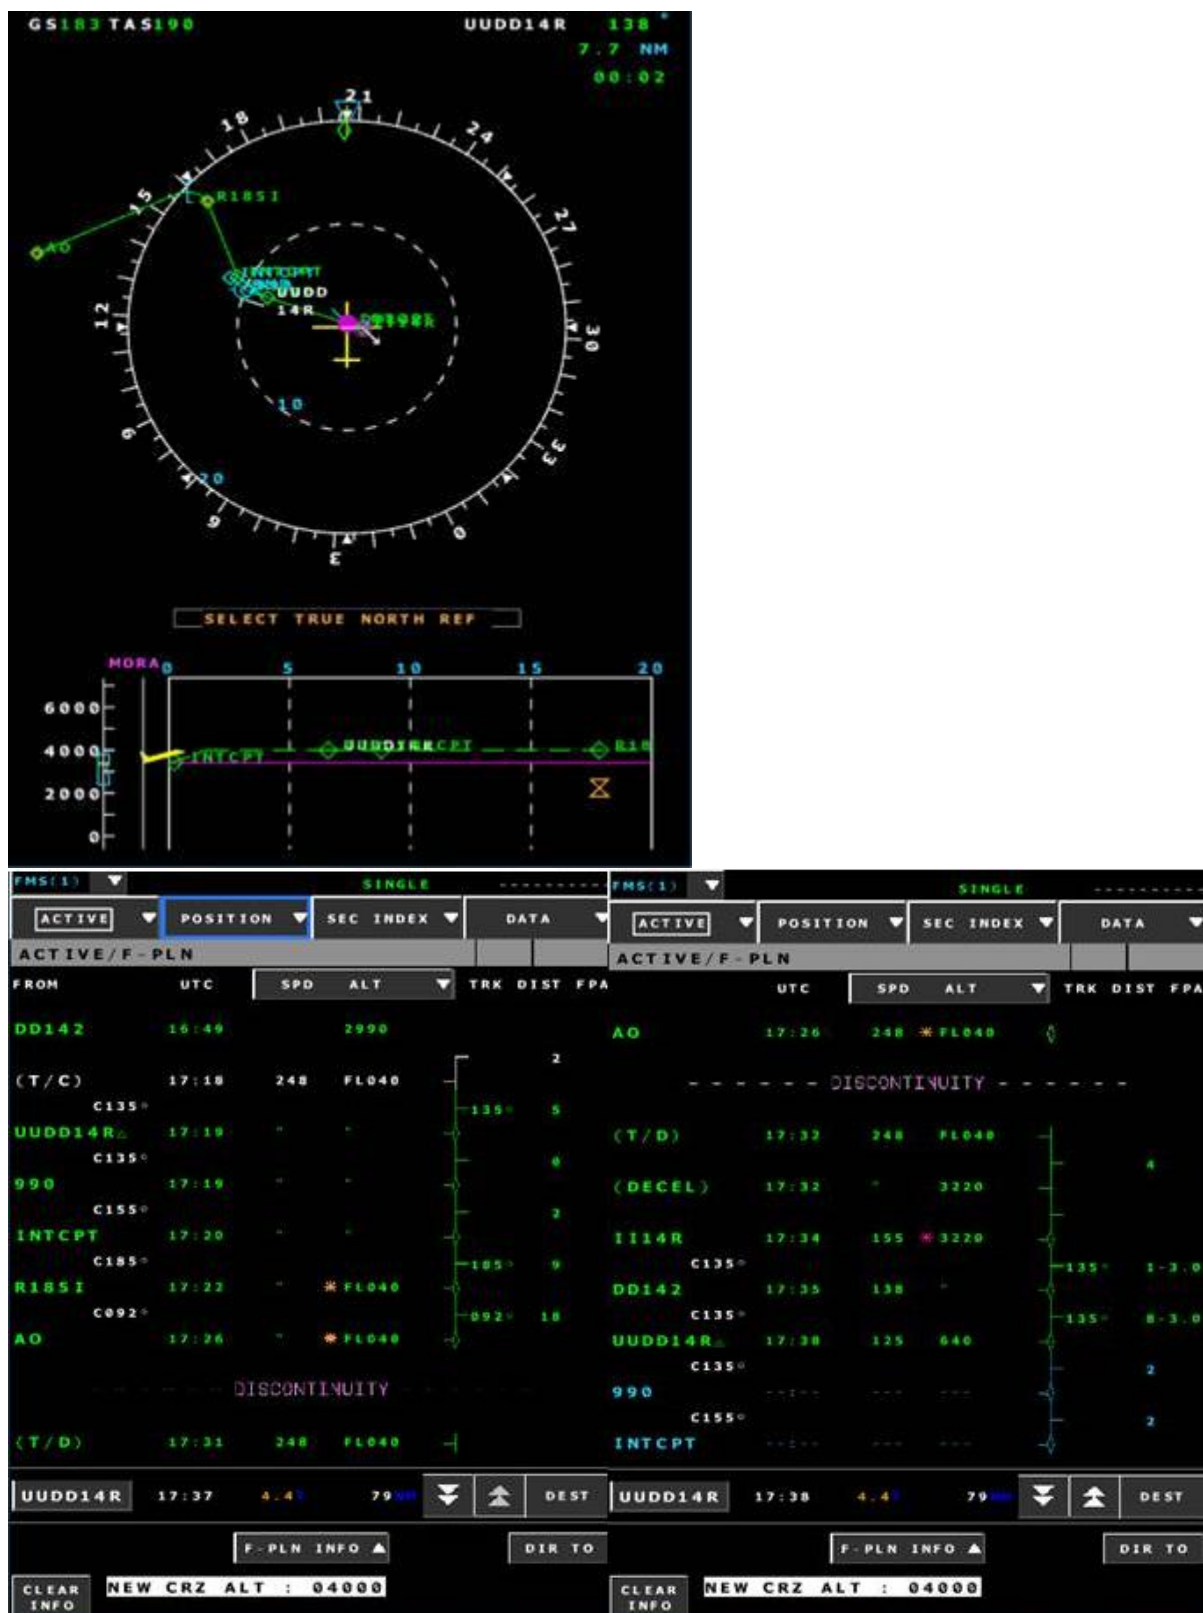
The previous ILS 14R approach was automatically re-strung into the FMS flight plan on the go-around flight phase as shown in figure A1.5 below).

Figure A1.5 – Illustration of FMS flight plan displays on MFD and ND when previous ILS 14R approach was automatically re-strung into the FMS flight plan on go-around flight phase

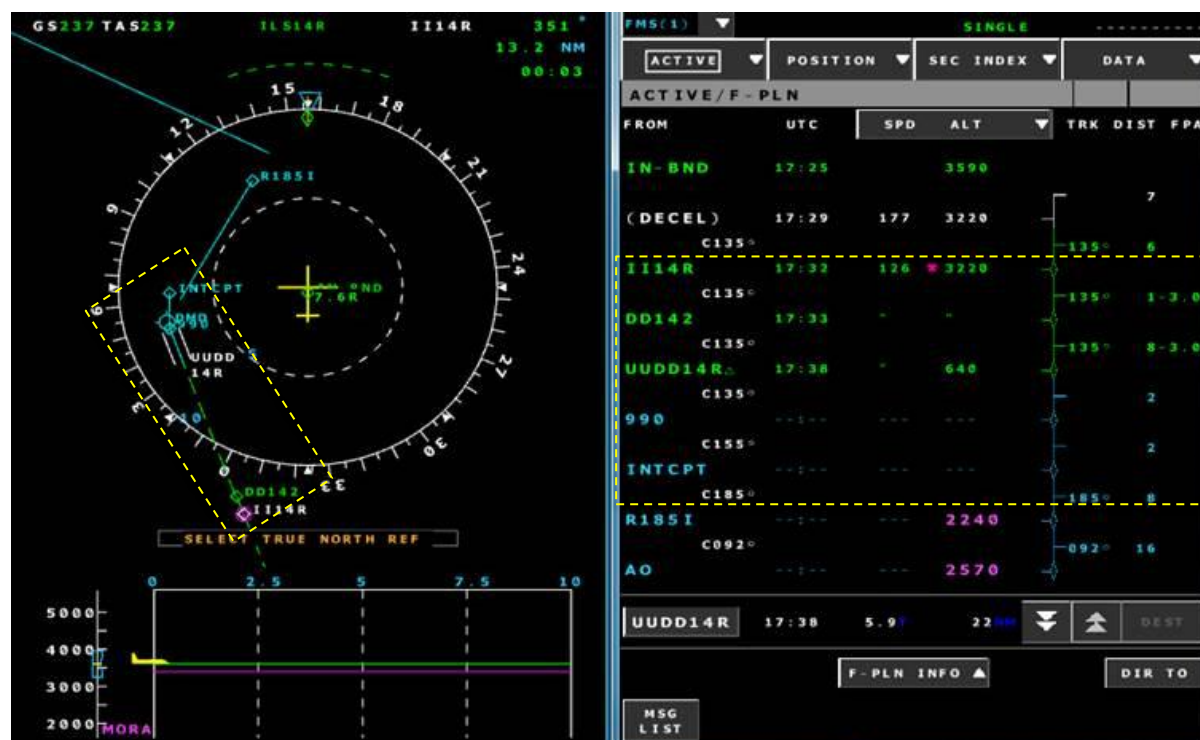
The figure A1.6 below illustrates the displayed FMS on the ND and MFD of both side (Commander and Co-pilot side), after selection of II14R waypoint using DIR TO CRS IN.

Figure A1.6 – Illustration of FMS flight plan displays on MFD and ND after selection of II14R waypoint using DIR TO CRS IN

At the time of DIR TO CRS IN function was performed, the Aircraft cross track position was more than seven nautical miles.
