## Accident to BOEING 777-328ER registered F-GSQL

on 16 September 2018

at Sir Seewoosagur Ramgoolam airport (Mauritius)

## In-flight retail trolley comes loose during take-off run, hitting passengers

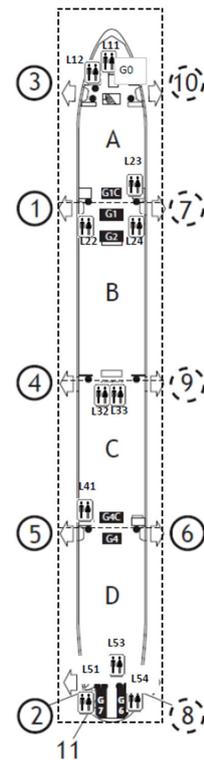
Figure 2: Example of an FSS for the Boeing 777 with the operating configuration used on the accident flight

This document assigns a station number (see Figure 2 above) to each of the members of the cabin crew. For each of the on-board service phases of the flight, a cabin crew member is assigned either to a door (1 to 5 for the Boeing 777<sup>(3)</sup>) or to a zone<sup>(4)</sup> inside the cabin. This sheet also reminds each cabin crew member of the zones in which they must perform some of the safety actions for which they are responsible.
