SERIOUS INCIDENT

Aircraft Type and Registration:	Airbus A320-214, OE-LOA
No & Type of Engines:	2 CFM56-5B turbofan engines
Year of Manufacture:	2007
Date & Time (UTC):	1 March 2019 at 2020 hrs
Location:	London Stansted Airport
Type of Flight:	Commercial Air Transport (Passenger)
Persons on Board:	Crew - 7 Passengers - 169
Injuries:	Crew - None Passengers - 10 (Minor)
Nature of Damage:	Left engine contained failure
Commander's Licence:	Air Transport Pilot's Licence
Commander's Age:	44 years
Commander's Flying Experience:	14,128 hours (of which 10,308 were on type) Last 90 days - 195 hours Last 28 days - 71 hours
Information Source:	AAIB Field Investigation

Synopsis

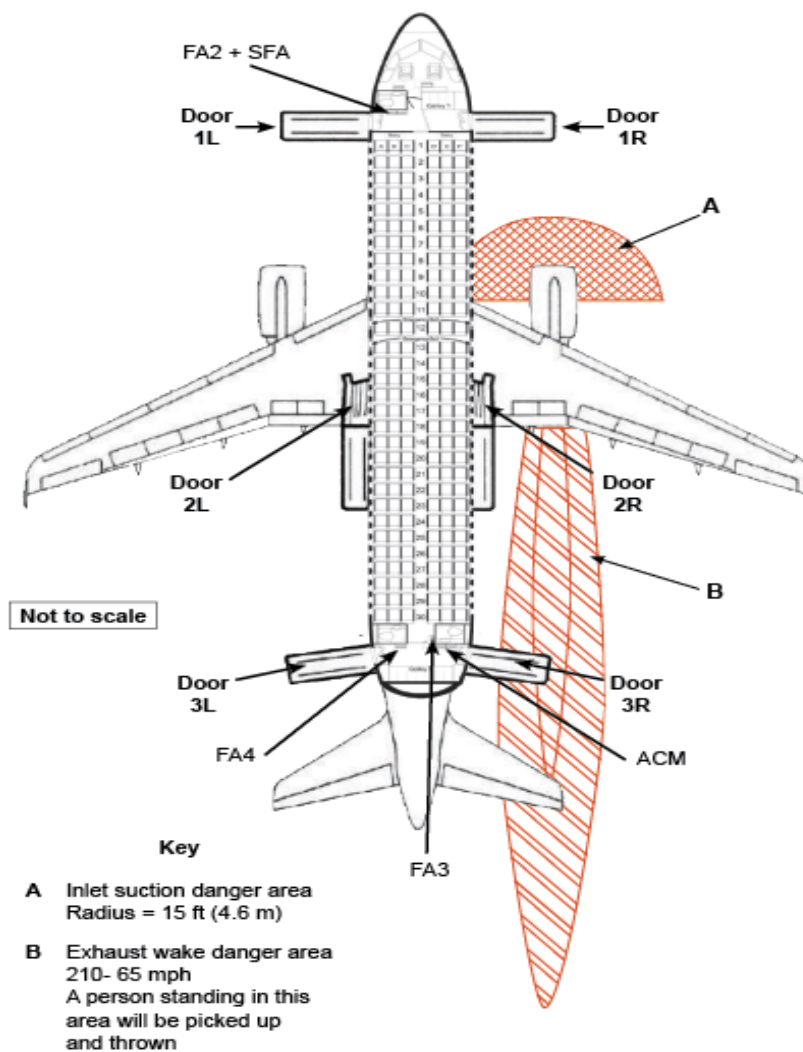
A320 doors, FA seating locations and engine hazard areas

Of those passengers that used Door 2R, several commented that they were either nearly blown over, or were blown over several times by the jet exhaust from the right engine, with some of their belongings blown away. Figure 1 shows passengers crossing behind the engine exhaust could have been exposed to 'wind' speeds of 65 mph or greater, even with the engines running at idle.

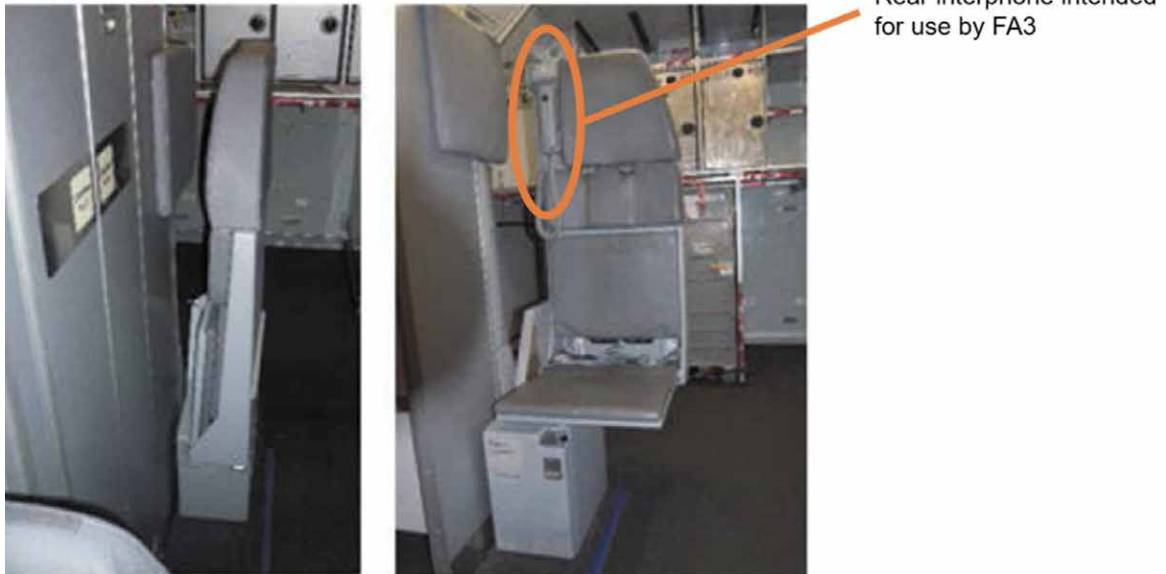
Figure 4

The SFA then tried to call FA3, in the rear of the aircraft, using the interphone, to check if everything was alright. However, when FA3 stood up, his crew swivel seat displaced the attached handset from its stowage and its cable became trapped in the now folded seat⁵. This caused the crew high/low chime⁶ in the cabin to be suppressed so it was difficult for the SFA to attract FA3's attention. There then followed an exchange between the SFA and FA3 which resulted in the SFA commanding an evacuation over the PA. See the *Flight attendants' comments* section for details of this exchange. Upon hearing the command, the FAs and passengers commenced the evacuation.

A rear aisle swivel seat folded away from the wall and locked into position to provide a forward-facing view into the passenger cabin. When the release latch was lifted, the seat automatically folded back into the stowed position (Figure 4).

The rear interphone intended for use by FA3 was located on the aisle swivel seat.

Rear aisle swivel seat in stowed (left) and forward-facing (right) positions

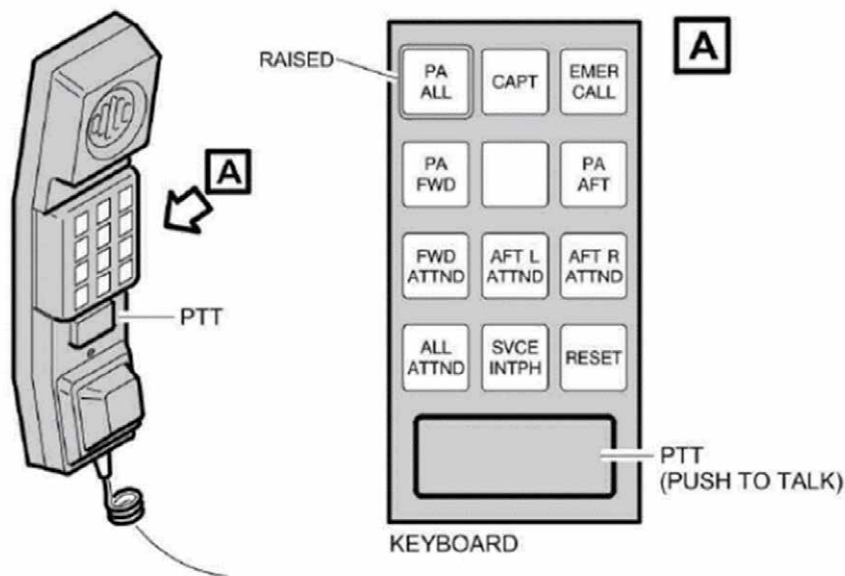
Figure 6
Interphone handset

Figure 6 shows the buttons available on the passenger cabin interphones. It was possible to call the FA3 interphone handset individually from the front handset using the AFT R[IGHT] ATTND [FLIGHT ATTENDANT] button or to call all handsets together using the ALL ATTND button. If the handset was called individually, and it was not fitted on its cradle, the attention getters of the chime and panel lights would not activate.

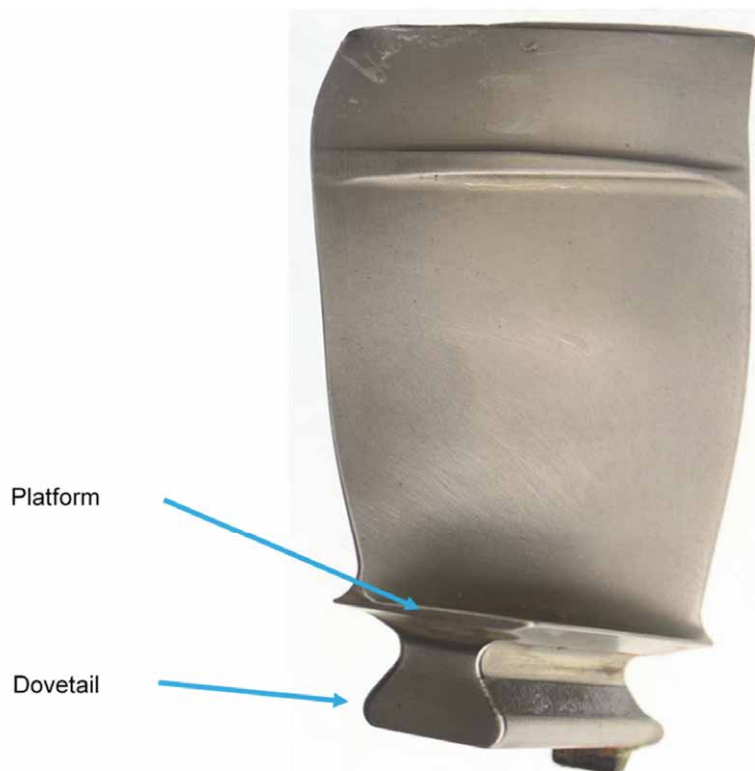
Figure 9

Example High Pressure Compressor rotor blade
