# Air Accident Investigation Sector

- Final Report -

AAIS Case N°: AIFN/0009/2019

## Severe Turbulence during Cruise

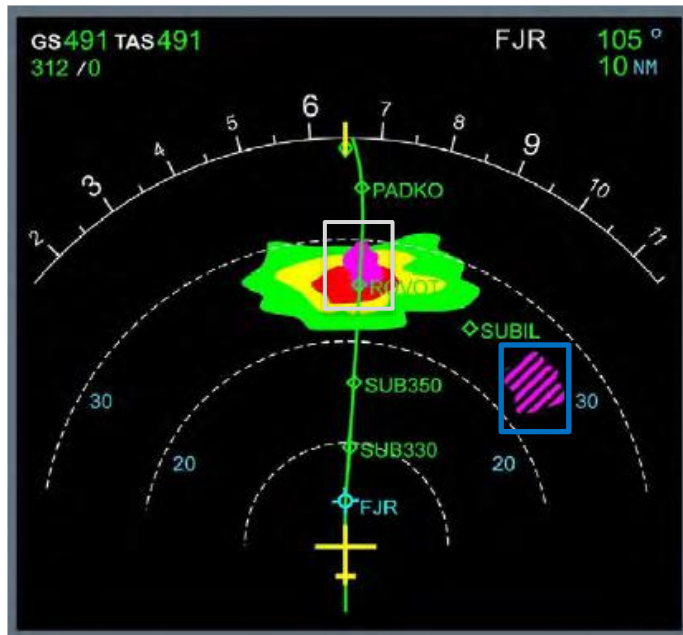
Figure 4. TURB area indication (magenta) on ND  
[Source: FCOM A380]

The turbulence detection (TURB) function is based on the Doppler effect<sup>7</sup> and detects wet turbulence in a volume of space ahead of the aircraft. This function is based on the movement of precipitation. The TURB detection function scans  $\pm 60$  degrees in azimuth, between 0 ft and 60 000 ft MSL and up to 40 NM in front of the aircraft. The ND displays the areas of wet turbulence in magenta color. As noted in figure 4, the magenta within the white box (the white box is used for illustration purpose only) is on-path wet turbulence. The magenta that is hashed within the blue box (the blue box is used for illustration only) is off-path wet turbulence. The VD does not display areas of wet turbulence.

The TURB function does not detect clear air turbulence or dry turbulence.

The Investigation recommends that the Operator reiterate to pilots the importance of using the full capability of the weather radar to better analyze adverse weather situations.

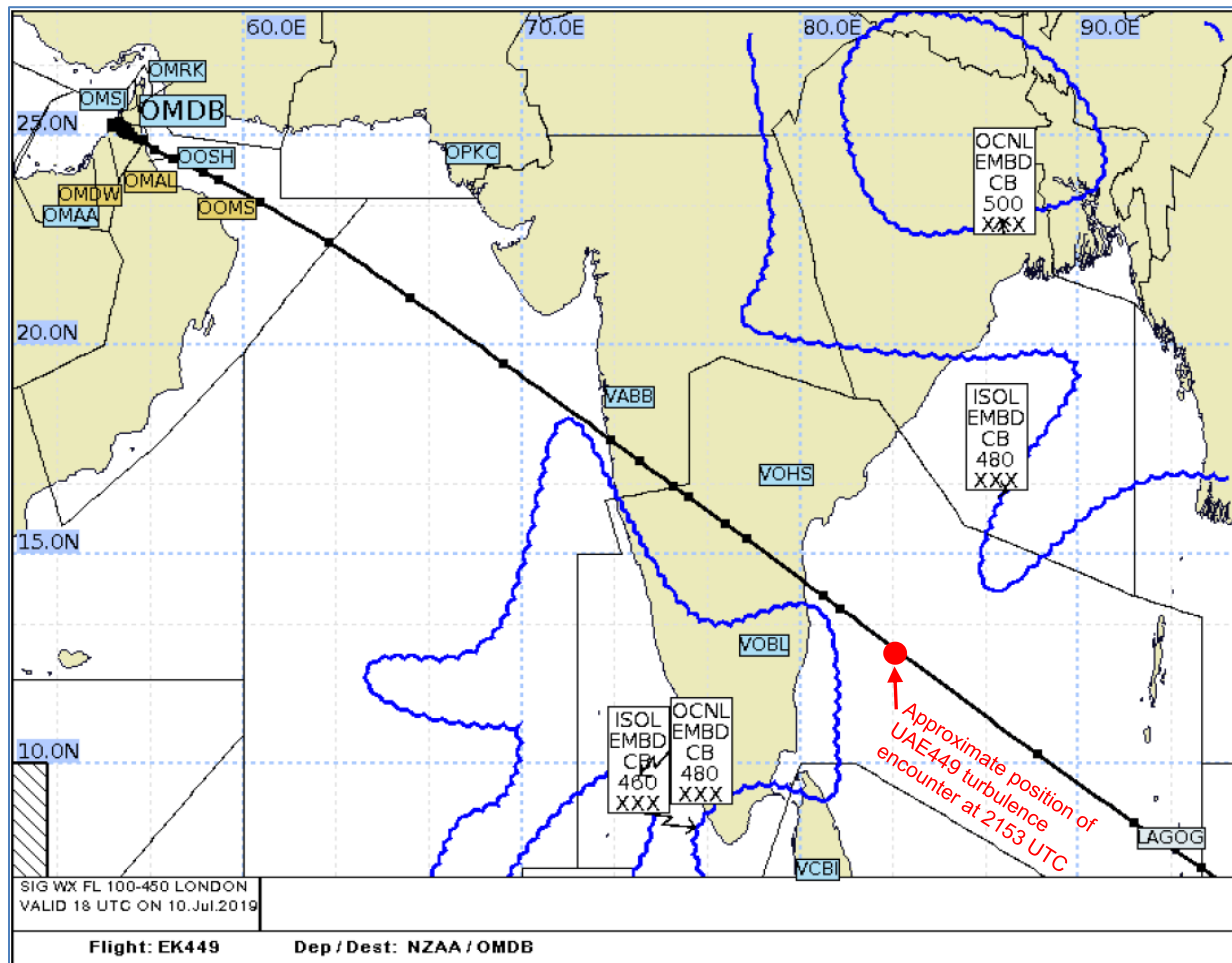
Figure 6. OFP significant weather chart at 1800 on 10 July 2019

The significant weather chart from the OFP that was effective at 1800 on 10 July 2019 is illustrated in figure 6. The approximate area of the turbulence encounter is indicated by the red dot.

The Investigation recommends that the Operator review, and enhance, flight planning taking into consideration known historical geographical locations that are affected by seasonal enroute significant weather and meteorological conditions.

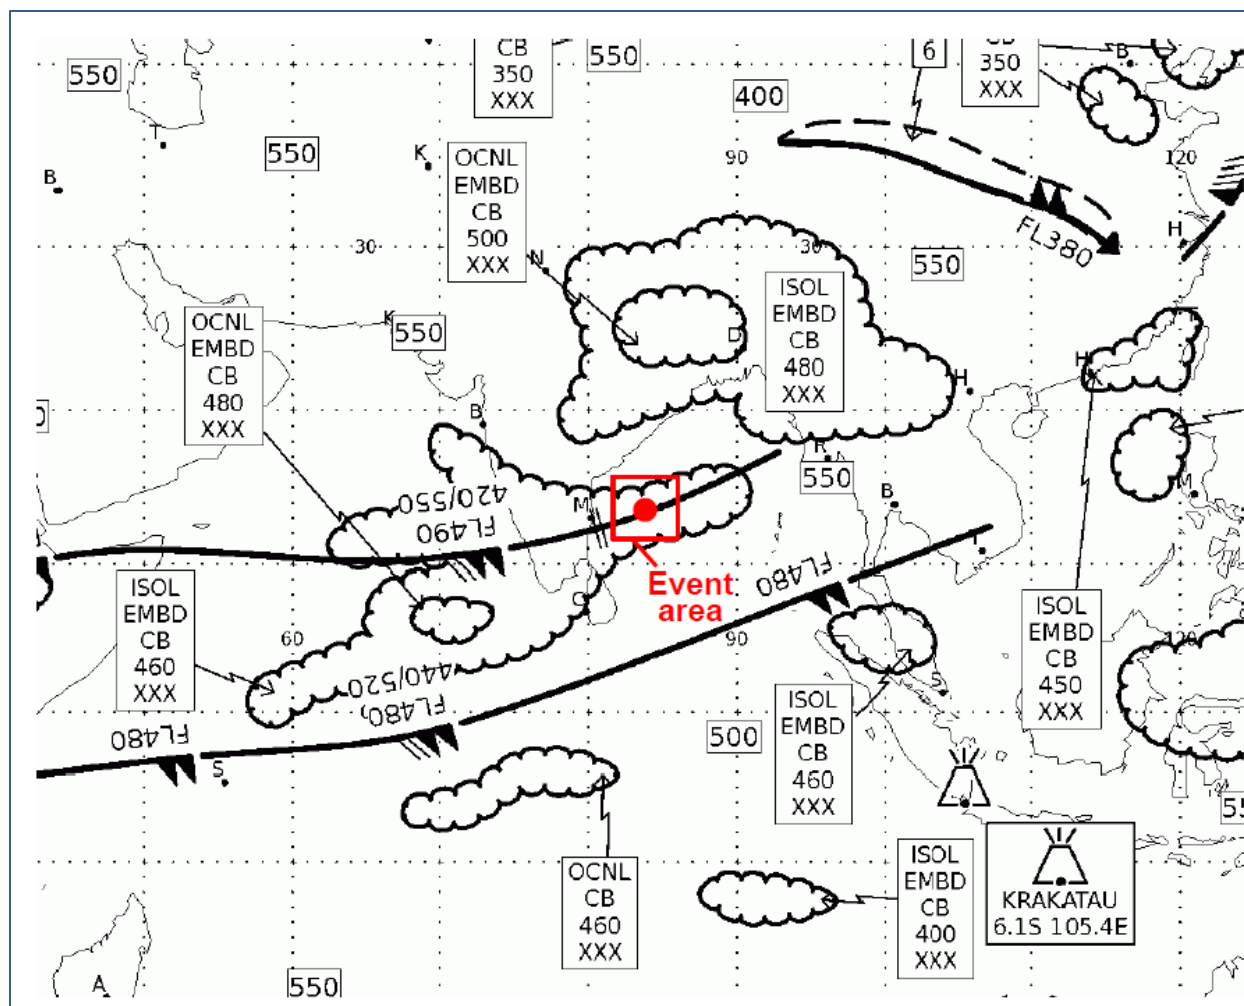
Figure 7. Forecasted significant weather chart at 0000 on 11 July 2019 [Source: see footnote No.9]

The weather chart as illustrated in figure 7<sup>9</sup> was made available to the Investigation by Airbus and shows the significant weather for this area at 0000 UTC on 11 July 2019. The chart shows an area of convective activity with isolated embedded cumulonimbus (CB) and tops at FL460. It also indicates an easterly jet stream at FL490 with maximum wind speed of 120 kt and depth of FL420 to FL550. The large area of low level convergence was oriented generally north-south, slightly northeast-southwest, approximately 100 to 150 NM east of the southern portion of the Indian Sub-Continent. Within this area of convergence, multiple isolated and embedded CBs and multiple lines of CBs can be identified in the chart. The area of convergence was moving east at approximately 15 NM per hour.

Figure 7 indicates the area of the turbulence encounter, shown as a boxed red dot.

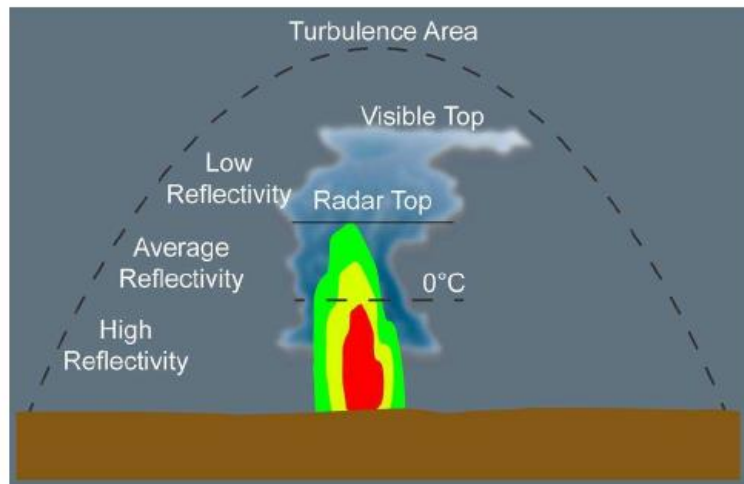
Figure 10. Turbulence area above the 'visible top' [Source *FCTM* A380]

The *FCTM* states that flight crew must be aware that radar top may not be the visible top of the convective cloud, and that convective cloud and associated areas of threat (e.g. turbulence) may significantly extend above the radar top as illustrated in figure 10.

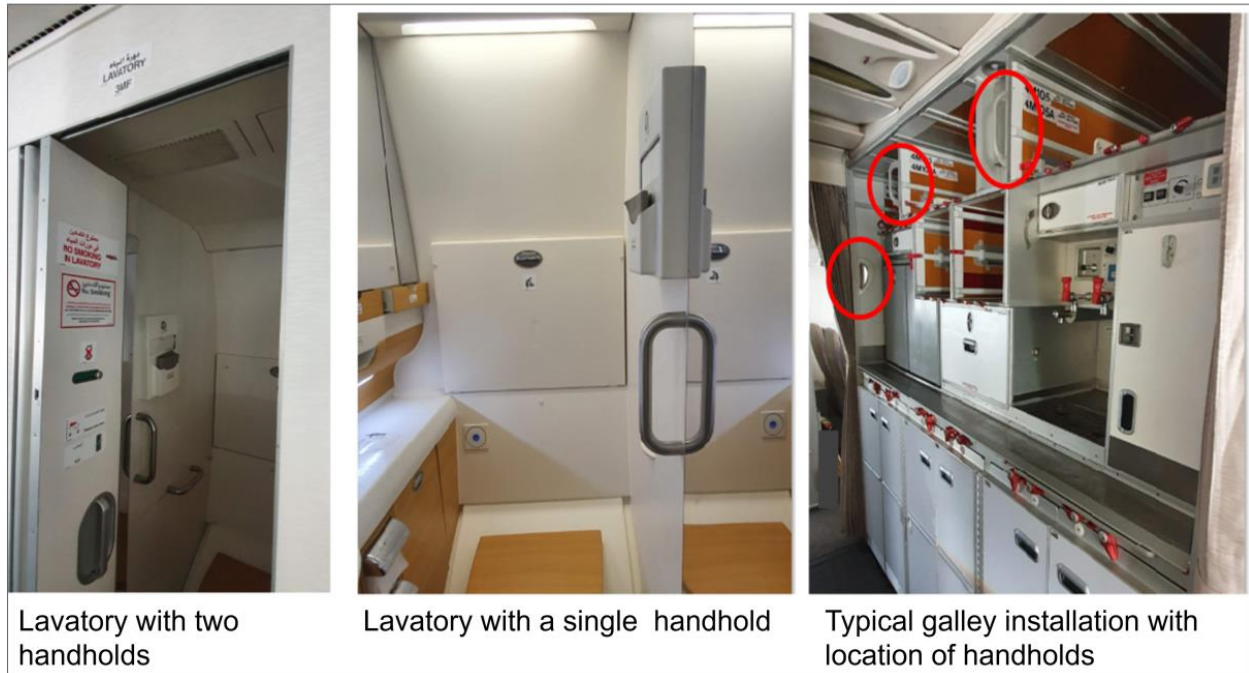
Figure 11. Examples of the A380 cabin handholds

Each of the nine cabin crew rest bed compartments, which were located in the aft section of the cabin, had a single seat belt which restrained the wearer at the waist. There was no handhold any of the bed compartments. The interior walls were made of fiber glass reinforced plastic.

Figure 11 illustrates samples of the A380 cabin handholds.
