ATSB TRANSPORT SAFETY REPORT

Aviation Occurrence Investigation

AO-2007-036

Fuel-related event
50 km NW of Swan Hill, Vic.
11 August 2007
VH-TJE
Boeing Company 737-476

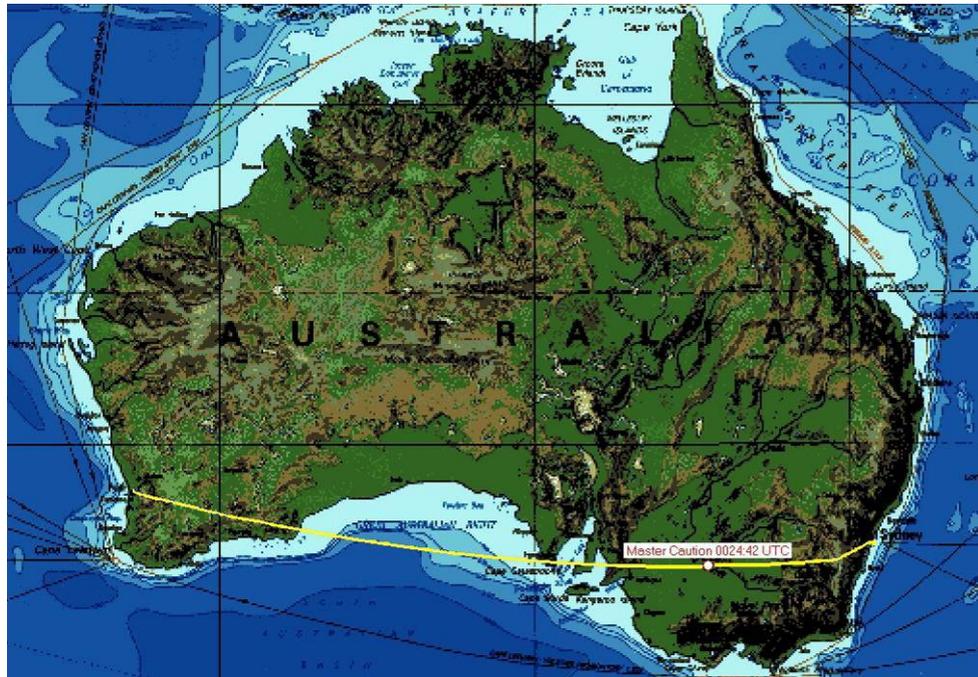
About 2 hours 40 minutes after takeoff, at 0824.42² (Figure 1), the master caution light illuminated, associated with low output pressure of the main tank fuel pumps. The main fuel tanks in the Boeing 737 series aircraft were located in each wing. A centre fuel tank, located in the wing centre section, was used for carrying additional fuel on longer flights, such as from Perth to Sydney.

Figure 1: Route flown with illumination of the master caution light indicated

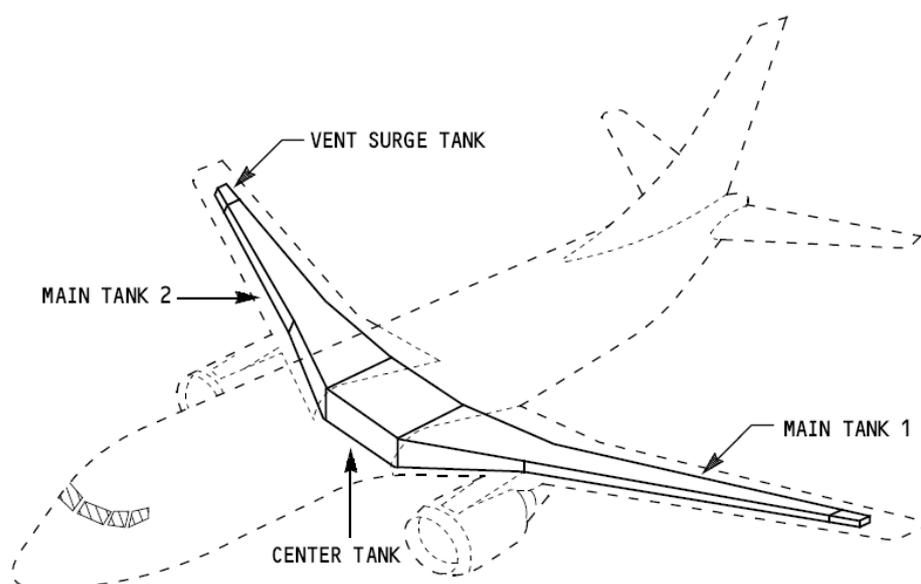
The aircraft's fuel system included three integral fuel tanks; the main fuel tanks in each wing and a centre fuel tank in the wing centre section for carrying additional fuel for long range flights (Figure 4). The aircraft had also been originally fitted with an auxiliary fuel tank located in the rear cargo compartment, but that tank had been deactivated.

Check valves regulate the output pressure from the fuel pumps. The centre tank check valves open at a lower pressure than the main tank check valves. Because of this, under normal operations with all pumps on, the engines would receive centre tank fuel first. When only residual fuel remains in the centre tank, the pumps in the main tanks then supply fuel to the engines. Thus, the aircraft would normally be operated and landed with fuel in the main tanks, with little or no fuel remaining in the centre tank.

Figure 4: Position of fuel tanks in B737-400 aircraft
