A Preliminary Examination of the Effectiveness of Hand-Held Extinguishers Against Hidden Fires in the Cabin Overhead Area of Narrow-Body and Wide-Body Transport Aircraft

Timothy R. Marker

July 2007

DOT/FAA/AR-TN04/33

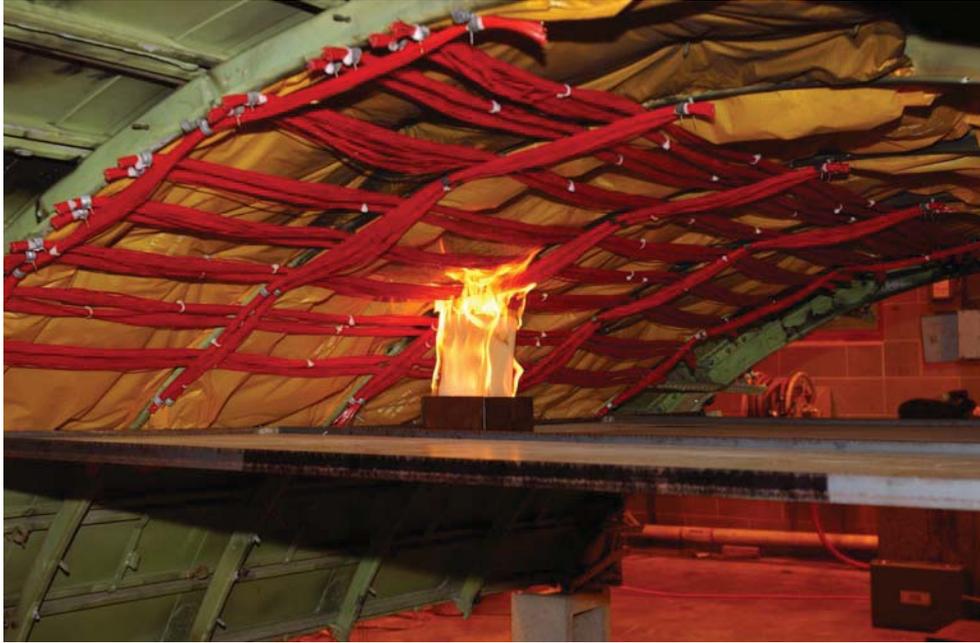
Figure 1. Wiring Test in a Simulated Cabin Overhead Area

Current Federal Aviation Administration (FAA) research is aimed at the development of more stringent fire test methods for materials located in hidden areas such as the ceiling overhead areas, cheek areas, and electronics and electrical (E/E) bays. This research targets the flammability of materials such as ducts, wires, panel closeouts, clamps, and other hardware located in the hidden and inaccessible areas to upgrade these materials to an equivalent level of fire resistance as recently adopted for thermal acoustic insulation [1]. The objective is to passively reduce the likelihood of an in-flight fire from occurring by substantially improving the fire resistance of materials in hidden areas. The research is coordinated with a subgroup of the International Aircraft Materials Fire Test Working Group, a government/industry group chaired by the FAA. Full-scale tests have been completed in which various types of wiring insulation were evaluated against a realistic fire threat (figure 1) [2].

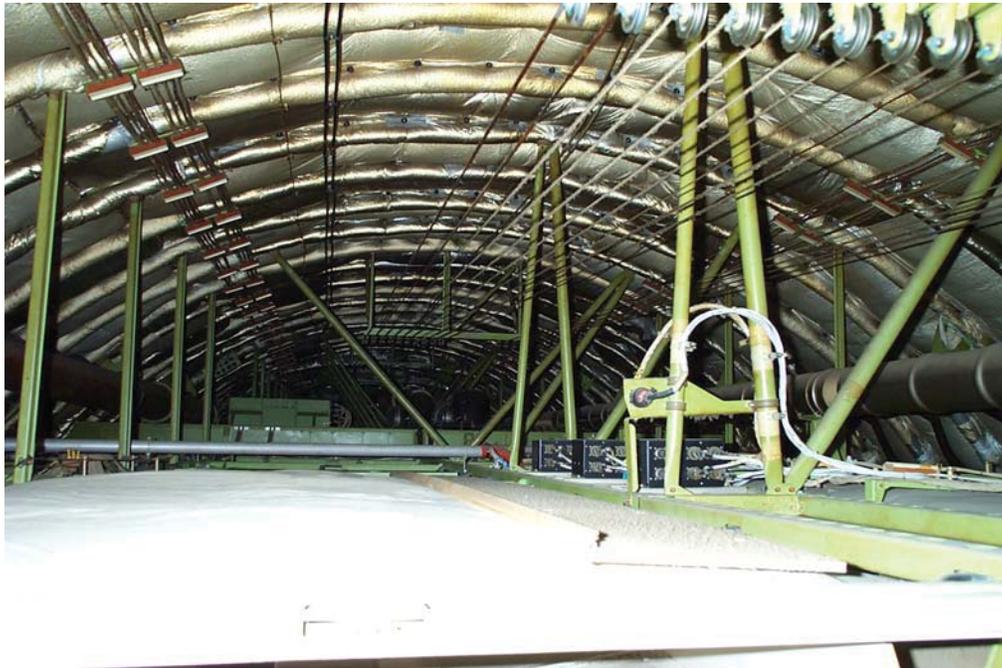
Figure 4. B-747SP Wide-Body Aircraft Aft Cabin Overhead Area

Although a majority of the cabin overhead volume is devoid of combustible materials, the periphery contains insulation blankets and adjacent wire bundles. There are also several wire bundles that run along the centerline, just above the ceiling panels. The aft overhead section of the B-747SP wide-body aircraft is shown in figure 4.

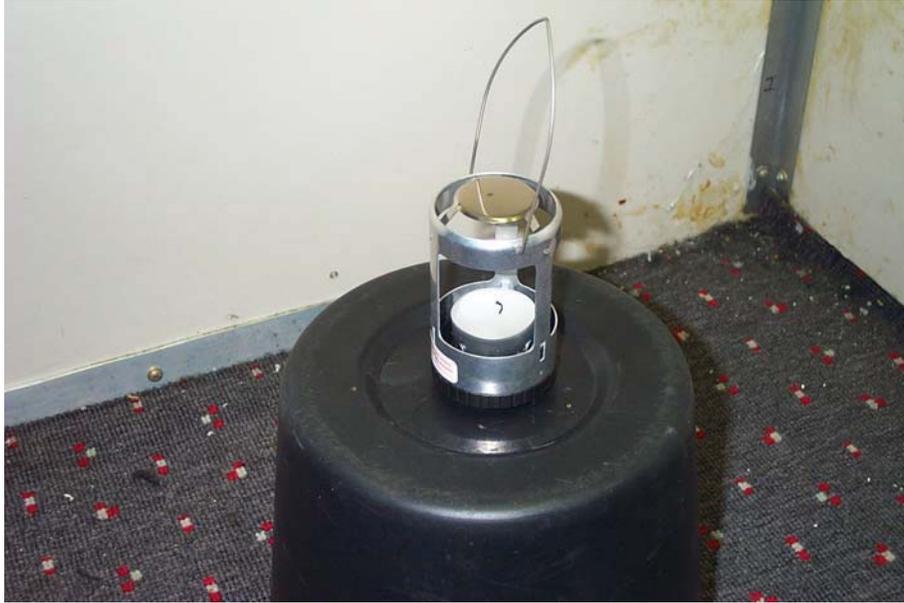
Figure 5. Candle Lanterns Used in Cabin Overhead Area Tests

Since the B-747SP was an operational test aircraft, as opposed to a true fire test article, care had to be taken not to cause damage to the interior during live fire tests. To create a realistic yet safe fire scenario, small candle lanterns were incorporated to measure the range and volume of fire extinguishant. The candles were paraffin-based discs, enclosed in a protective metal shroud to prevent wax spillage and ignition in the event that the candle tips over (figure 5). The candle lanterns were equipped with glass cylinders that shrouded the flames, making it somewhat difficult to extinguish them. For this reason, the glass shrouds were removed for all tests performed in the cabin overhead area. Once lit, the candle lanterns could burn continuously for 4 hours, making them ideal for this type of hidden space test.

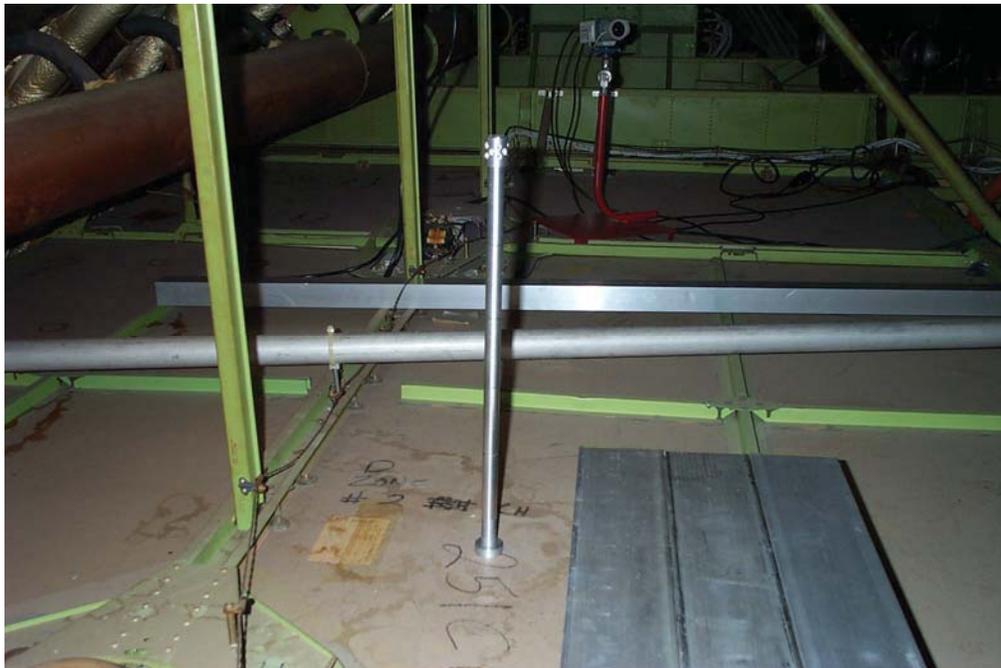
Figure 7. Ceiling-Mounted Port Extension Tube Mounted in Cabin Ceiling

To use the available extinguishing agent most efficiently, the initial ceiling-mounted port was designed to extend above the cabin ceiling to promote extinguishing agent transport to the combustible materials near the crown of the aircraft. The port and discharge head contained a series of threaded extension tubes, each measuring approximately 6 inches long. When five extension tubes were used in conjunction with the head, the discharge point was situated 30 inches above the cabin ceiling. The discharge head was designed to propel the agent radially (figures 7 and 8).

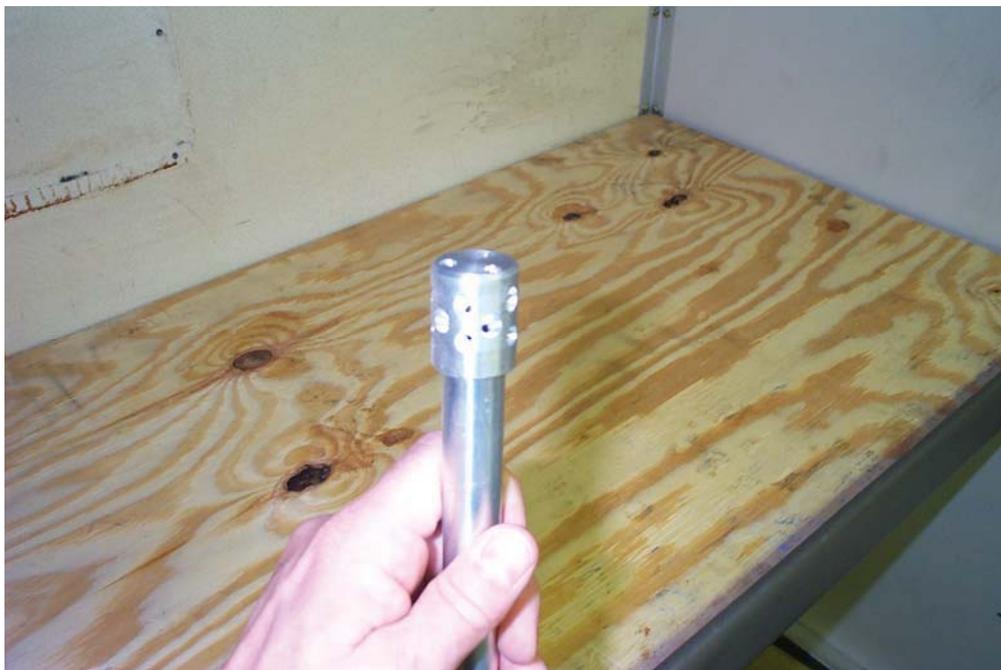
Figure 8. Ceiling-Mounted Port Prototype Discharge Head

Test 2 was run using the prototype discharge head (figure 8) attached to the end of the ceiling-mounted port. This configuration provided extinguishment of four of the six candles, a much better result than test 1. Although the overall thrust of the extinguisher was restricted with this design, it did convey the extinguishing agent far enough radially to give this outcome.

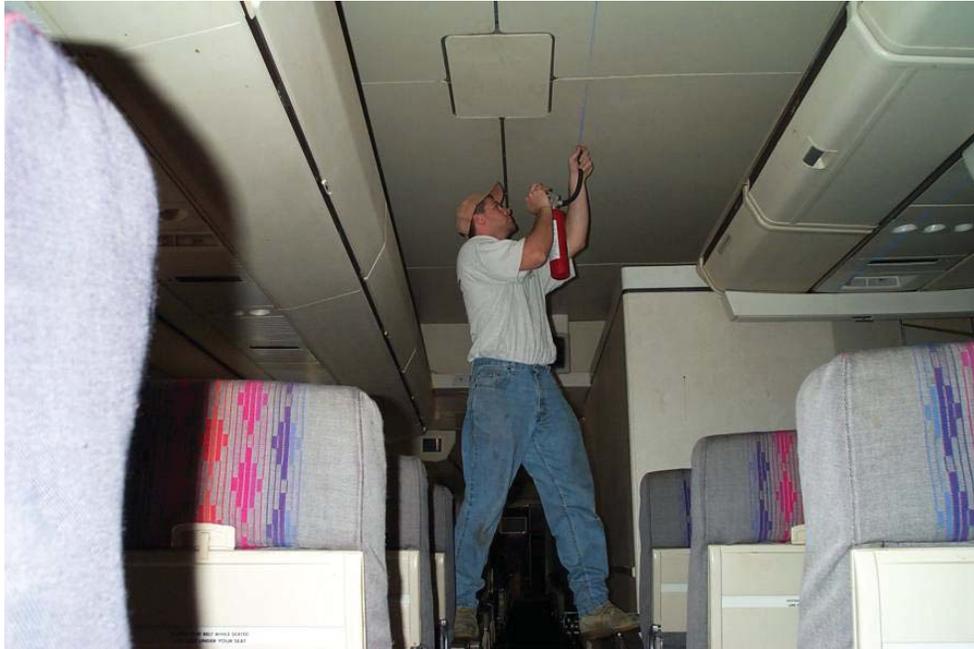
Figure 9. Extinguishing Agent Discharged Through the Port in the Wide-Body Aircraft

The ceiling-mounted port and associated tubes and head were centered over the left aisle, just aft of the crew rest area, which was converted into a control room for these tests. Cameras were mounted in the cabin overhead area to capture the sequence of events during extinguishing agent discharge. One important note was that all extinguishers incorporated a flexible discharge hose, allowing the extinguisher to remain perfectly upright during discharge. This enabled full expulsion of the extinguisher contents, which would not be possible otherwise, since the extinguisher would need to be held horizontally to engage the ceiling-mounted port. Also of note was the requirement that the person discharging the extinguishing agent needed to stand on the armrests of the seats to reach the ceiling-mounted port (figure 9).

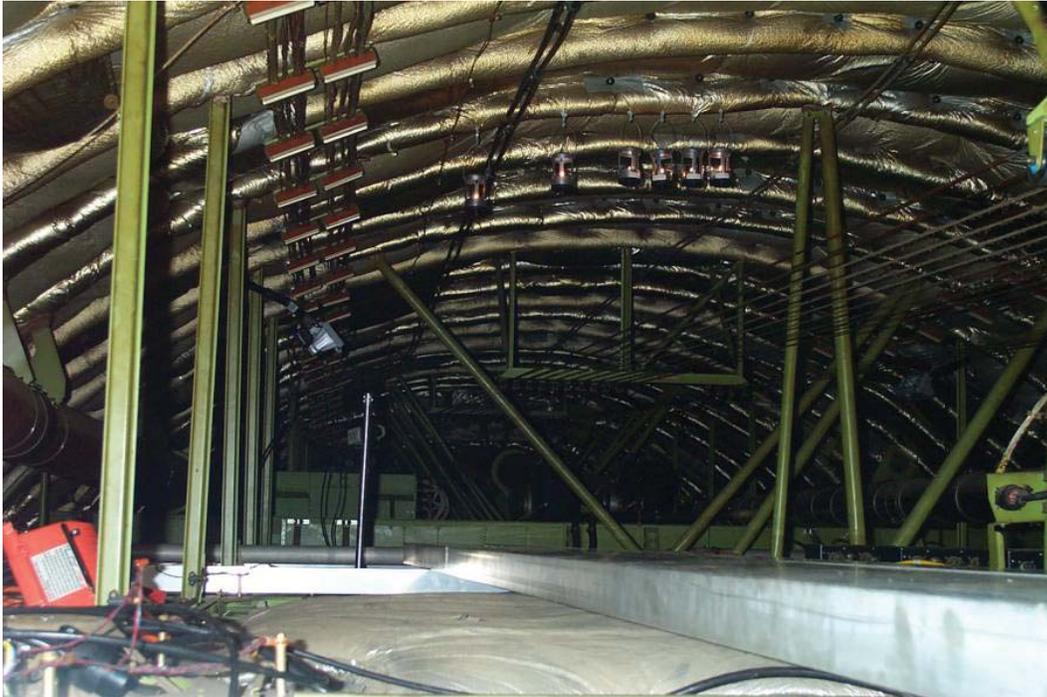
Figure 12. Modified Candle Lantern Test Configuration in Cabin Overhead Area

Using this arrangement, the candles were hung closer to the discharge head, perpendicular to the axis of the aircraft (figures 11 and 12). The distance from the first candle situated directly over the port to the last candle was approximately 42 inches.

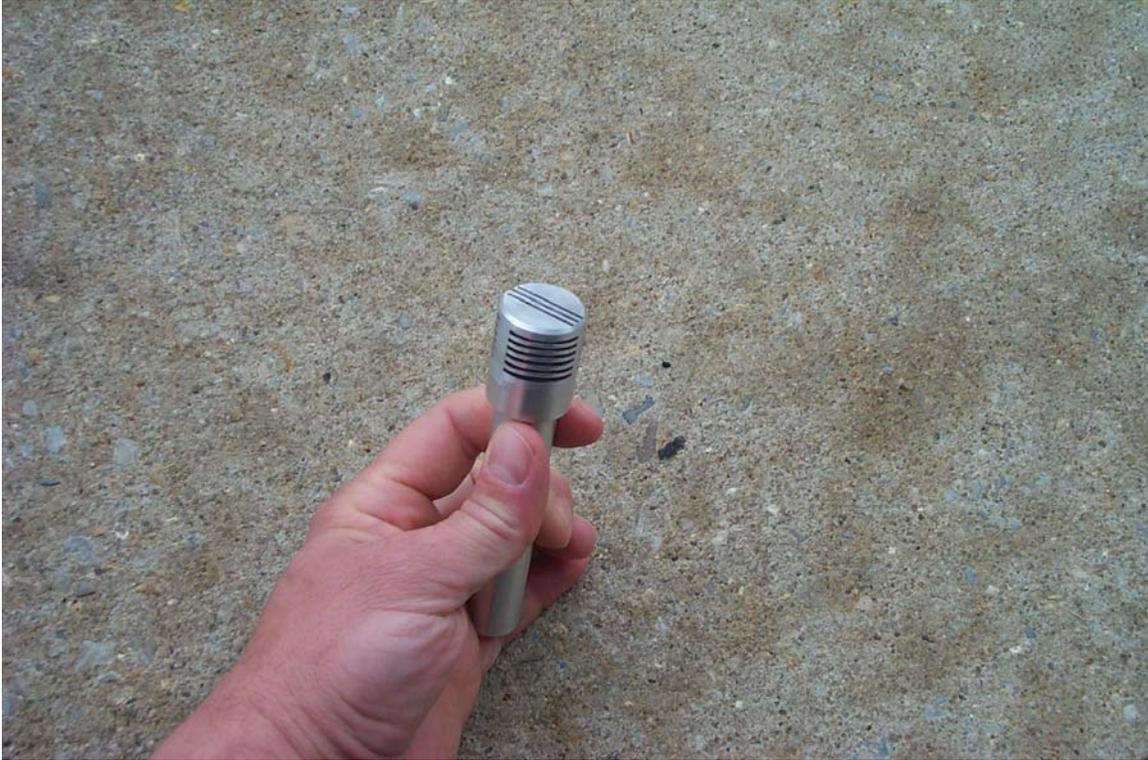
Figure 13. Grill Design Discharge Head

As a result, a second discharge head was designed and fitted to the ceiling-mounted port. The new discharge head featured a grill design and was much less restrictive than the previous discharge head with holes (figure 13).

During test 3, the prototype discharge head was replaced with the grilled design discharge head (figure 13). In earlier wide-body aircraft tests, this grill discharge head proved to be less restrictive, giving a slight advantage in performance over the prototype discharge head. However, the wide-body aircraft tests were run with the candle lanterns mostly vertical in relation to the discharge head, whereas the narrow-body aircraft tests were run with the candles nearly horizontal to the discharge head. Following full discharge, only three of the six candles were extinguished. Although the grill discharge head was less restrictive, it appeared slightly vertically biased, allowing more vertical discharge than radial. Given this characteristic, the

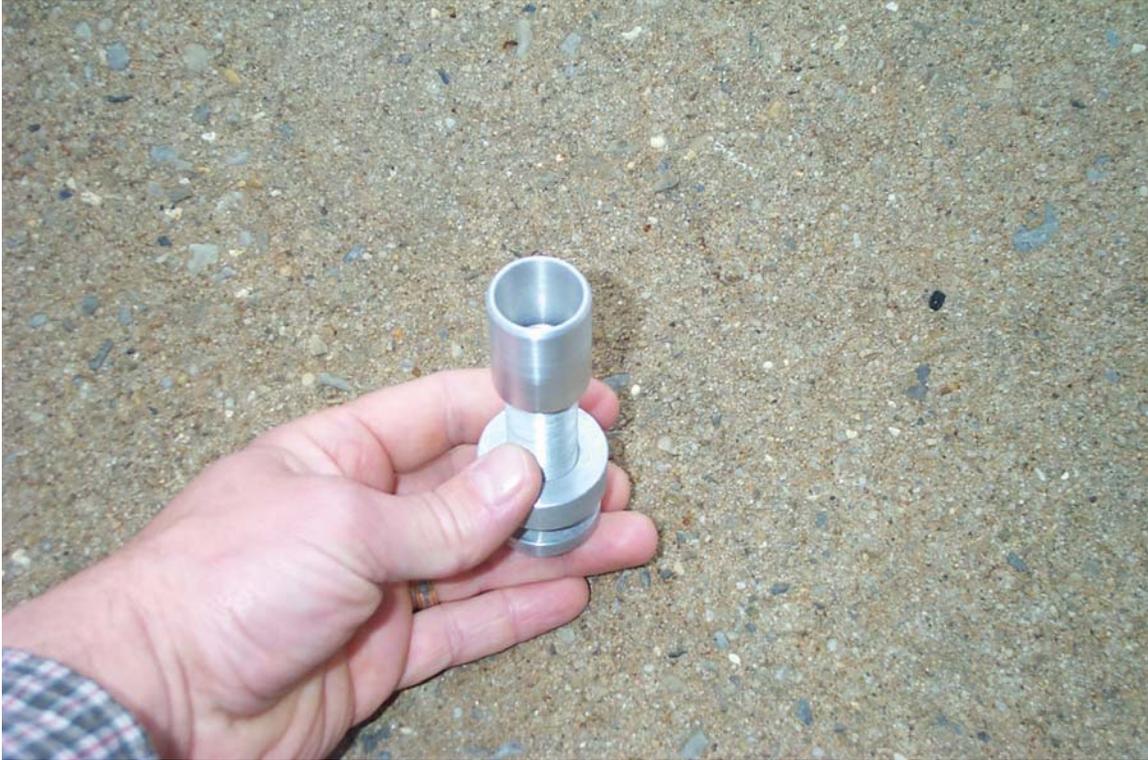
Figure 14. Feedthrough Design Discharge Head

To substantiate this theory, in test 5, a feedthrough design discharge head was attached to the end of the ceiling-mounted port (figure 14). This, again, resulted in five of the six candle lanterns being extinguished. In this case, the nonextinguished lantern was farthest from the discharge location, indicating good upward thrust, but slightly reduced radial range.

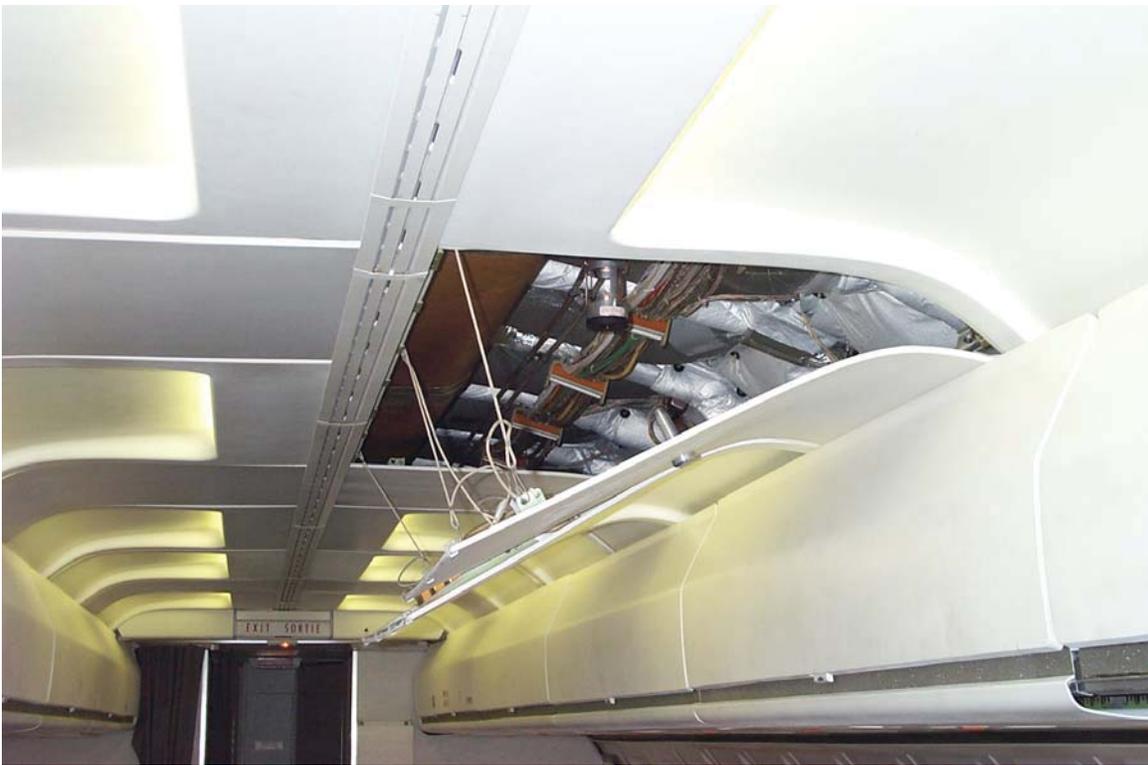
Figure 17. Narrow-Body Aircraft Showing Cabin Overhead Area Access

During the pretest inspection of the narrow-body aircraft, it was determined that the cabin overhead panels could be unfastened and rotated downward, giving nearly unlimited access to the cabin overhead area (figure 17). Although the locking mechanism for the panels was hidden in the overhead stowage bins and was somewhat difficult to activate, it became much easier to perform once the operator became familiar with it. This was a significant finding in that, given the proper training, a fire in the hidden overhead area of this type of aircraft with this particular panel attachment scheme could easily be accessed and extinguished. This was not true for the wide-body aircraft, in which the ceiling height was much greater and the ceiling panels were significantly larger.

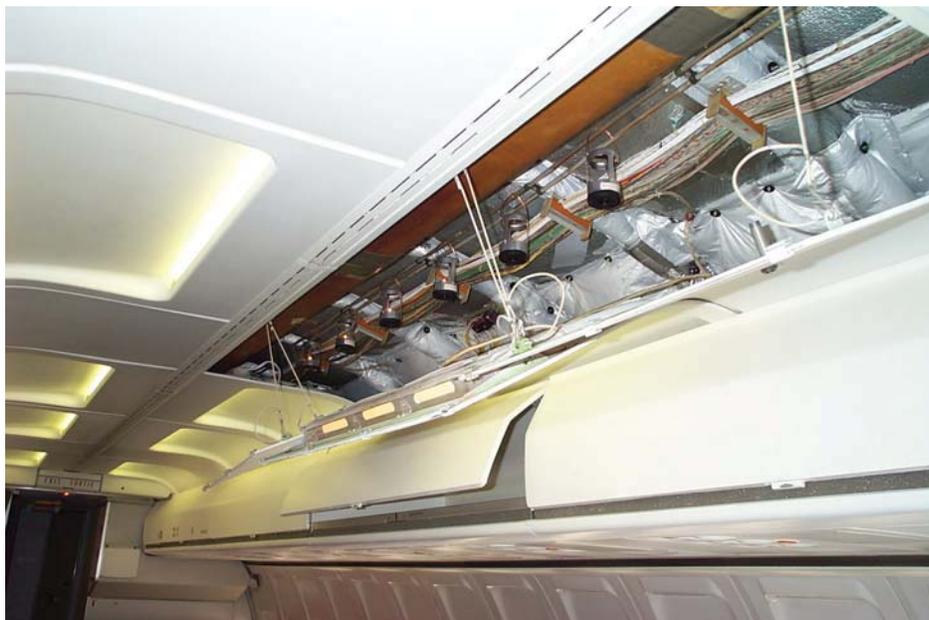
Figure 19. Narrow-Body Aircraft Test Configuration Showing Location of Candle Lanterns

Since the cabin overhead area of the narrow-body aircraft was relatively small and cluttered in comparison with the wide-body aircraft, there were only a few possibilities in terms of the location of the candle lantern fire sources. As such, the lanterns were hung from a hydraulic line that was mounted to the fuselage formers in the cabin overhead area (figure 18). This resulted in the lanterns being very close to a large wire bundle that ran forward to aft, which was a realistic simulation in terms of fire location (figure 19). The ceiling-mounted port was installed 15 inches from the centerline of the aircraft, which was approximately aligned with the candle lanterns.

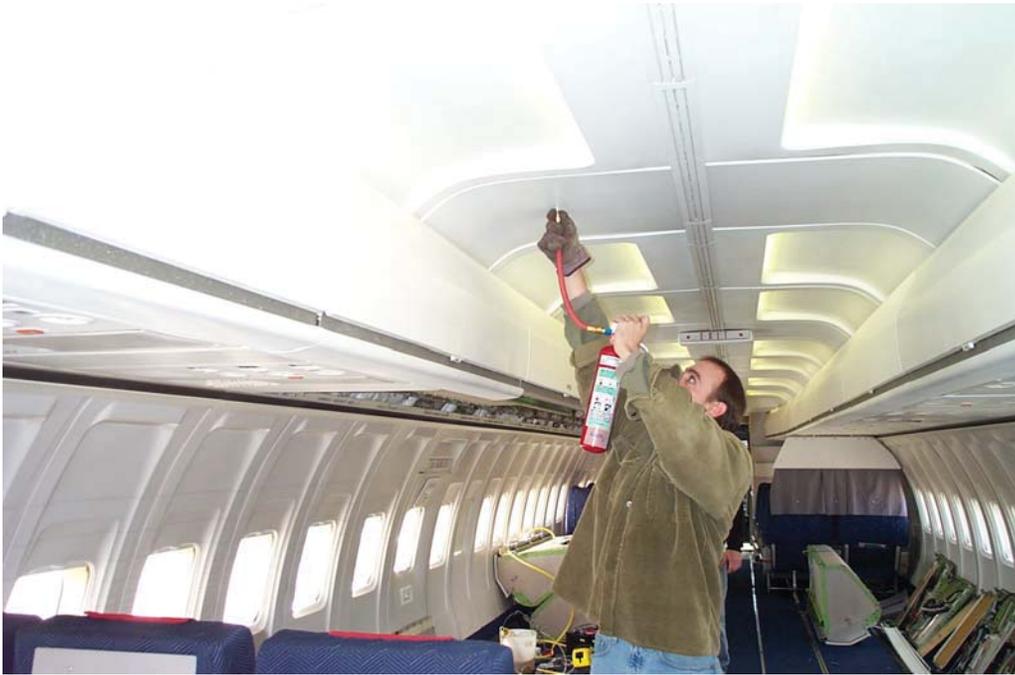
Figure 21. Halon 1211 Discharged Through Ceiling-Mounted Port

After lighting all six candle lanterns, the ceiling panels were quickly reinstalled to their proper position. The 2.5-lb Halon 1211 extinguisher was then fully discharged through the ceiling-mounted port, followed by a brief 1-minute settling period to allow the extinguishing agent to fully disperse in the cabin overhead area (figure 21). The ceiling panels were then unfastened to allow inspection of the candle lanterns. This procedure was followed for all tests.
