**Statens haverikommission**  
Swedish Accident Investigation Board

***Report RL 2009:19e***

**Incident involving aircraft HA-LPB over  
Kalmar county, Sweden on 2 March 2009**

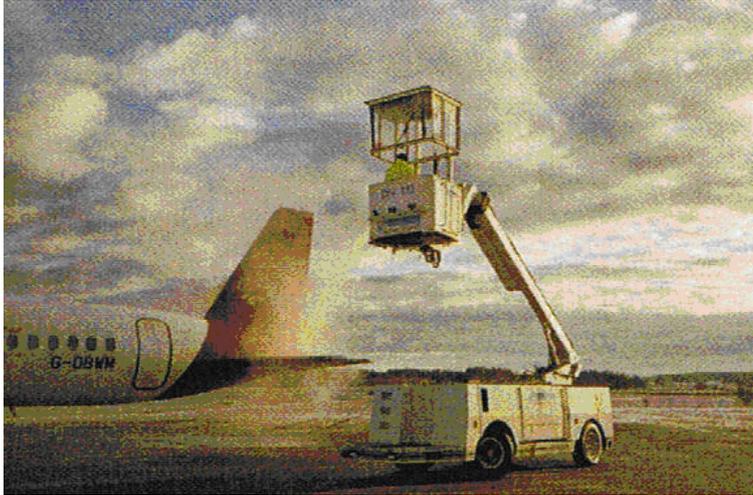
Västerås Flygplats AB has at its disposal for de-icing services a mobile de-icing unit of DIV 110 type, see Figure 1. The unit is operated by one person, who both drives the vehicle and manoeuvres a pivoted de-icing nozzle from a platform on the end of an arm that can be raised and lowered. The vehicle has three fluid tanks, for water, Type I and Type II fluid. The water and Type I tanks are equipped with immersion heaters. The de-icing fluid and water can be mixed in different proportions before the mixture is sprayed on to the aircraft. The mixing proportion is determined by the external air temperature, aircraft skin temperature, precipitation and the desired holdover time in accordance with the tables provided by the fluid manufacturer. The de-icing mixture is set by the operator of the vehicle in accordance with the order from the commander and the table values for the existing conditions.

Figure 1. Type DIV 110 de-icing vehicle.
