SMOKE, FIRE AND FUMES IN TRANSPORT AIRCRAFT

PAST HISTORY, CURRENT RISKS AND RECOMMENDED MITIGATIONS

Part 1: Reference

A Specialist Paper by the **Royal Aeronautical Society**

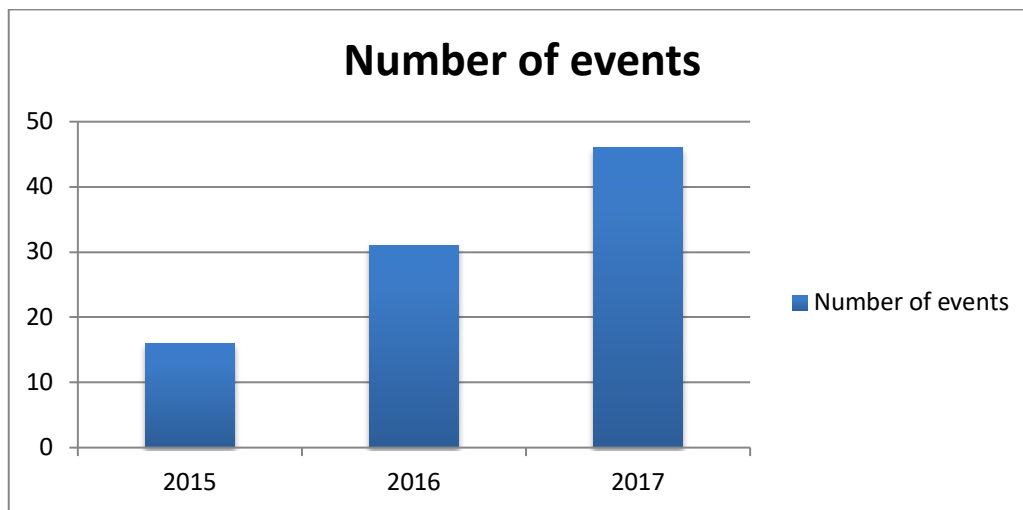
(FAA, 2015)

One of the largest trends in the growth of in-flight fires is due to the transportation of lithium batteries. From March 1991 to August 2018, the FAA office of Security and Hazardous Materials Safety recorded 225 cases of aviation incidents involving smoke, fire, extreme heat or explosion involving batteries and battery powered devices (FAA, 2018). Lithium batteries were the majority of battery types in the incidents. Of particular concern is the increasing number of lithium battery fires

onboard aeroplanes. In 2018 between January and August there were 34 events, in 2017 there were 46 events, in 2016 there were 31, and in 2015 there were 16 (FAA 2018).

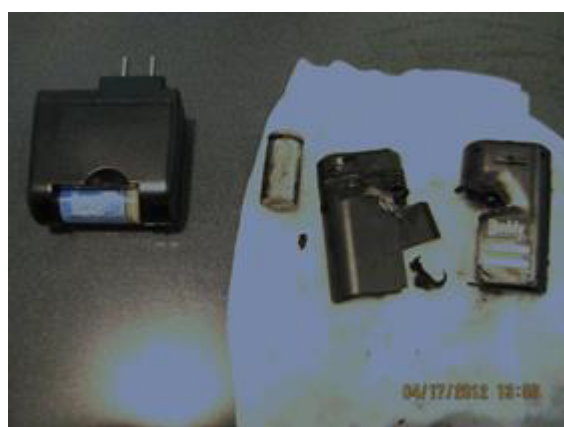
Photo of Mini Air Purifying Device after lithium-ion battery fire on flight from Toronto, Canada, to Minneapolis/Saint Paul, Minnesota, 17 April 2012.

During the in-flight service, the cabin crew noted that the device was on fire on the floor; its battery was burning several feet from the device. Using water from the service cart, the cabin crew put out the fire using wet paper towels. One of the cabin crew then submerged the battery in a cup of water because the battery was still smouldering. On the flight deck, the captain sensed a very strong burning electrical odour coming from the cabin. An emergency was declared and the flight diverted and landed safely at Traverse City, Michigan.

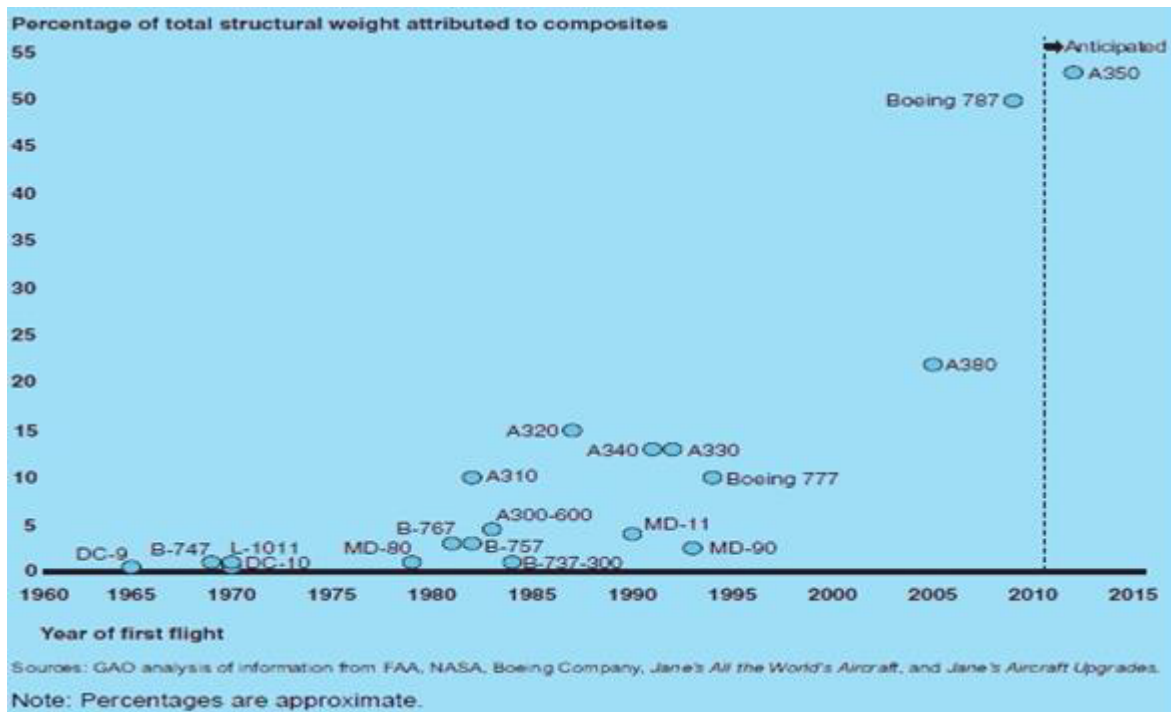
The following figure shows the percentage of total structural weight attributed to composite materials used in aeroplane construction since the mid-1980s:
