**DOT/FAA/AR-08/25**

# **Safety Study of Wire Strike Devices Installed on Civil and Military Helicopters**

September 2008

Final Report

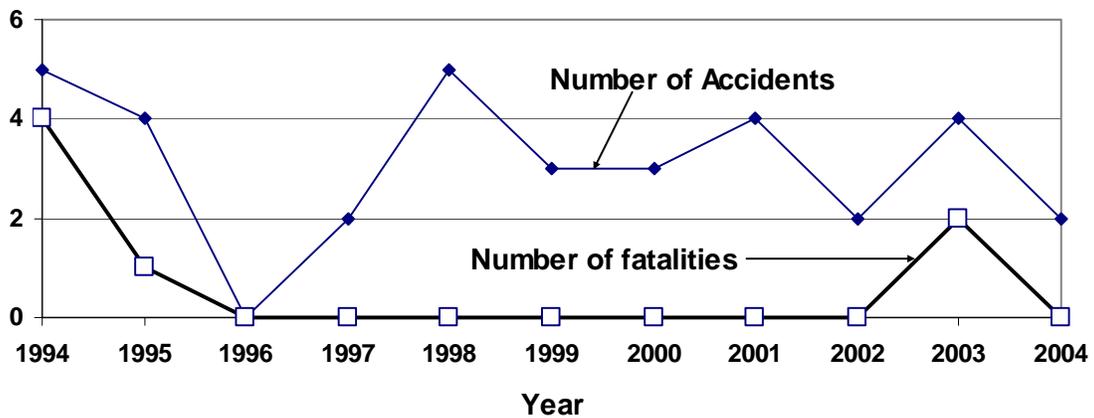
Figure 2 shows the yearly number of wire strike accidents. Between 1997 and 2002, the number of wire strike accidents was between two and five per year. Figure 2 also shows the number of fatalities in wire strike accidents. After 1995, there were no fatalities in accidents involving wire strikes, even though the number of wire strikes did not decrease. There were two fatalities in 2003 that involved an AH-64A model that was conducting a night reconnaissance and surveillance mission using night vision systems. One reason for this impressive safety record can be the installation of wire cutters (WSPS) on Army helicopters.

Figure 2. U.S. Army Helicopter Wire Strike Accidents and Fatalities

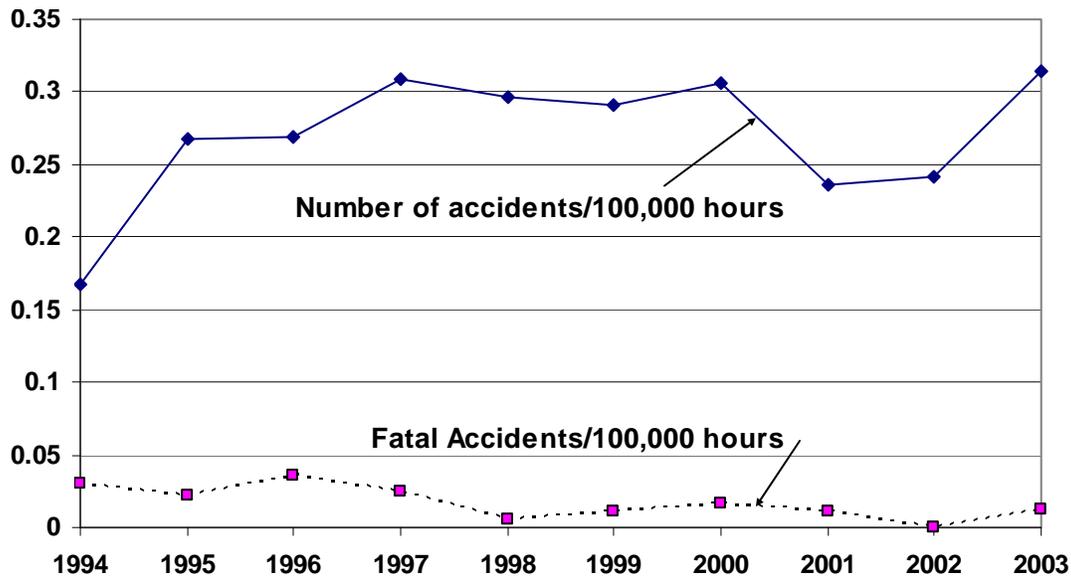
The rate of accidents in 2003 was close to ten accidents per 100,000 flight hours. There were 1.74 fatal accidents per 100,000 hours in the year 2003. The corresponding rates for fixed-wing aircraft operated by air carriers under 14 CFR 121 are shown in figure 9. In the year 2003, the number of accidents for fixed-wing of aircraft was slightly above 0.3 accidents per 100,000 flight

hours. Thus, the rate of accidents per 100,000 hours for fixed-wing aircraft is 3% of the accident rate for helicopters.

Figure 9. Accident Rates, 1994 Through 2003, for U.S. Air Carriers Operating Under 14 CFR 121

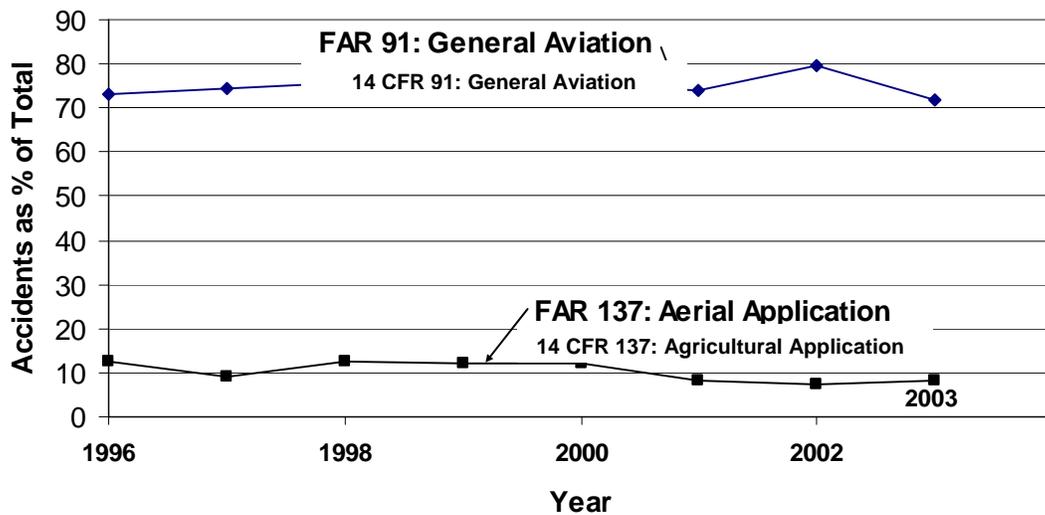
Figure 13 shows the accidents in which helicopters conducting 14 CFR Part 91 (general aviation) and 14 CFR Part 137 (agricultural application) operations were involved. Helicopters conducting general aviation operations were involved in 70% to 80% of all civil helicopter accidents. Helicopters involved in agricultural application operations accounted for about 10% of all the accidents.

Figure 13. U.S. Civil Helicopter Accidents by Type of Operation

As a comparison, the percentage breakdown of civil helicopter accidents was general aviation: between 70% and 80% and agricultural: 10% (figure 13).

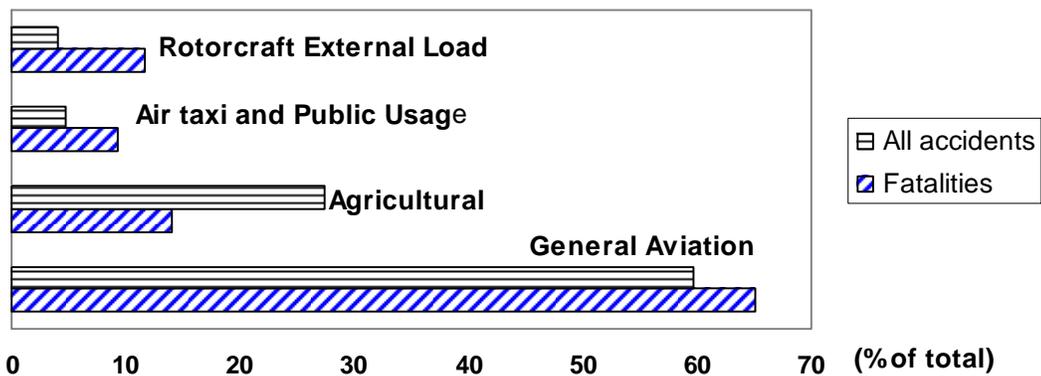
Figure 22 shows a comparison of the proportion of all wire strike accidents (as percentage of the total) with the fatalities in each type of operation. Operations under 14 CFR Part 91 general aviation account for about 65% of wire strike accidents and for about 60% of the fatalities. Agricultural operations account for about 27% of wire strike accidents and about 14% of fatalities in wire strikes (14 CFR Part 137).

Figure 22. Comparison of Accidents and Fatalities by Type of Operation (1994-2003)

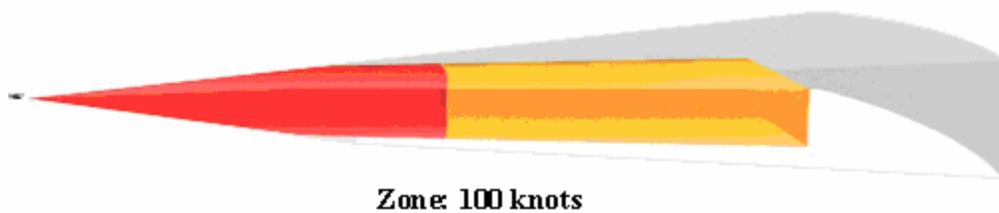
Figure 27. Zone of Scan at 100 Knots, OASys

The OASys radar (Amphitech Systems) uses a radar mounted on the nose of the helicopter to transmit a 35-GHz radio frequency for detecting obstacles in the flight path. The radar constantly searches for obstacles in its field of view. At a given instant of time, the system uses data from the aircraft's GPS receiver to calculate the aircraft's flight path for the succeeding 19 seconds. Three zones of increasing potential risk are then designated by the system. If the obstacle is located in any of these three zones, the pilot is given a level of alert that depends on the proximity and zone of the obstacle and is notified by a small display in the cockpit that illuminates in accordance with the distance and direction to the obstacle. OASys also adapts to the requirements of the flight. For instance, during takeoff, the system scans a wide angle around the helicopter, but only a short distance in front of it. However, when the aircraft is cruising at high speeds, the scan narrows, but looks far ahead in the flight path [10]. These zones are shown in figures 26 and 27.

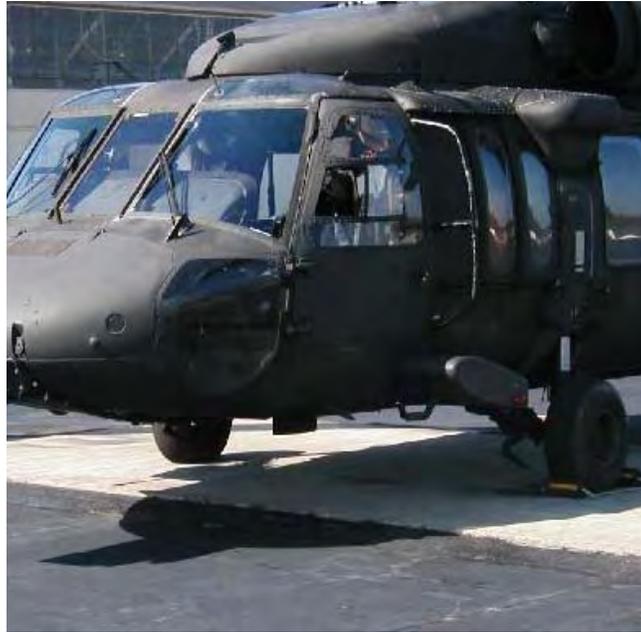
Figure 30. HELLAS Installed on UH-60 Helicopter

rotorcraft too close to the obstacle [22]. The system is connected to the helicopter by a standard interface, which requires 28 Vdc [23]. Figure 30 shows the optical display box installed on the fuselage.
