Controlled Flight Into Terrain

Education and Training Aid

Flight Safety Foundation

Welcome to the Controlled Flight Into Terrain (CFIT) Education and Training Aid

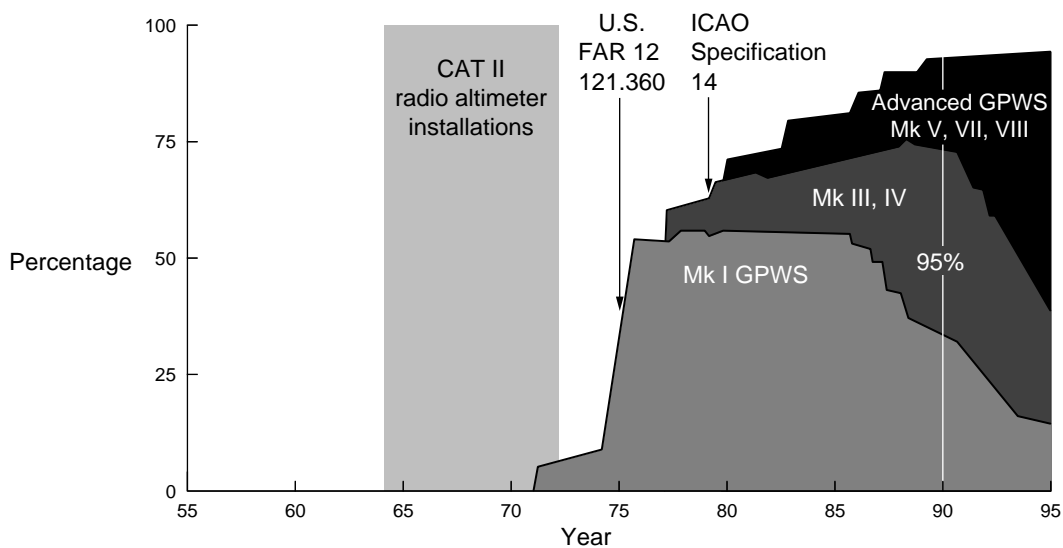
Figure 7
World Airline Jet
Fleet Equipped With
GPWS

Installation of GPWS on all airplanes should be the goal of the international aviation industry. It is estimated that over the next 15 years, half of the current unequipped airplanes will be retired from service. However, this still leaves nearly 200 airplanes that do not have GPWS installed. Currently, less than 5% of the world's commercial airplane fleet is not equipped with GPWS; however, these unequipped airplanes are involved in nearly 50% of CFIT accidents (Figures 7 and 8).

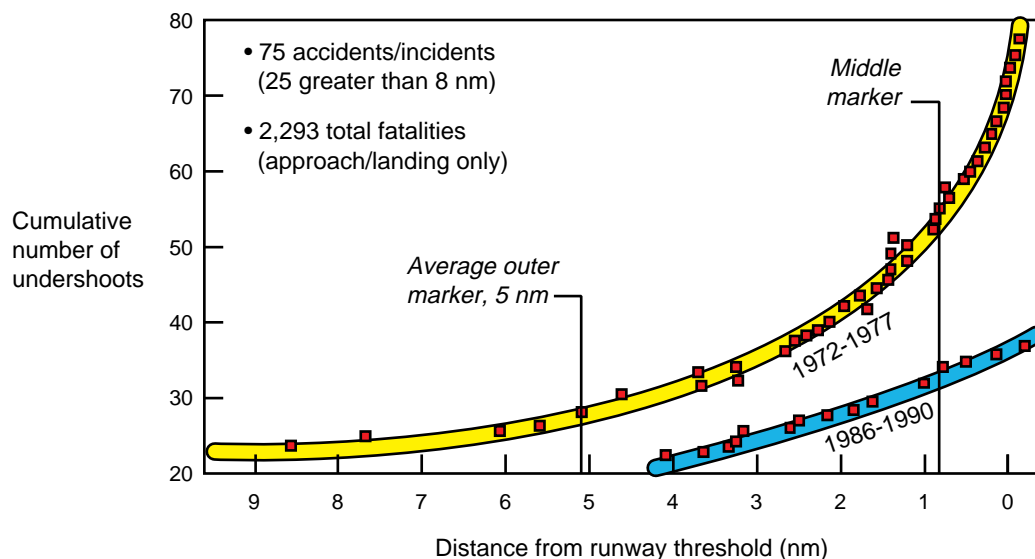
Figure 13
Geographical
Location of CFIT
Accidents

The geographical locations of CFIT accidents during the 1970s show a different pattern than those in the late 1980s and 1990s (Figure 13). During the 5-year period from 1972 through 1977, there were 75 CFIT accidents or incidents. Twenty-five of these accidents/incidents were greater than 8 nm from the runway. The preponderance of the remaining accidents/incidents were inside the middle marker. However, for the period 1986 to 1990, the distribution of accidents/incidents was relatively even. This difference may be the result of improvements made in runway approach aids that took place during this time period. Additional ILS were installed, as well as runway approach lighting systems. Continued capital investment in runway precision approach and lighting systems needs to be made worldwide.

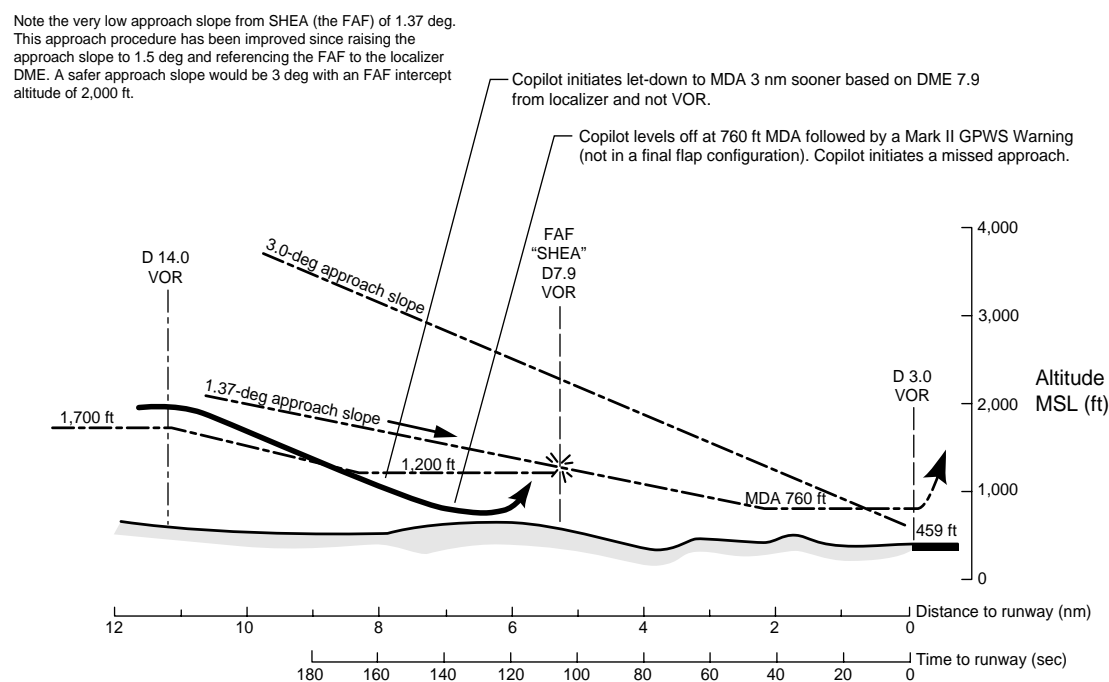
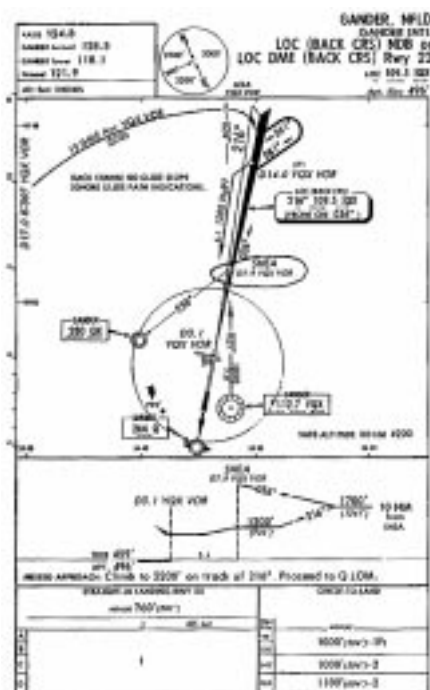
Figure 15
Flight Path
Profile—ASRS
Report 254276

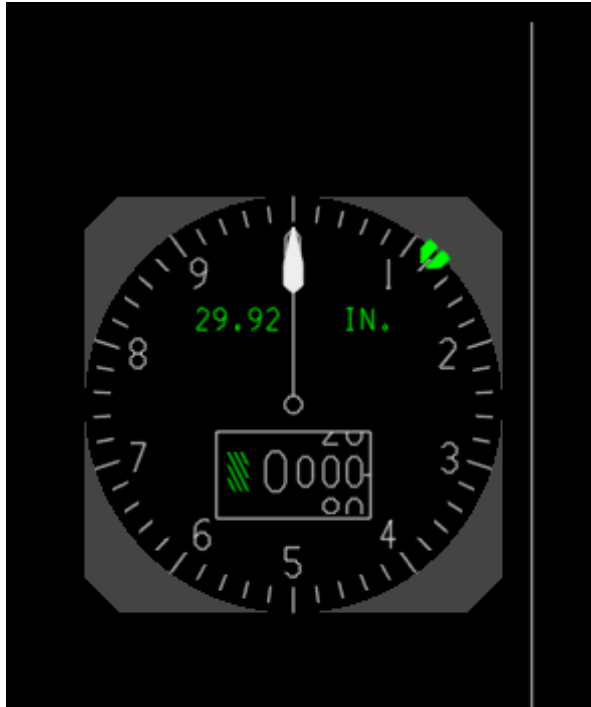
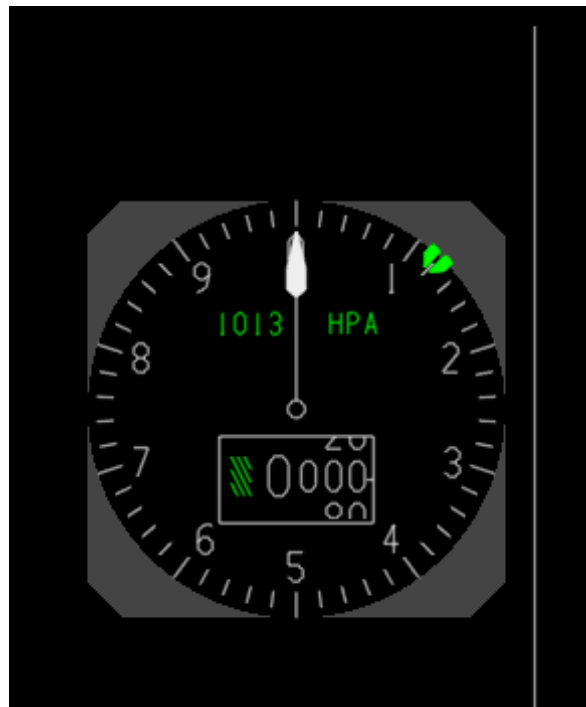
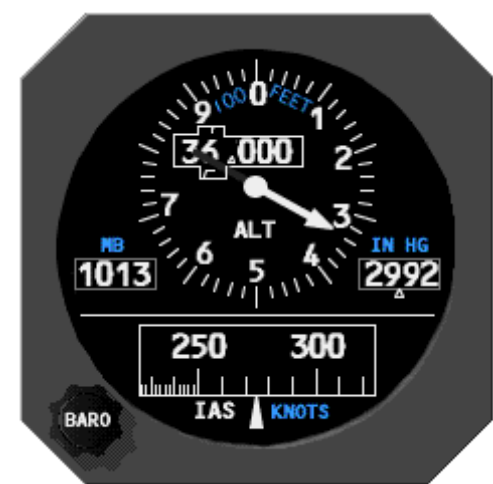
- Know what altimeter units of measurement are used for the area.
- Be vigilant during radio transmissions. Verify if in doubt.
- Be prepared to convert feet and meters.

Inches of Mercury

HectoPascals

Millibars

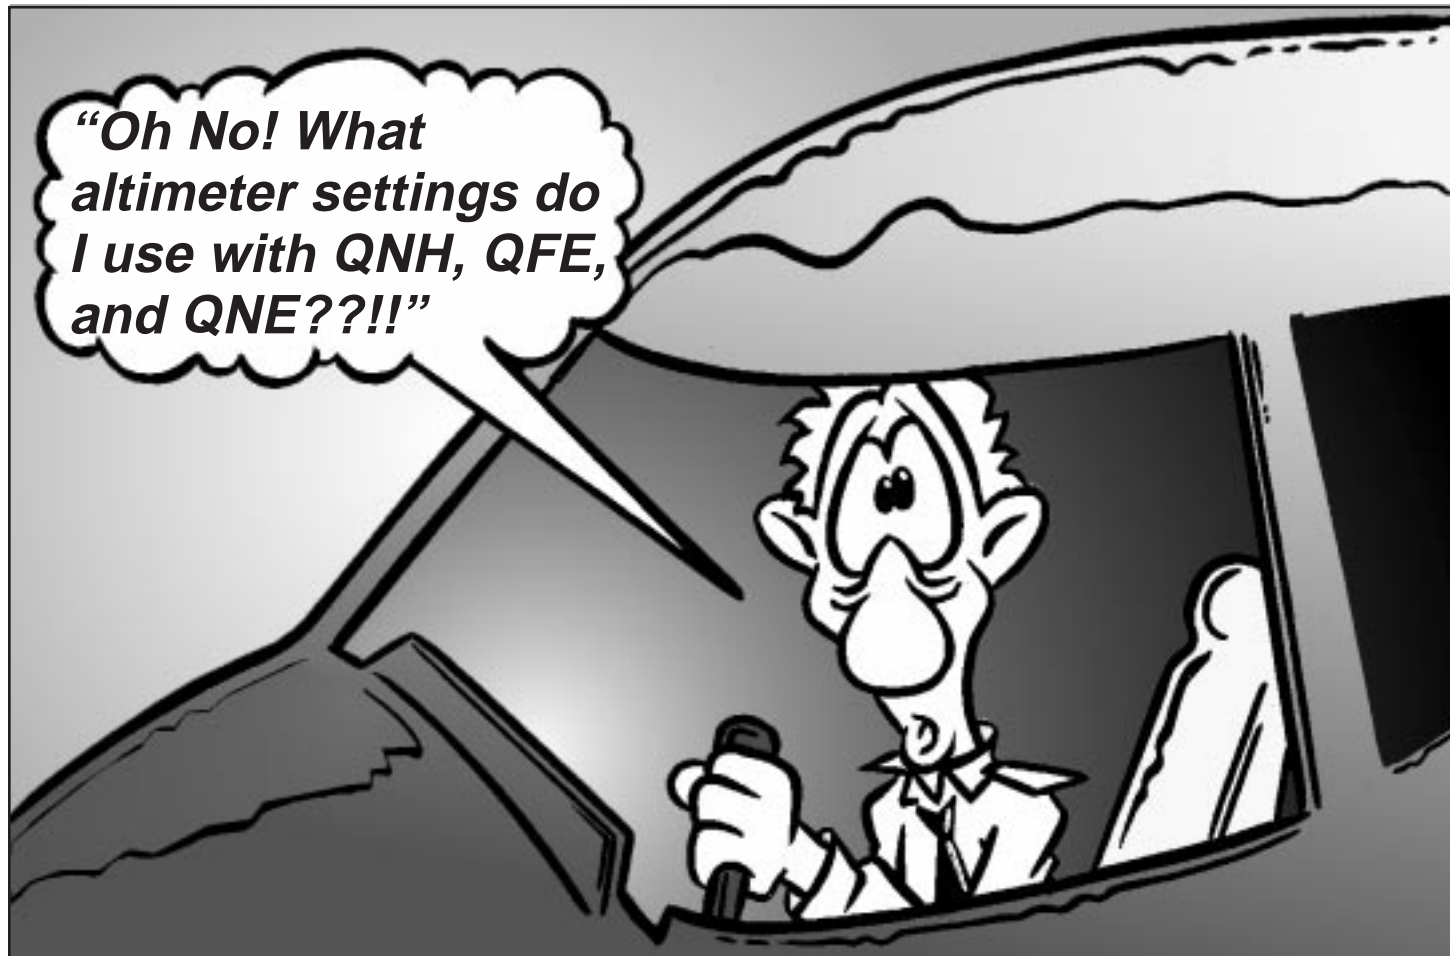
Figure 4-C.9

Extreme atmospheric anomalies, such as low temperatures or low pressures, can affect altimeters and result in reduced altitude margins of safety.

It is easy to make mistakes with altimeters. For example, 28.82 inches of mercury is an unusually low setting. Pilots have erroneously set 29 instead of 28 because of the rare occurrences of such a low setting. They have formed a habit of using the “normal” 29. *This mistake will make you fly 1,000 feet lower than required!*

- Know what altimeter units of measurement are used for the area.
- Know the phase of flight to apply the appropriate altimeter setting.
- Use altimeter setting cross-check and readback cockpit procedure.
- Cross-check radio altimeter and barometric altimeter readings.
- Operate at higher than minimum altitudes during atmospheric anomalies.
