SARG

Onshore Helicopter Review Report

CAP 1864

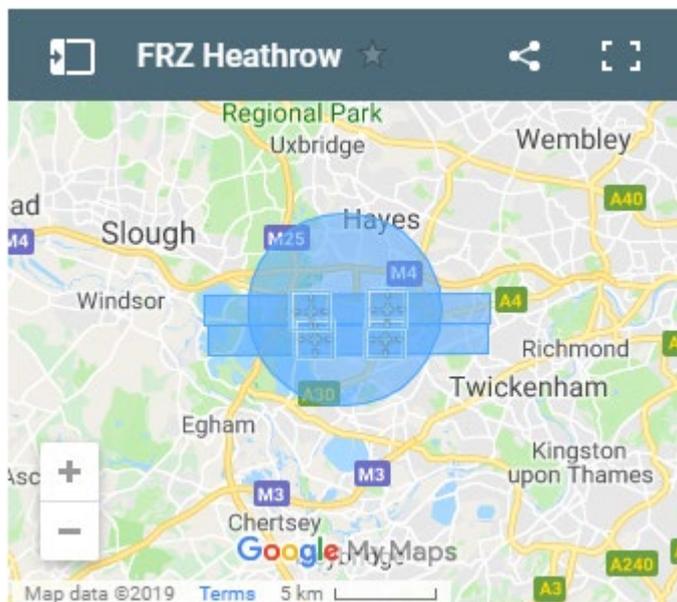
Following on from an incident at Gatwick airport in December 2018 where there were reports of drone activity within 1km of the airport boundary new regulations were put in place. On 13 March 2019 the drone flight restriction zone (FRZ) around airports and airfields came into place. This restriction uses the airfield existing aerodrome traffic zone which has a radius of either two or two and a half nautical miles and then 5km by 1km zones starting from the point known as the “threshold” at the end of each of the airfields runways. Both zones extend upwards to a height of 2000ft above the airfield. It is illegal to fly a drone at any time within these restricted zones unless you have permission from air traffic control at the airport or, if air traffic control is not operational, from the airport itself.

Figure 1 Heathrow flight restriction zone

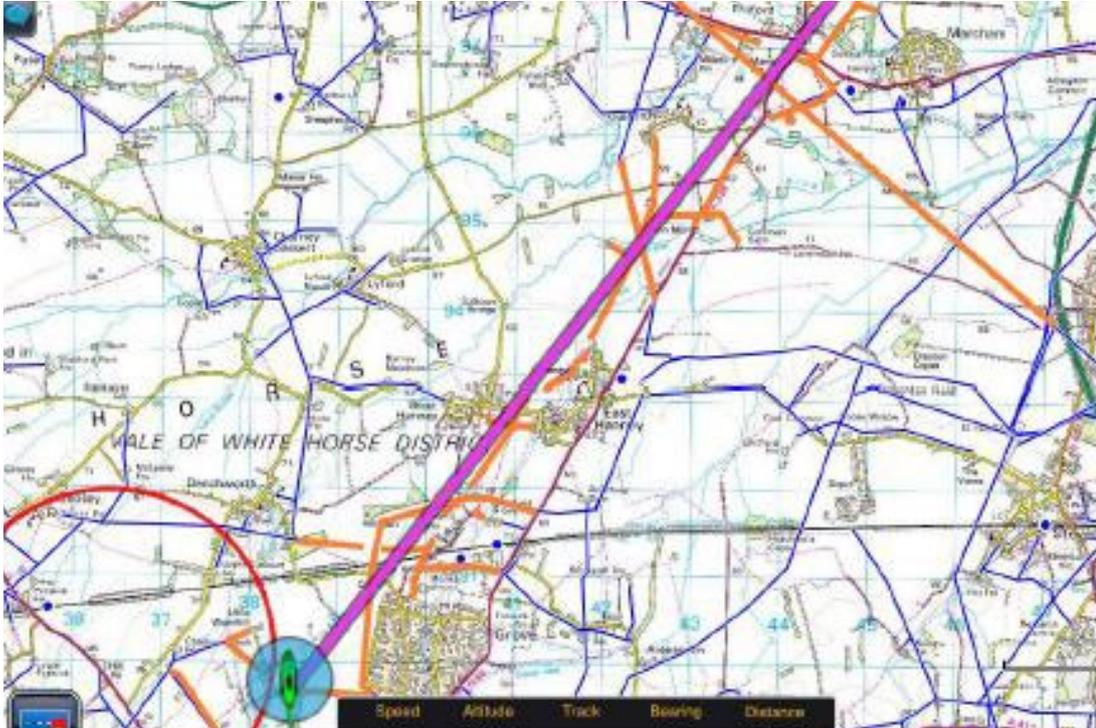
R18 *It is recommended that Police/SAR/HEMS operators should include in their safety risk mitigations, fitting their helicopters with systems for the detection and avoidance of obstacles and wires.*

Figure 3 Wire Awareness Software Product

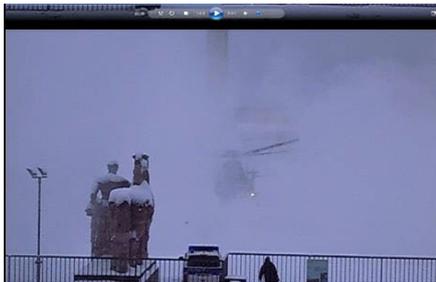
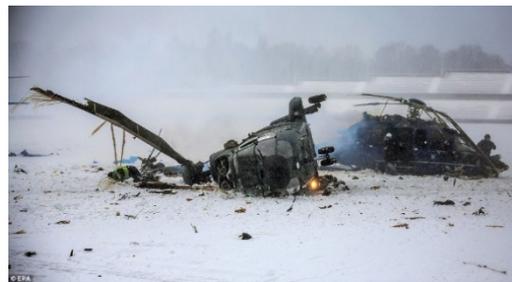
Figure 7 German Federal Police landing at the Olympia Stadium Berlin 21 March 2013

In Germany, an AS332 and EC155 helicopter collided in white out conditions at a sports stadium when landing during a training mission.

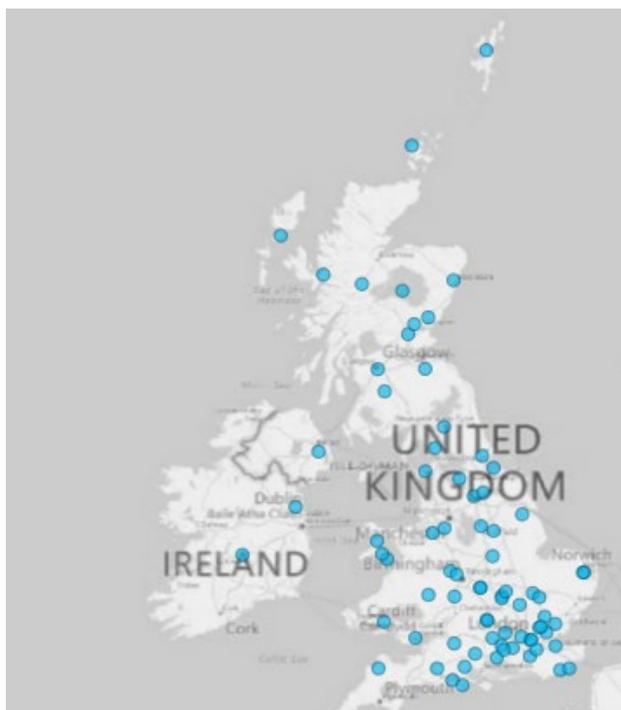
Figure 8 Locations of all accidents

It was agreed that the team should review the locations for all the accidents to elicit any connection with operators concerns with regard to terrain, airspace, aviation services or even weather factors. As such the locations are given in Figure 8. The research concludes there is no obvious connection to the event type and a geographic location. However, the wider report does cite those concerns further.

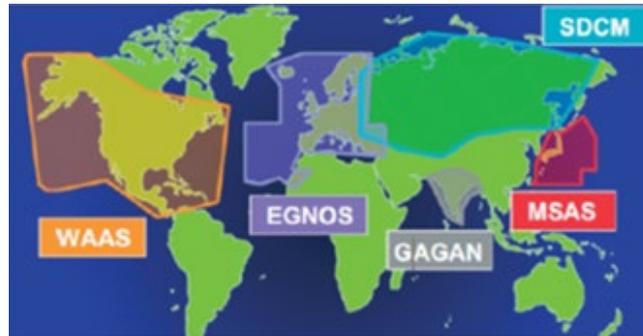
Figure 1 Interoperability with SBAS Systems

1. European Geostationary Navigation Overlay Service (EGNOS), is a Satellite based Augmentation System (SBAS), which improves GPS performance, by increasing accuracy and providing integrity which is crucial for safety critical applications.

EGNOS will give a unique opportunity to extend operational capabilities in HEMS and onshore operations whilst improving flight safety.

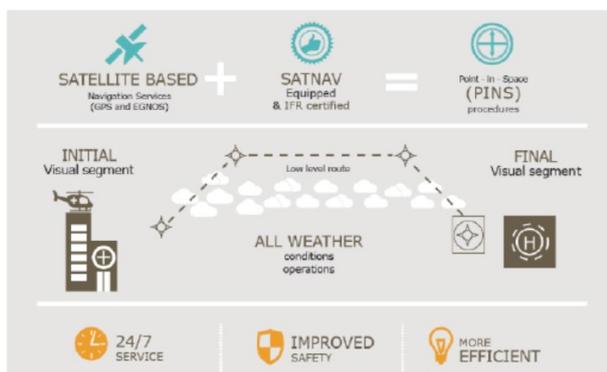
Figure 2 EGNOS for rotorcraft

- a. Improved IFR operations
 - b. Low-level RNAV routes
 - c. Point in space
 - d. Curved procedures
 - e. Direct approach with vertical guidance (LPV)
 - f. Simultaneous non-interfering operations
- 3 Point in Space, offers:
- a. An approach procedure designed for helicopters only, that includes both an instrument and a visual segment.
 - b. PinS approach is a non-precision approach (2D).

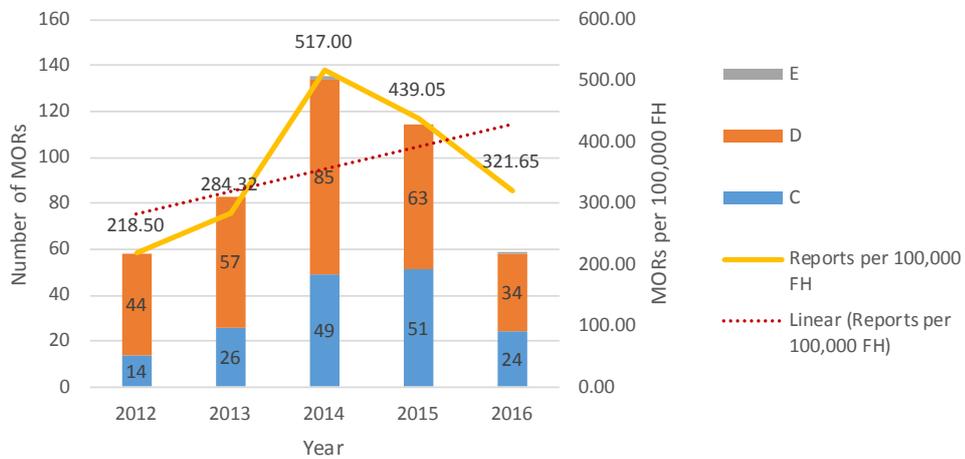
1.34 464 MOR's were received during the reporting period. The highest graded MOR received during the reporting period was graded at C1 medium severity and high probability. Peak reporting levels were between 2014 and 2015 and could be attributed to increased levels of reporting of fuel quantity issues, following the Glasgow Clutha accident and subsequent release of EASA AD's and TC holder Service Bulletins on the issue. Overall MOR reporting levels, per 100,000 Flight Hours were declining in 2015 and 2016. Reference

Figure 14 EC 135 MOR reporting levels and Grades 2012 - 2016

Number of EC 135 MORs and Rate of MORs per 100,000 Flight Hours

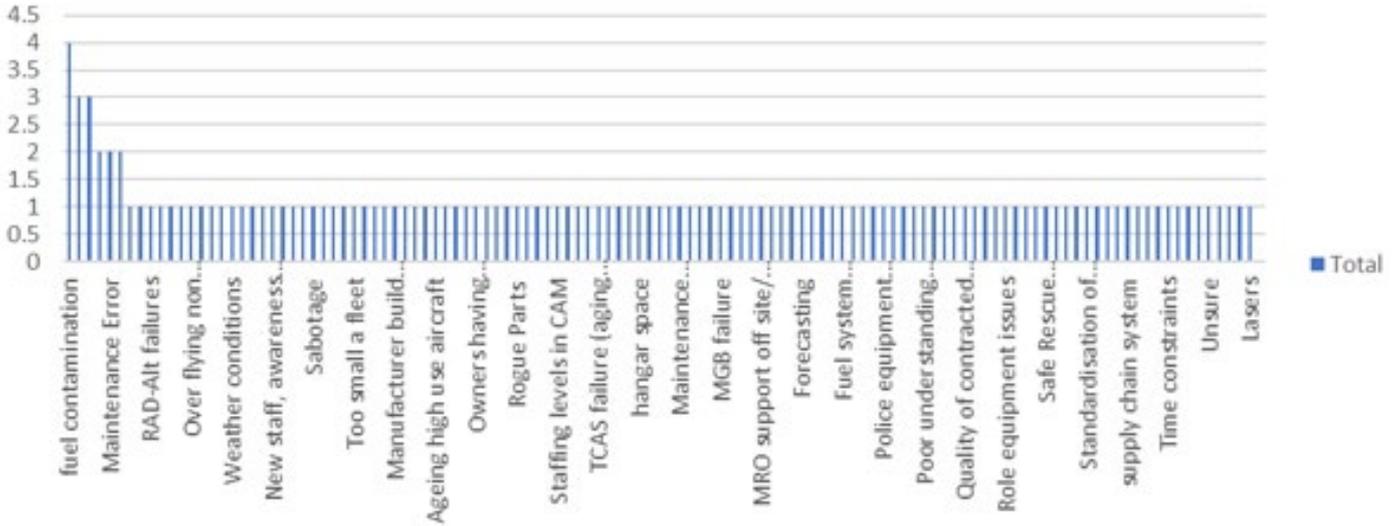
Figure 1 Survey Response

What, if identified, are the Top 5 Airworthiness related risks to your operation?

- 1.17 Engagement with the onshore helicopter A31 working group identified one key issue, that was not necessarily captured through the industry survey. The issue related to the provisioning of Instructions for Continued Airworthiness, specifically newly introduced types to their respective operations. ICA's were often incomplete, missing or ambiguous resulting in additional burden and pressure on operations and engineering personnel when they were faced with performing certain maintenance tasks. The CAA has engaged with operators to capture current issues relating to the provisioning of ICA data and has shared this with EASA. It is recommended that a review of the provisioning of ICA's is conducted to ensure future helicopter entries to service is improved to mitigate the burden and pressure placed on operators.
