Aircraft Serious Incident Report

In-Flight Crew Incapacitation

A321-200, HL8071

**During Approach to Kaohsiung International
Airport(KHH) in Taiwan(60NM North)**

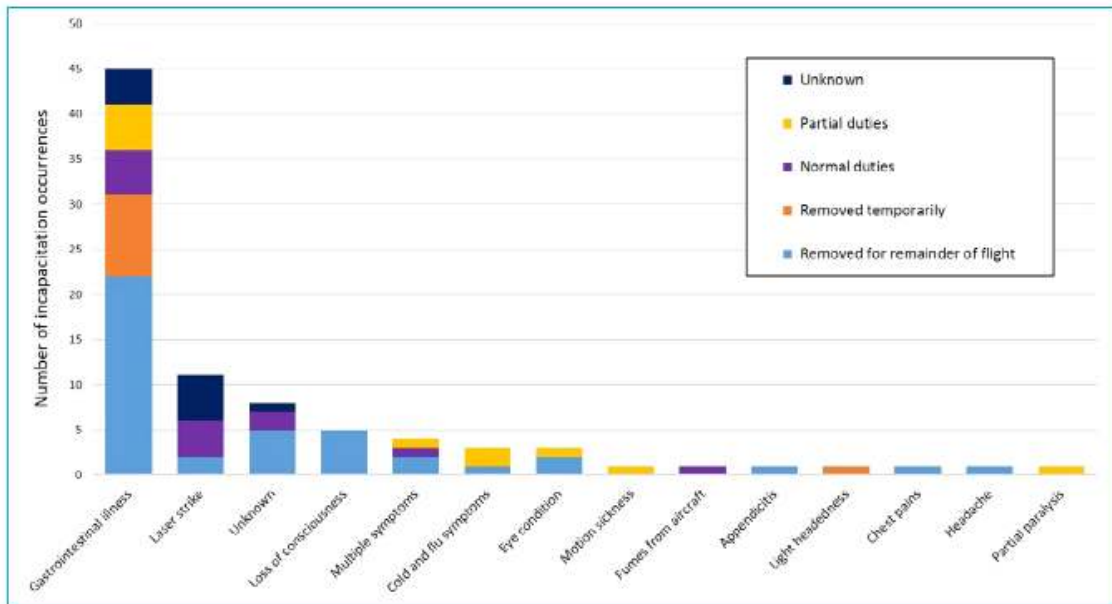
[Figure 4] Cause of Crew Incapacitation (ATSB Research Report)

According to ATSB report(AR-2015-096), there have been 86 cases of flight crew (Transport category) incapacitation during the research period from 2010 to 2014. About more than 50% of the incapacitation occurrences were related to gastroenteritis such as food poisoning. Five cases were related to crew unconsciousness. (See Figure 4)

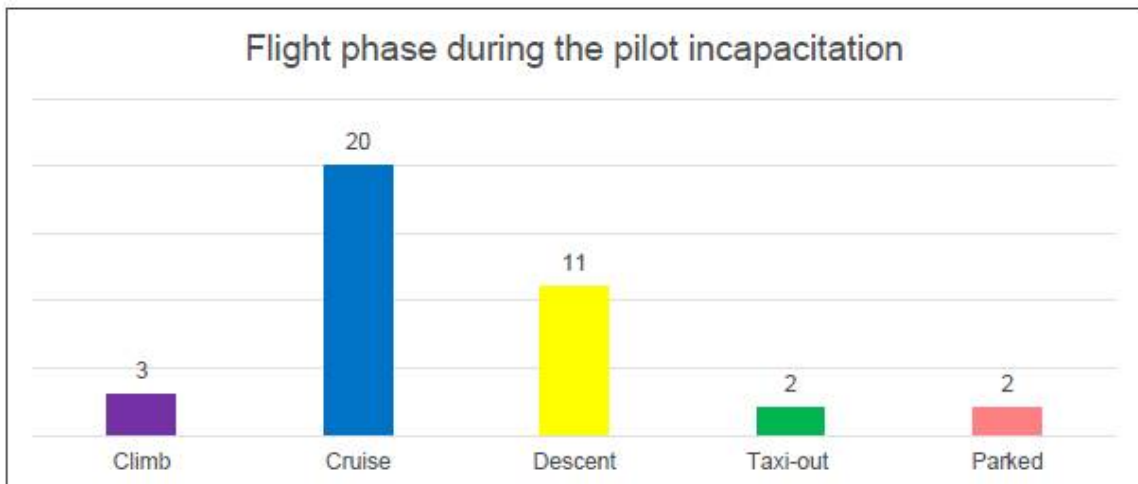
[Figure 5] Frequency of each flight phase during pilot incapacitation
(UAE Accident Investigation Report)

According to the UAE report as shown in [Figure 5], crew incapacitation commonly occurred in cruise and descent phase of a flight. The investigation relayed both reports to the operator for reference. The operator changed the simulator training profile of the pilot incapacitation from climb phase to descent phase.

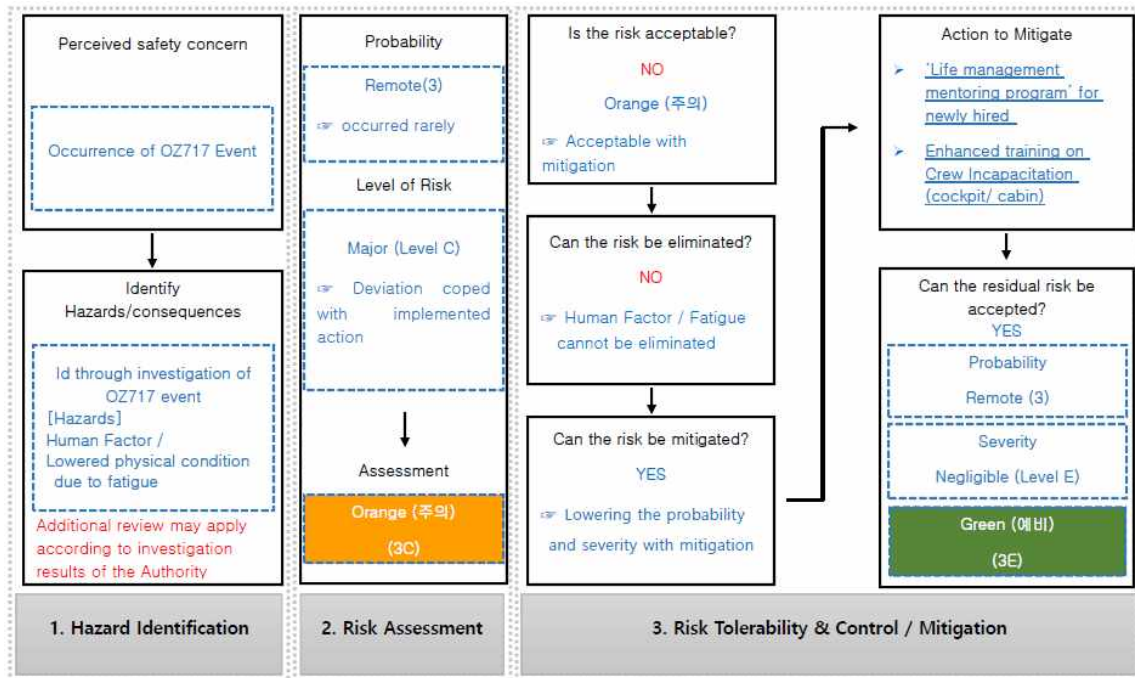
[Figure 9] SMS Risk Analysis and Process of Mitigation Measure

After the serious incident occurred, the operator has held its own safety committee to identify issues, measure risk factors, endure risk, take mitigation measures and analyze action results as prescribed in safety management system manual. As a result, the operator performed improvement activities for two actions taken to mitigate risk factors.

1. Provide personal life management program for newly employed first officers
2. Enhance training in response to crew incapacitation (operations/cabin)
