HAZARDOUS WEATHER PHENOMENA

High Ice Water Content

Bureau of Meteorology › Aviation Weather Services

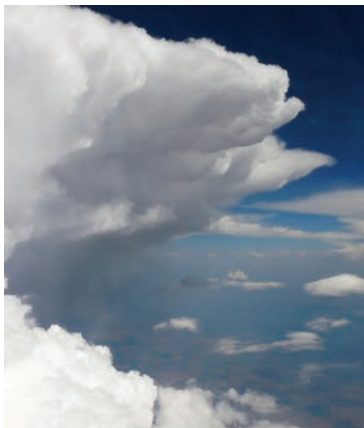
Anvil cloud
